***Pacific Gas and
Electric Company***

Diablo Canyon Units 1 and 2

Licensee Event Report 1-1999-007-01

Plant Outside Design Basis Due to Degraded Indicating Lamp Sockets

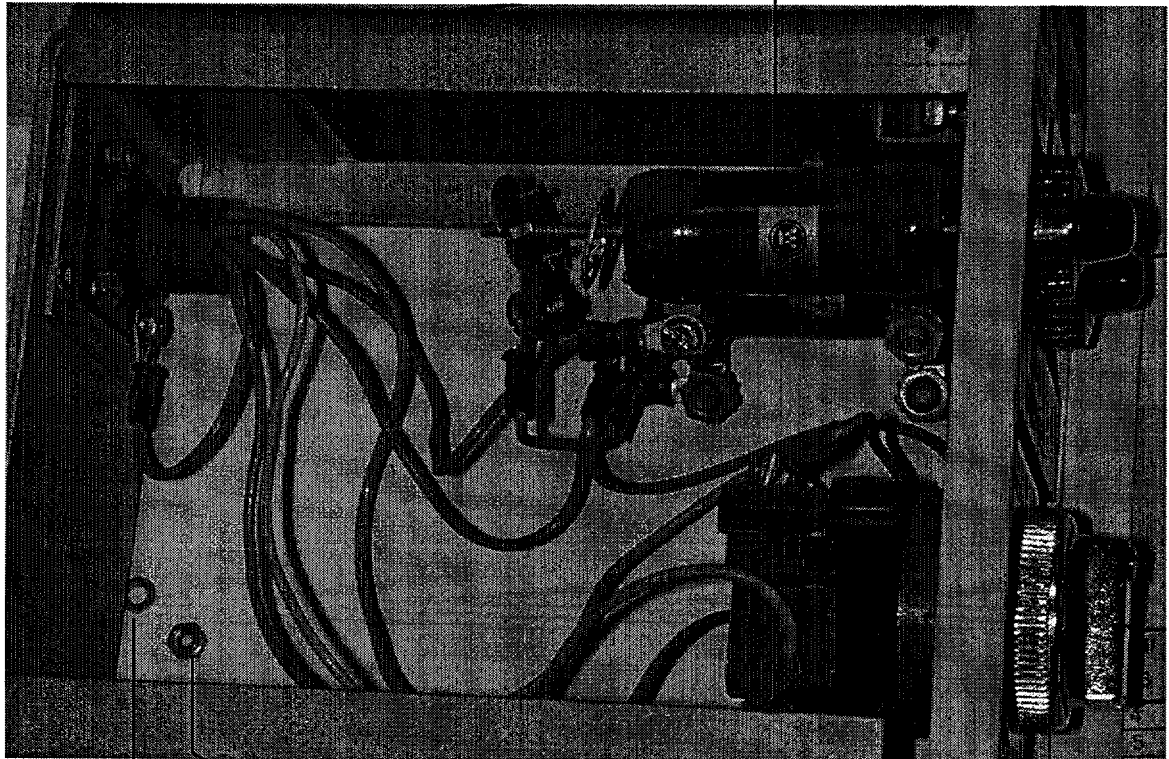
Figure 1
Broken Minalite Socket Installed

The socket assemblies were originally supplied by Westinghouse as a subcomponent of the control boards. Refer to Figures 1 and 2 for illustrations of the lamp socket placement within a switch module and identification of major components, respectively.

PG&E found two specific degraded conditions in the sockets. Some sockets were broken (separated). Others were cracked to various extents but the socket remained integral. PG&E has replaced broken sockets and cracked sockets that broke during a 3-lb force check. PG&E has also replaced many of the cracked sockets.

The root cause was determined to be lamp socket design. An easily achievable torque in the socket assembly retaining nut generates a stress in the plastic socket material exceeding its yield value. Plasticity occurs along with creep (time dependent deformation) at the socket operating temperature.

The creep eventually leads to cracking at the top edge of the socket's

thinnest section. The crack continues to grow as long as some stress remains. The failure mechanism proceeds until either the stress is relieved by the crack opening further, or the socket breaks.

The inspections include a visual inspection of the socket with an insulated boroscope to identify cracking or breakage. In addition, a structural integrity check is performed by applying 3-lbs of force using an insulated force gage. The remaining sockets will be inspected and replaced as necessary.

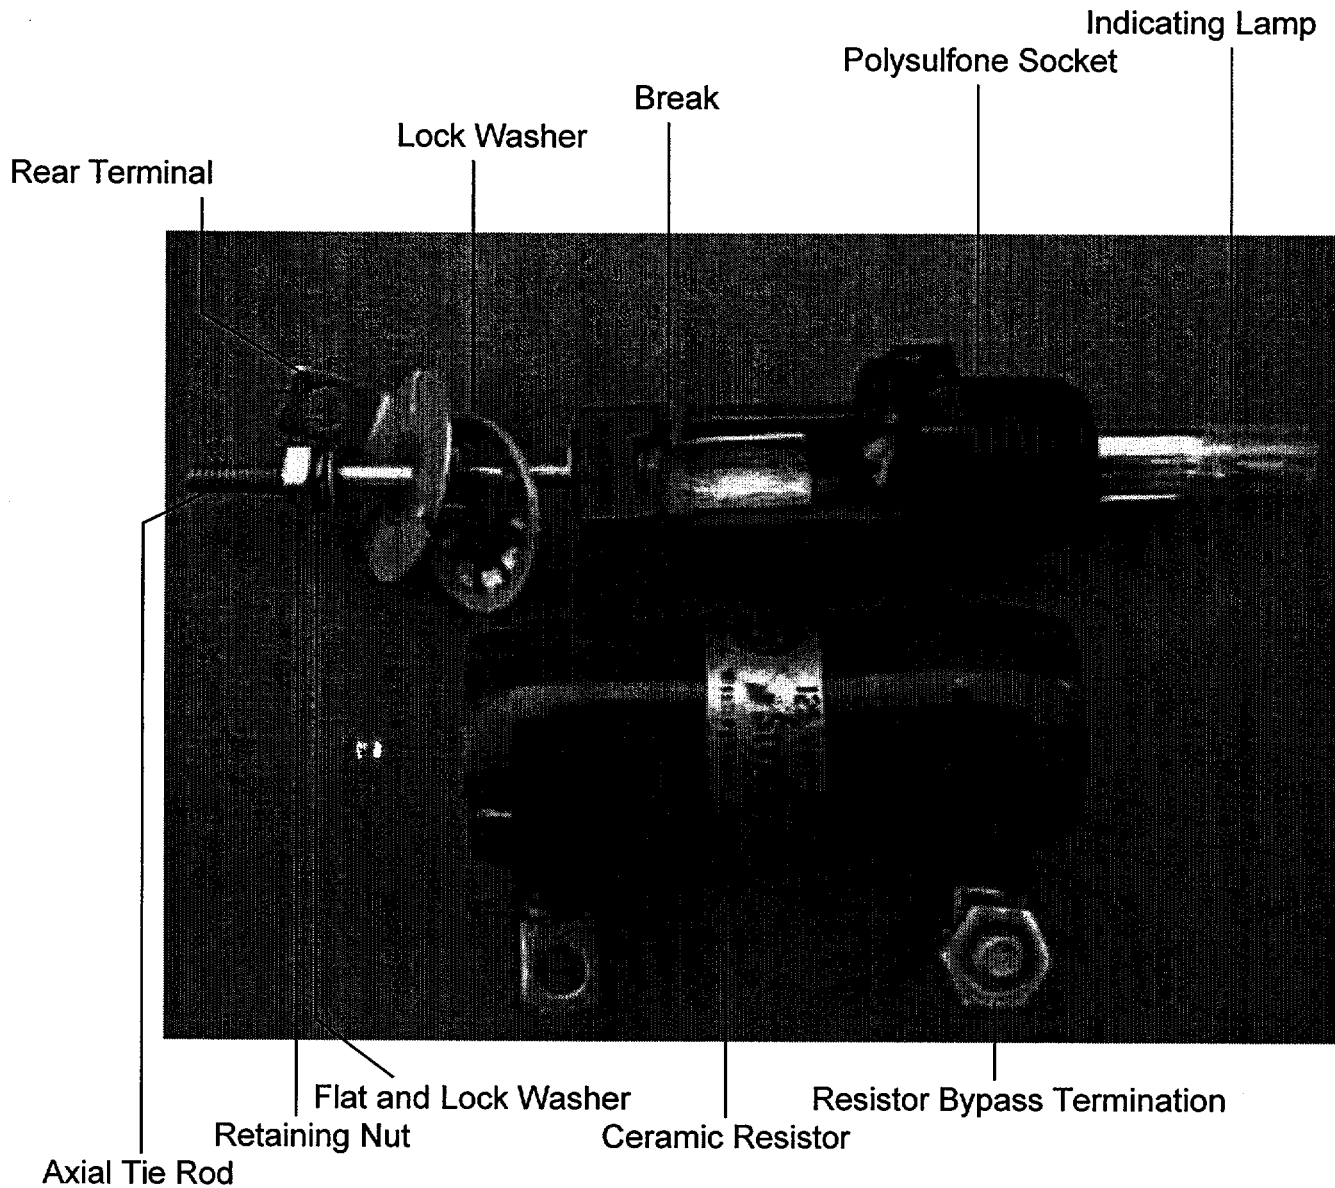
Figure 2
Disassembled Lamp Socket Assembly

The cause of the condition is lamp socket design. An easily achievable torque in the socket assembly retaining nut generates a stress in the plastic socket material exceeding its yield value. Time dependent deformation occurs, eventually leading to cracking and failure.
