Beaver Valley Power Station, Unit No. 2
Docket No. 50-412 License No. NPF-73
LER 99-009-01

LER 99-009-01

TITLE (4)
Missed Performance of Technical Specification Surveillance Requirement 4.8.1.1.1a Following Failure to Re-Establish Auto Bus Transfer Capability of 4KV Bus 2A

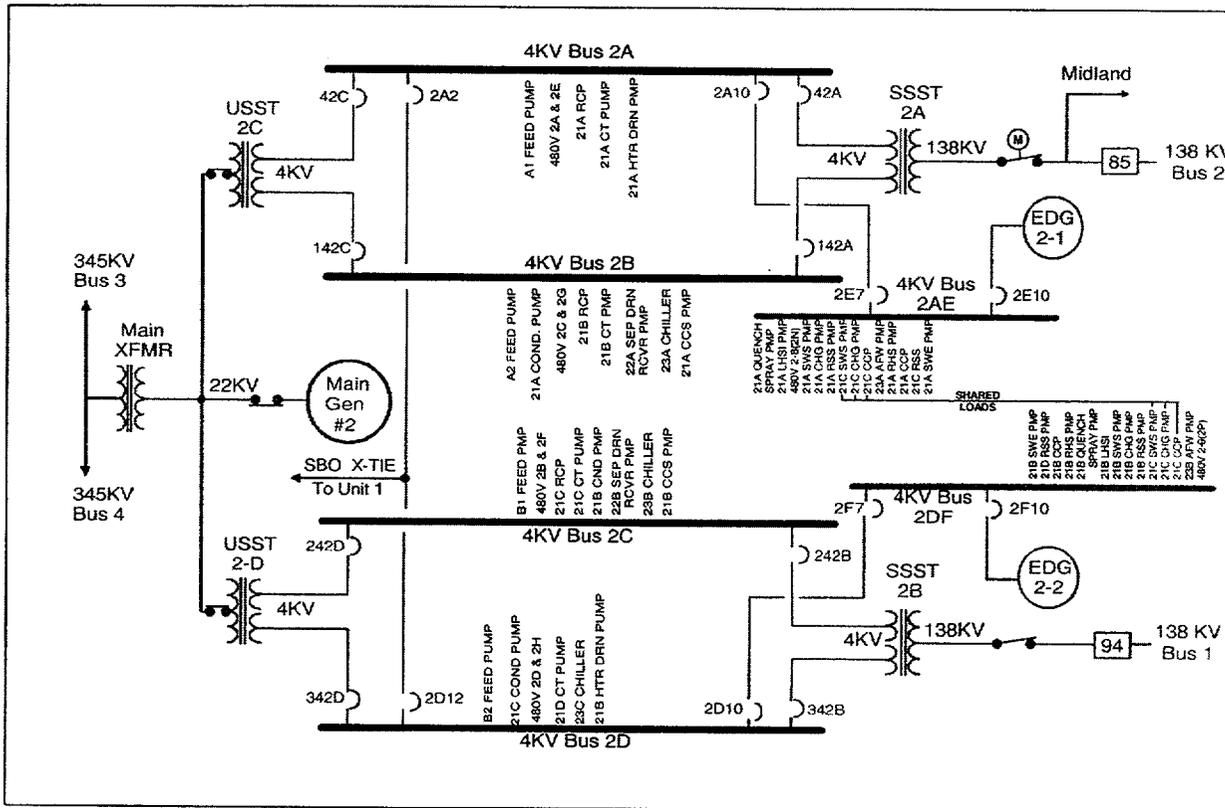
FIGURE 1

On October 12, 1999, at approximately 1730 hours, the power supply input to Unit 2 4KV Bus 2A was transferred from the onsite Unit Station Service Transformer (USST) 2C to the offsite System Station Service (SSST) Transformer 2A (see Figure 1). This was done to support start-up of a cooling tower pump. The pump was started and 4KV Bus 2A was realigned back to USST 2C, at approximately 1741 hours (same day). Subsequently, at approximately 0322 hours on October 13, 1999, it was discovered that the auto bus transfer feature of 4KV Bus 2A to the off-site alternating current (A.C.) power source had not been reestablished when 4KV Bus 2A was realigned back to USST 2C. This event occurred when the auto-closure circuit for input power supply breaker ACB-42A of SSST 2A to 4KV Bus 2A Bus was not placed in the "after-close position", as required by procedure. This had rendered 4KV automatic offsite A.C. power to Bus 2A inoperable and required entry into ACTION a of Technical Specification (TS) 3.8.1.1 within 1 hour, which was not performed. The TS implications of this event were recognized at approximately 1700 hours on October 13, 1999.

This event resulted from personnel error by the PO on October 12, 1999, when he failed to properly line up the auto-closure circuit for input power supply breaker ACB-42A of SSST 2A to 4KV Bus 2A.

4KV Electrical Distribution - Unit 2
