James A. FitzPatrick  
Nuclear Power Plant  
268 Lake Road  
P.O. Box 41  
Lycoming, New York 13093  
315-342-3840

Subject: **Docket No. 50-333**  
**LICENSEE EVENT REPORT: LER-00-002 (DER-00-00348)**

**HPCI Inoperable Due To Speed Control Problem**

**TITLE (4)**  
HPCI Inoperable Due To Speed Control Problem

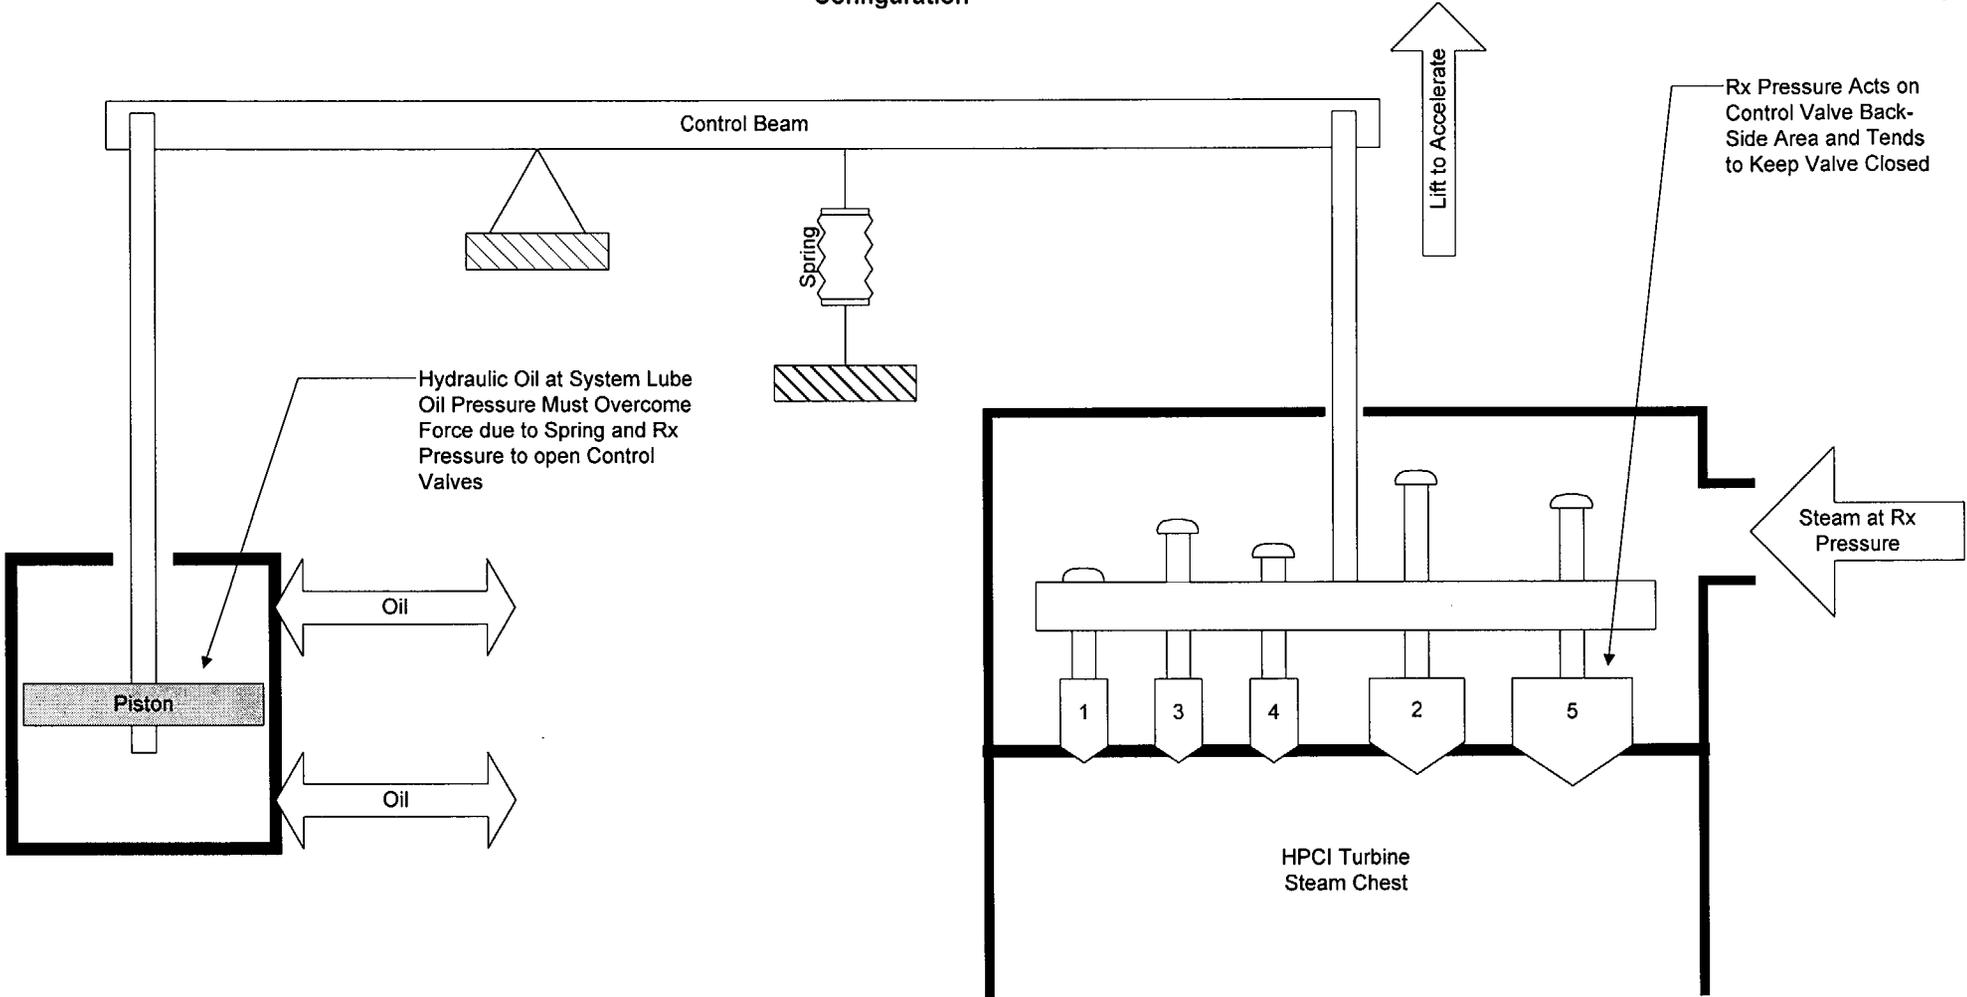
Figure 1  
LER 00-002

The HPCI turbine steam chest is configured with 5 control valves (CVs) of varying diameters, which open in stages to admit steam to the HPCI turbine. These valves are sized to maintain adequate turbine horsepower over the entire spectrum of reactor pressures for which the HPCI system is credited (150-1195 psid-Reactor to Torus). In order to open any one CV, the hydraulic oil pressure must overcome the combined force of the spring, which closes all CVs on loss of oil pressure, and the force due to reactor pressure acting on the upstream side of the respective CV.

The high hydraulic oil pressure resulted in the equilibrium force balance on CV5 occurring at higher reactor pressures than intended by original design, resulting in opening CV5. When CV5 opened at these higher reactor pressures, high-energy steam was admitted to the turbine steam chest through CV5 causing speed transient which was corrected by the HPCI System speed control loop.

Post event evaluation also determined that the spring tension on the HPCI governor control beam was not in accordance with the vendor manual. This discrepancy had an effect analogous to high system oil pressure because it took less force from the hydraulic control system to open CV5 than it would have with the spring tension set in accordance with the vendor manual.

An evaluation of the relative contribution of these discrepancies determined that the oil system setpoint was the predominant contributor to the speed transient and that the spring tension setting contributed to a lesser degree.

Simplified Diagram  
HPCI Control Valve  
Configuration

1. The HPCI system oil pressure was reset to a lower value with the turbine running at 4000 RPM. This resolved the degraded condition. **(Complete)**
2. This condition resulted in the HPCI system discharge piping and associated instrumentation being subjected to pressures beyond design. The condition of the piping and associated instrumentation was evaluated and determined to be operable. **(Complete)**

5. The spring tension on the HPCI governor control beam will be reset in accordance with the vendor manual. **(Scheduled Completion Date: Prior to Restart from RO14)**
