Millstone Nuclear Power Station, Unit No. 2
Licensee Event Report 2000-001-00
Manual Reactor Trip Due to Secondary System Transient

LER 2000-001-00

TITLE (4)
Manual Reactor Trip Due to Secondary System Transient

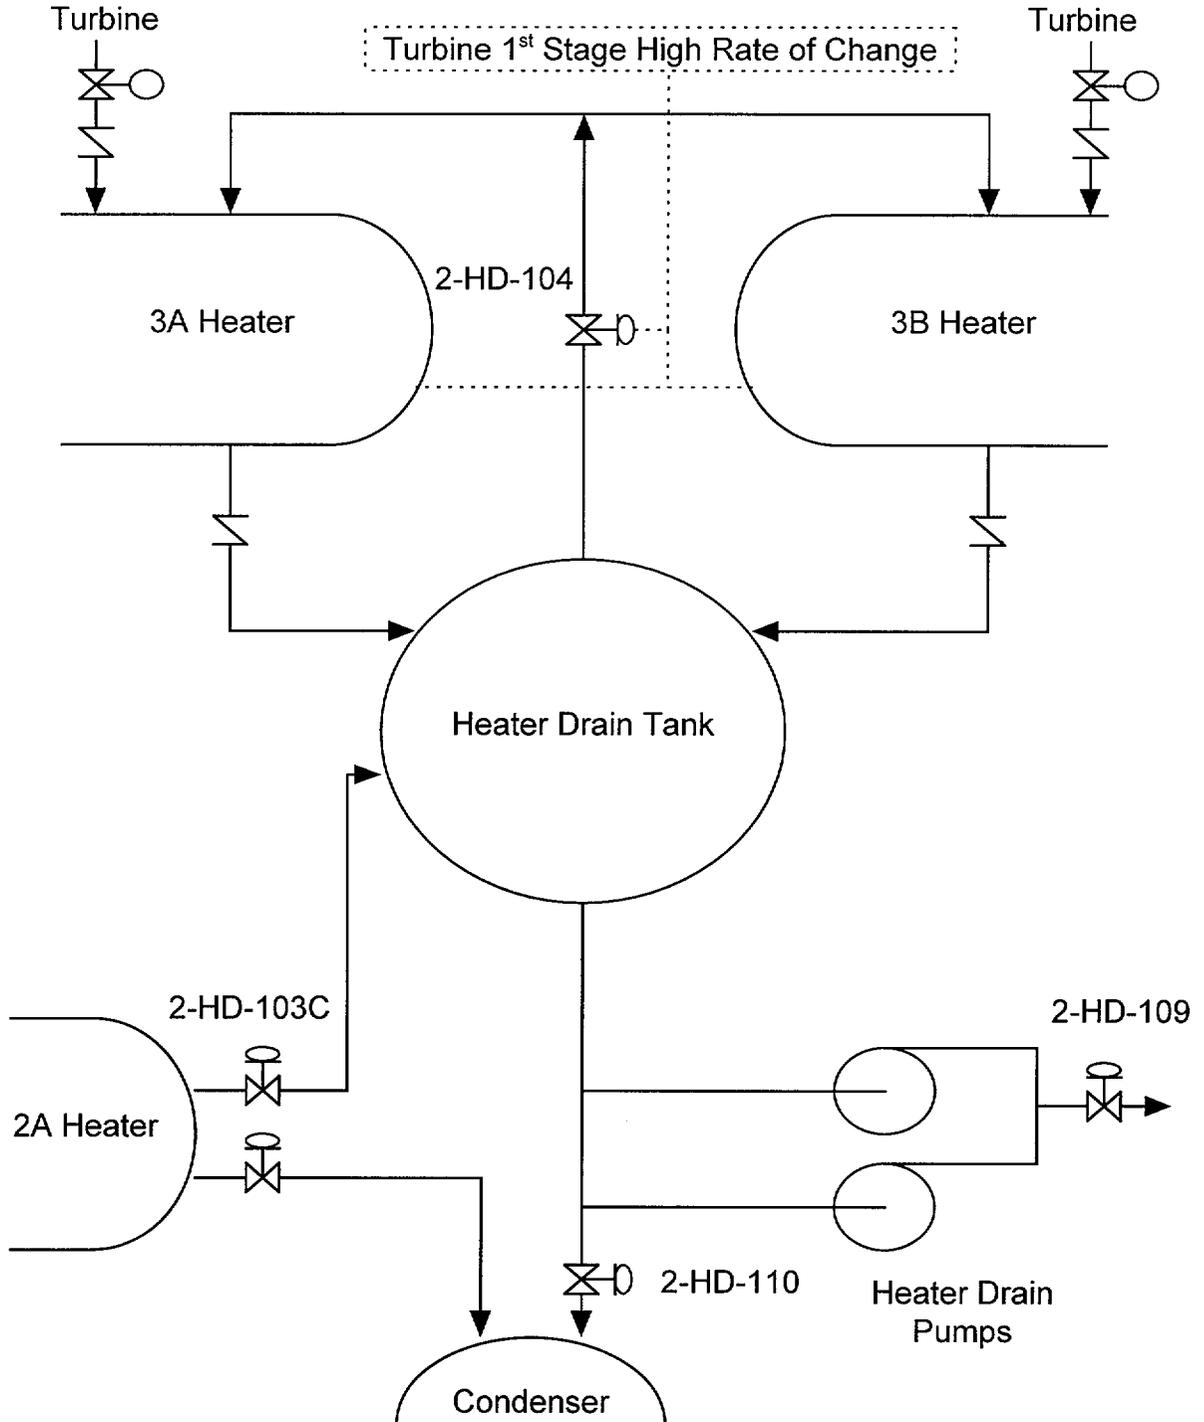
Figure 1

After post-trip analysis, it was determined that the transient was initiated following a leak repair and restoration of the 2A feedwater heater [HX] sight glass [LG] (see figures 1 and 2 for simplified arrangement sketches of the heater drain system [SM] and sight glass/level sensor). This action combined with a slow actuation of the 2A feedwater heater level control valve [LCV] 2-HD-103C, exacerbated the severity of the transient, resulting in a large volume of relatively hot water entering the heater drain tank [TK]. Heater drain tank pressure increased, stopping or reducing flow from the 3A/B feedwater heaters resulting in high level and automatic extraction steam valve isolation.

With extraction steam isolated to the 3A/B heaters, steam pressure in those heaters decayed approximately 30 psi over a short time period. During this period, the heater drain tank vent valve [VTV] 2-HD-104 to the 3A/B feedwater heaters remained open from the initiation of the transient until the main turbine [TRB] tripped following the reactor trip. This vent valve should have closed upon receipt of either the 3A or 3B heater high level alarm. With the vent valve open and extraction steam isolated, the 3A/B heaters condensed steam from the heater drain tank and caused a rapid depressurization of the tank. Because conditions in this portion of the feedwater heater system are near saturation conditions, the sudden loss of pressure caused the water in the heater drain tank to flash to steam which ultimately resulted in a loss of net positive suction head to the heater drain pumps and loss of heater drain flow to the SGs. Shortly thereafter, SG feed pump suction pressure decreased and resulted in a SGFP trip. As level in the SGs began to decrease, the primary plant was manually tripped.

It was determined that this event was caused by the loss of all heater drain flow to the suction of the SGFPs as a result of bulk flashing in the heater drain tank. As event precursors, it was determined that the transient was initiated due to the restoration of the 2A feedwater heater's sight glass causing oscillations in the feedwater control system that adversely affected the systems' ability to recover from the transient. Also, it was concluded that the heater drain tank vent control valve 2-HD-104 control logic wiring did not permit the valve to function properly in order to mitigate the consequences of a loss or rapid reduction of extraction steam pressure on the heater drain tank.

1. The feedwater heater system performance was optimized by improving the stroke time for the level controller valve.
2. The control logic for 2-HD-104 has been corrected such that the valve will close to prevent depressurization of the heater drain tank.
