Subject: Grand Gulf Nuclear Station  
Docket No. 50-416  
License No. NPF-29  
Main Steam Lines Exceeded Leakage Limits  
LER 1999-006-01

GNRO-2000/00012

NRC FORM 366 (6-1998)		U.S. NUCLEAR REGULATORY COMMISSION			APPROVED BY OMB NO. 3150-0104 EXPIRES 06/30/2001 Estimated burden per response to comply with this mandatory information collection request: 50.0 hrs. Reported lessons learned are incorporated into the licensing process and fed back to industry. Forward comments regarding burden estimate to the Records Management Branch (T-6 F33), U.S. Nuclear Regulatory Commission, Washington, DC 20555-0001, and to the Paperwork Reduction Project (3150-0104), Office of Management and Budget, Washington, DC 20503. If an information collection does not display a currently valid OMB control number, the NRC may not conduct or sponsor, and a person is not required to respond to, the information collection.				
<b>LICENSEE EVENT REPORT (LER)</b>					DOCKET NUMBER (2) <b>05000-416</b>		PAGE (3) <b>1 of 8</b>		
FACILITY NAME (1) <b>Grand Gulf Nuclear Station</b>					TITLE (4) <b>Main Steam Lines Exceeded Leakage Limits</b>

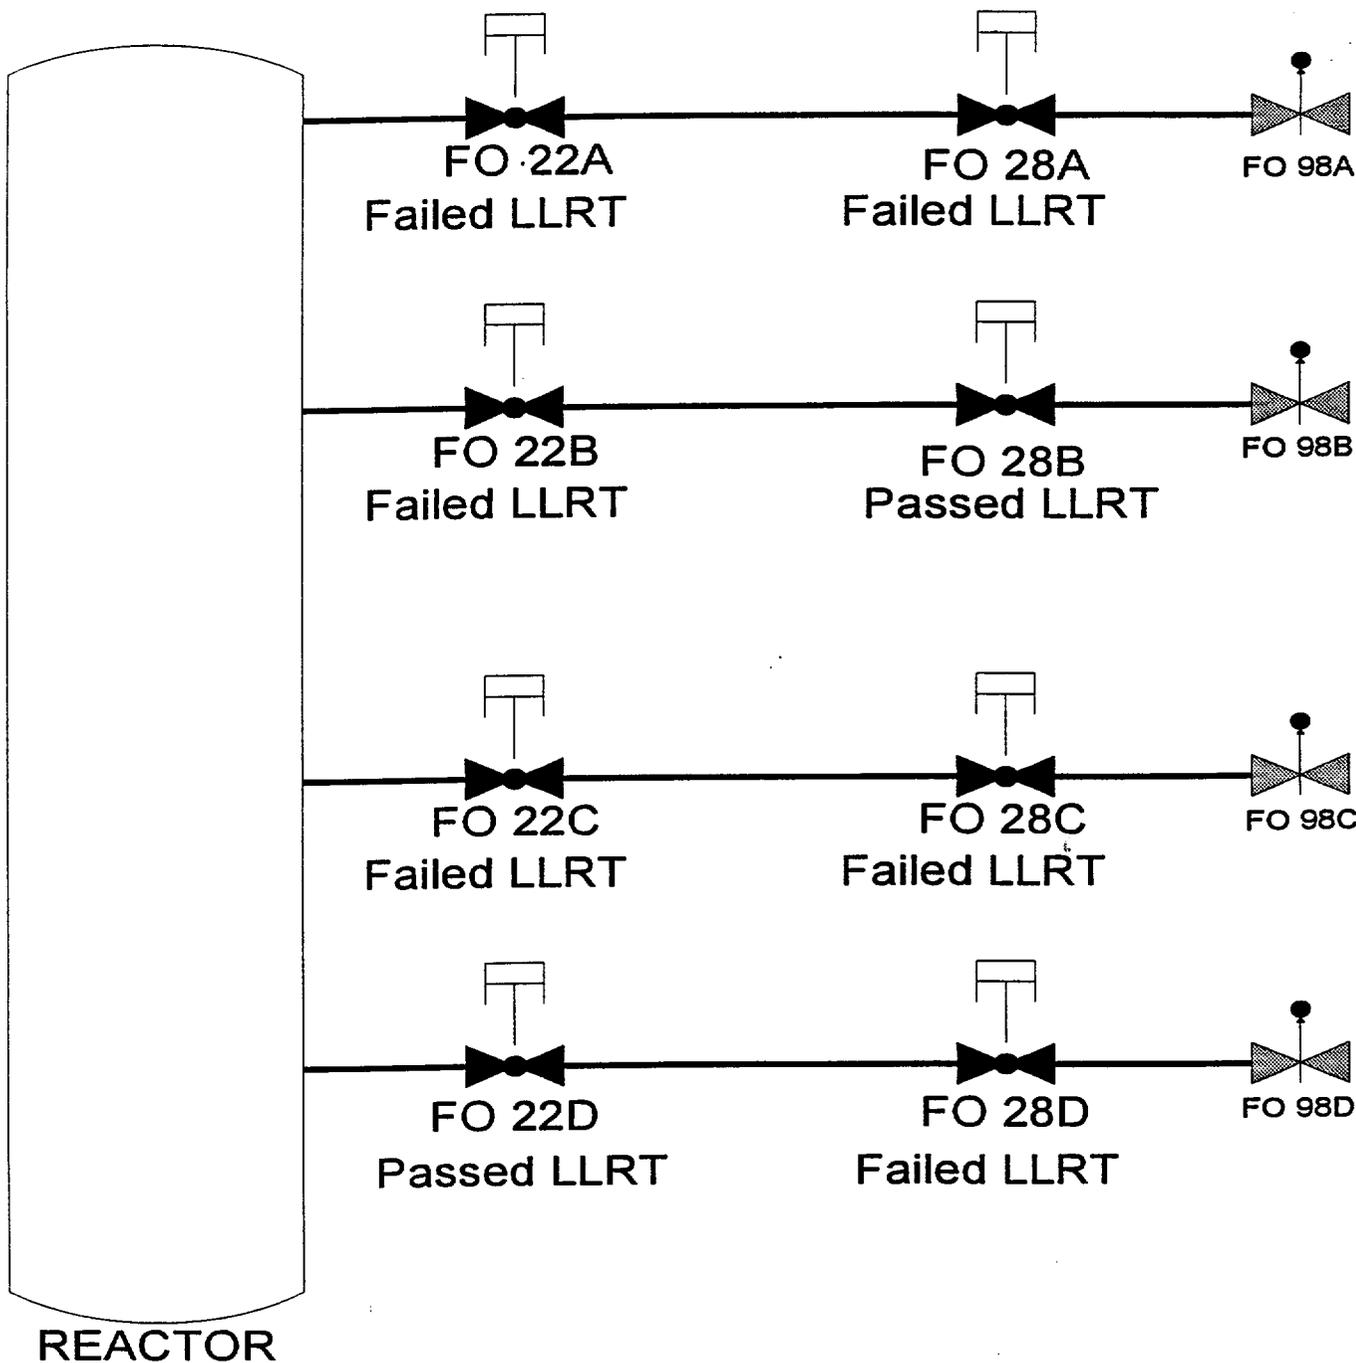
Technical Specification 3.6.1.3 requires that the leakage rate through all four main steam line penetrations be limited to a cumulative leakage rate of less than or equal to 100 scfh (47,200 sccm). Following performance of Local Leak Rate Testing of all eight MSIVs, the leakage rates for six of the valves exceeded both the Technical Specification leakage limit for total MSL leakage and the acceptance limit of 11,800 sccm (25 scfh) for each individual MSIV (minimum pathway leakage). Of this population of six MSIVs, the leakage through four MSIVs could not be quantified due to excessive leakage beyond the capability of the test equipment to pressurize the test volume to the required test pressure. Thus, the leakage is considered to have exceeded the total TS allowed MSL penetration leakage of 100 scfh (47,200 sccm). As-found data for each of the eight MSIVs is provided in Section G "Additional Information", of this report. Section G also provides as Figure 1, an information-only schematic of the valve configurations being discussed in this report. The MSSVs are designated as F098A-D.

Realistically, it is not expected that this condition would have resulted in a large release given a postulated radiological accident since the MSLs can be isolated by the Main Steam Shutoff Valves (MSSVs), designated in Figure 1 as F098A-D. The MSSVs were verified to be leaktight by testing and confirmed to have been capable of mitigating the magnitude of any postulated offsite releases. If during a LOCA, adequate core cooling cannot be maintained, then entry into the Severe Accident Procedures (SAPs) would occur. The SAPs direct operators to initiate the MSIV Leakage Control (MSIV-LCS), if required. Procedure 04-1-01-E32-1 states that the outboard MSIV-LCS is the preferred system to initiate, which directs closure of the MSSVs. While these valves do not meet the redundant power supply requirement (i. e., all MSSVs are powered by ESF Div. II), their effectiveness in isolating the steam lines and thus substantially mitigating any postulated steam line releases would be assured for all but the very low probability event of a severe accident coincident with both a loss of offsite power and a Div. II failure.
