LER 2000-001
Davis-Besse Nuclear Power Station, Unit No. 1
Date of Occurrence - September 26, 1998

FACILITY NAME (1) Davis-Besse Unit Number 1		DOCKET NUMBER (2) 05000346	PAGE (3) 1 OF 6
--	--	-------------------------------	--------------------

TITLE (4)
Failure To Perform Technical Specification Action With Switchyard Circuit Inoperable Due To Inadequate Procedure

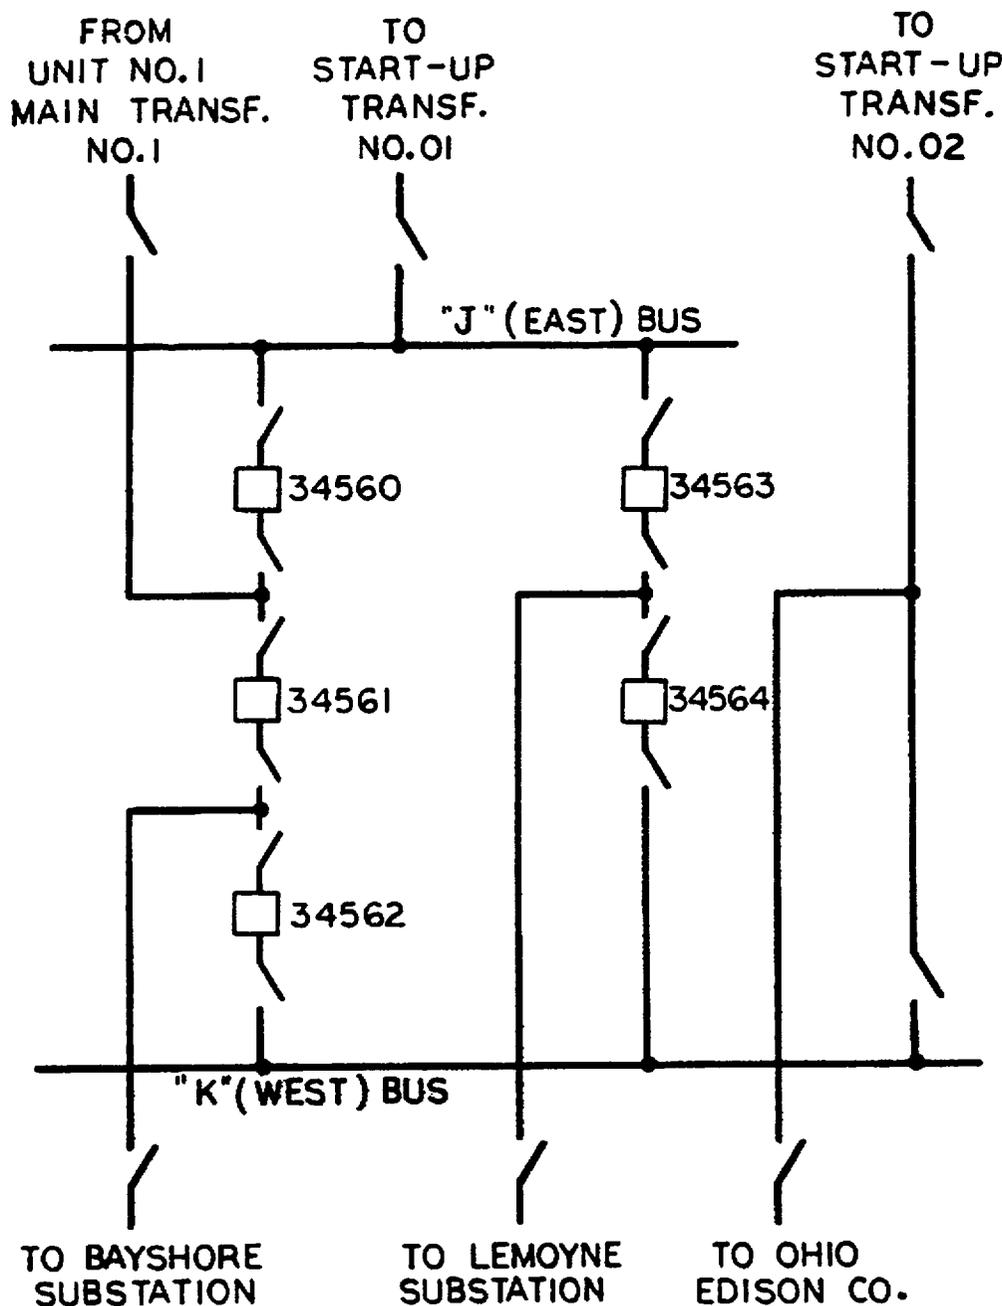
FIGURE 1

Davis-Besse Nuclear Power Station 345 kV Switchyard One-Line Diagram
