1CAN020006

Subject: Arkansas Nuclear One - Unit 1
Docket No. 50-313
License No. DPR-51
Alternate Code Repair for the ANO-1 Hot Leg Level Nozzle RC-1071/1072

**ENTERGY OPERATIONS, INC.
ARKANSAS NUCLEAR ONE – UNIT 1
3rd TEN YEAR INTERVAL
REQUEST NO. 00-1-001, Revision 0**

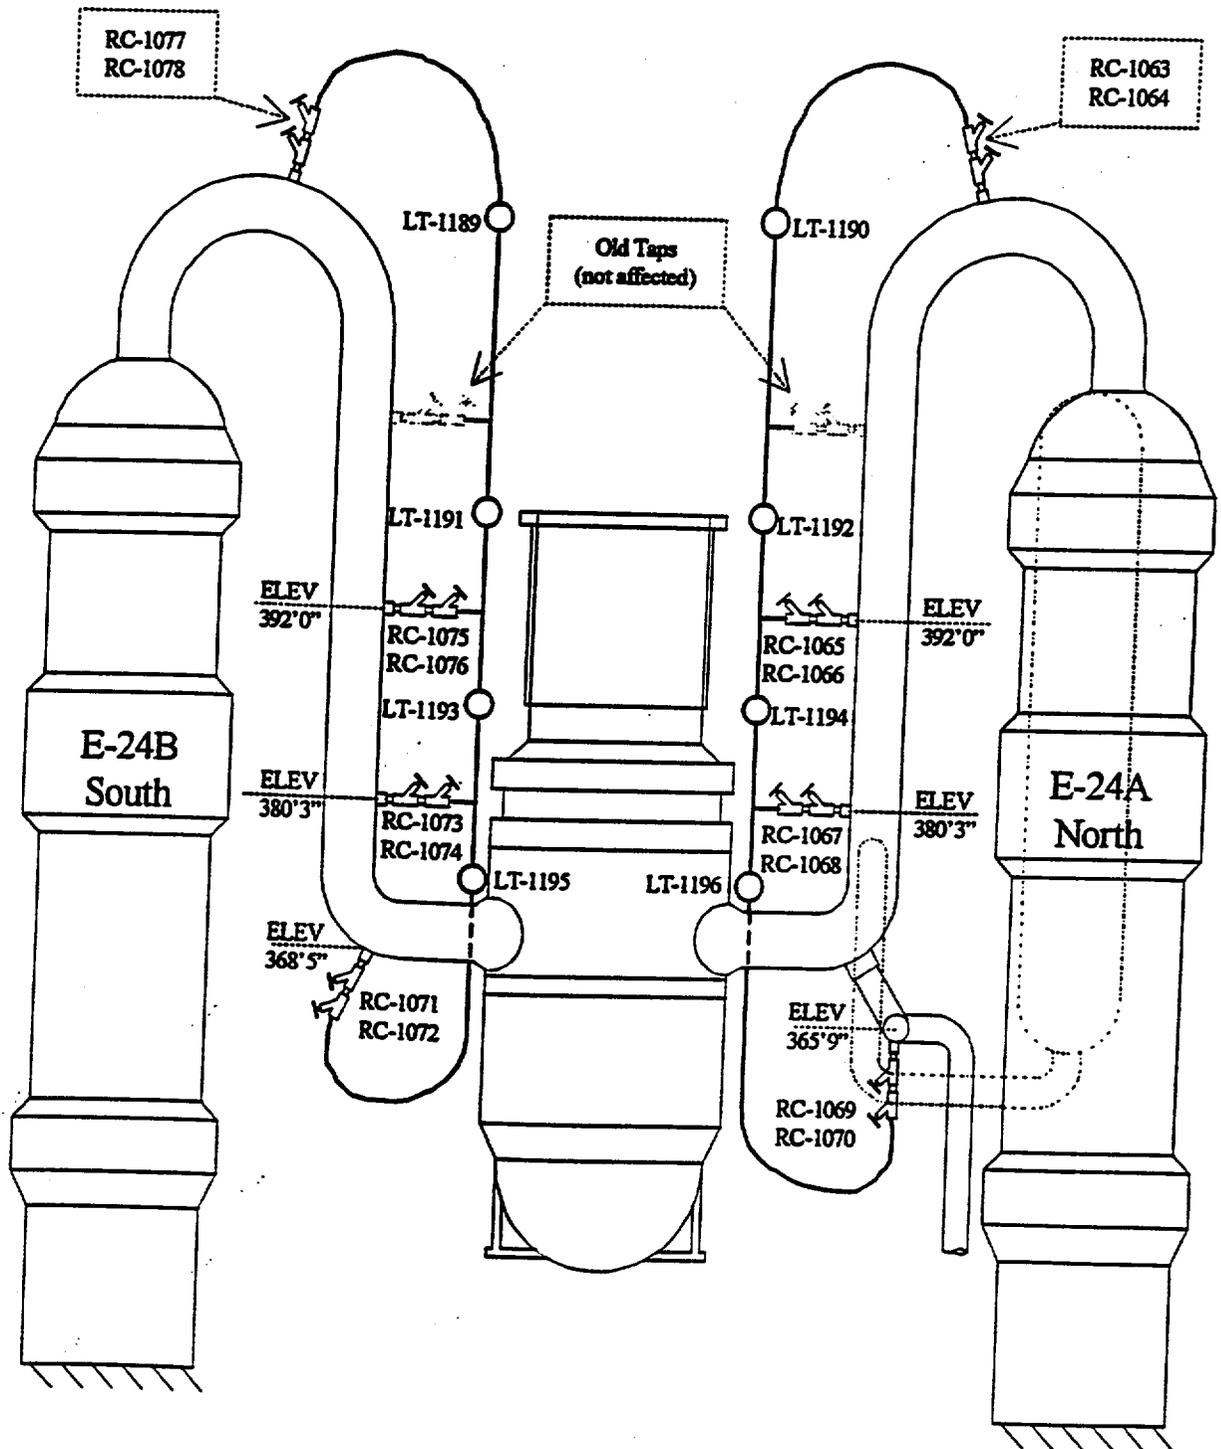
Figure 1

During maintenance activities at Arkansas Nuclear One - Unit 1 (ANO-1), a boron build-up was detected around a Reactor Coolant System (RCS) Instrument Tap in the Loop "A" hot leg for root valves RC-1063/1064 (see Figure 1). Upon further investigation, it was determined that the leakage occurred in the branch connection weld that attaches the nozzle to the hot leg. In total, there are 7 nozzles of common design and six have been identified to have had leakage. Five of the nozzles having indicated leakage and the one that had not leaked are being replaced with a new design to prevent recurrence. Replacement of these six nozzles is in accordance with ASME Section XI (Reference 1). However, the remaining nozzle RC-1071/1072 located on the loop "B" hot leg at elevation 368'5" is located sufficiently below the reactor water level to prevent removal of the nozzle without a full core off-load and subsequent drain down. To perform a full core off-load at this time would result in significant impact to the planned outage. An estimated 22 additional outage days would be required to remove and install a replacement nozzle.

RCS Level Instrument Tap Locations

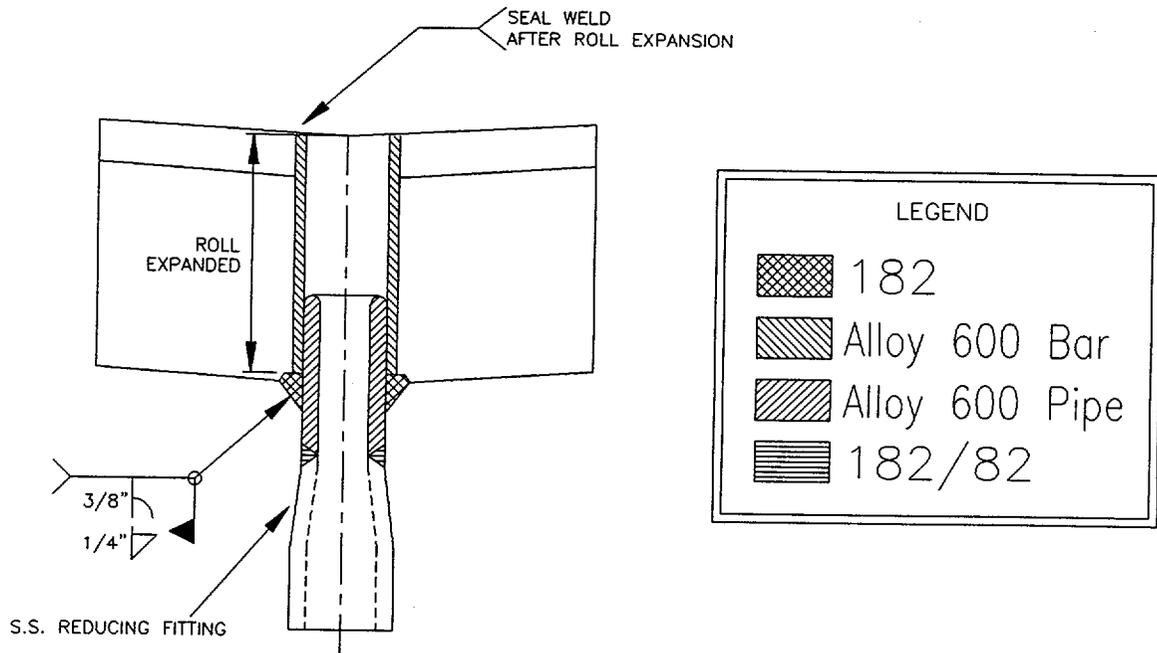
The weld attaching the subject instrument nozzle to the hot leg is designed to be a 3/8 inch partial penetration J-groove with a 1/4 inch fillet weld. The weld connects the nozzle to the outside of the hot leg pipe. Liquid penetrant examinations

confirm the presence of crack-like indications that are oriented in the circumferential and radial direction of the nozzle weld. All indications are contained within the weld material, and there is no evidence of crack propagation into the base material of the nozzle or the hot leg. Analytical evaluations in accordance with IWB-3600 have demonstrated that the worst case assumed flaws do not significantly penetrate the base metal for the remainder of the operating cycle as described later.

The currently installed nozzle was a 1986 field installation (for NUREG-0737) performed in accordance with ASME Section XI complying with the material, design and fabrication rules of Reference 7. The current configuration is illustrated in Figure 2 which is basically an Alloy 600, ¾ inch SCH 160 pipe welded to the OD of the elbow. The elbow is ferritic steel consistent with the requirements of SA-516 GR70 formed in two halves and then welded to form the elbow. The nozzle partial penetration weld may lie partly in the elbow base metal and partly in the weld. The exact location does not affect the conclusion of the acceptability of the repair. The attachment to the elbow is a partial penetration weld sized in accordance with Reference 7. The partial penetration and fillet weld material is a NiCrFe alloy commonly known as Inco 182 or 82. The unique feature of the current design was the installation of an Alloy 600 sleeve in the penetration to shield the ferritic elbow material from the primary coolant. This feature was desirable to limit corrosion that could effect the long-term geometric stability of the penetration and add contaminants to the reactor coolant system. This feature has been shown to be desirable but not necessary (Reference 8).

Original Hot Leg Nozzle Configuration

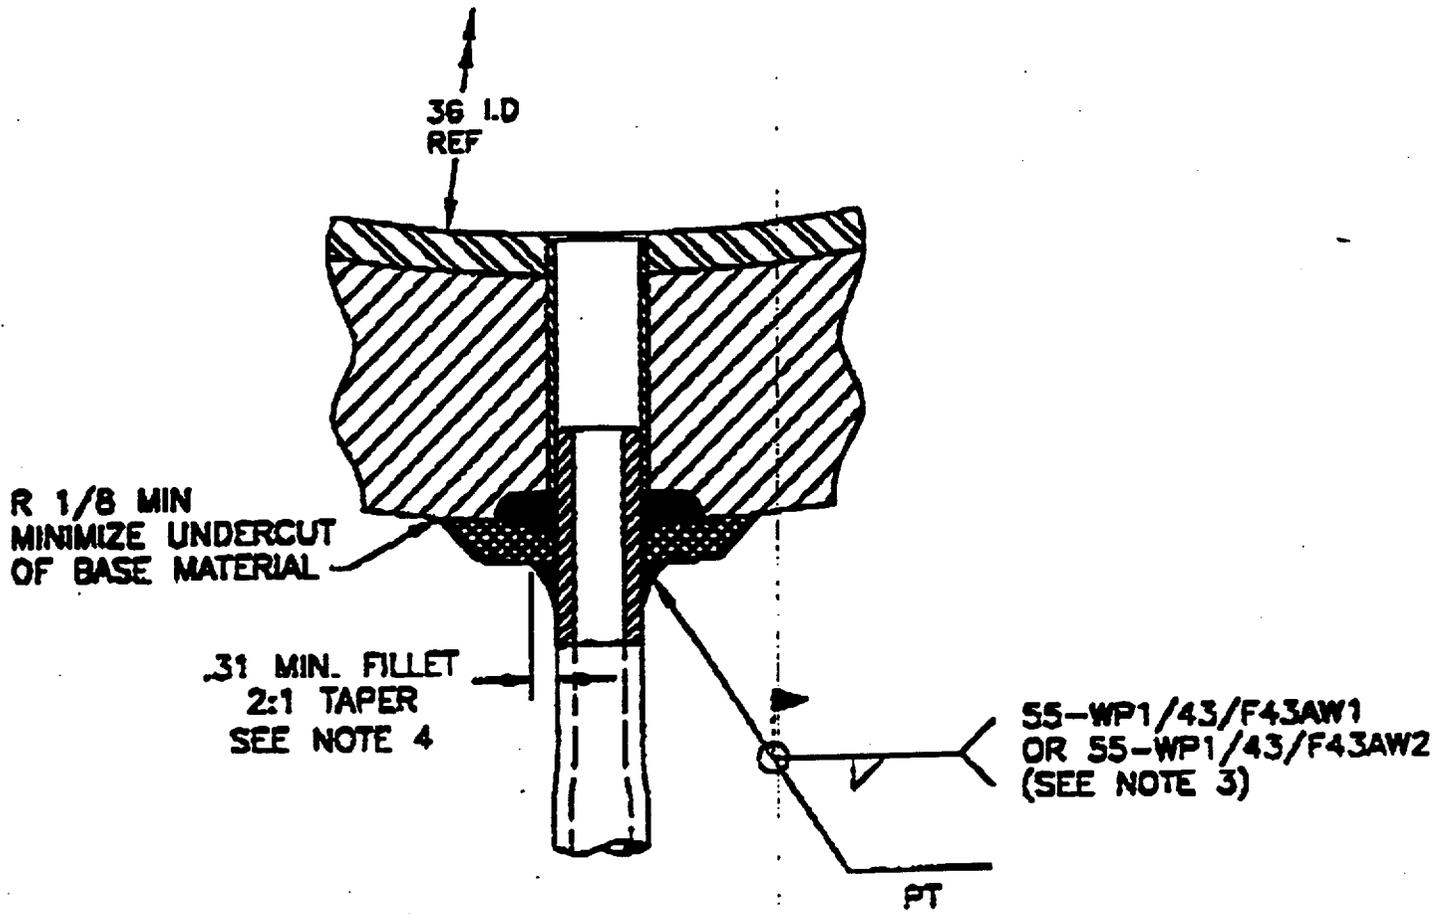
Figure 3

Fillet Weld for Alternate Repair

As an alternative to removing or reducing the flaws to an acceptable size and re-welding in accordance with ASME Section III, it is proposed that a full structural overlay weld be installed over the degraded branch connection weld. The request for alternative is limited for the remainder of the current operating cycle. At refuel outage 1R16, the overlay and nozzle will be replaced with a design change meeting all the requirements of ASME Section III and Section XI.

- C) An initial weld layer will be applied over the existing branch connection weld and base metal to the extent shown in Figure 3. This weld layer will be ground sufficiently to permit a liquid penetrant examination to verify the absence of defects in accordance with Reference 4.

- D) The remainder of the overlay including the fillet weld transition will be applied to meet the requirements of Reference 4. Final weld examination will include an ultrasonic and liquid penetrant examination, and a dimensional verification for compliance with design requirements.
