Entergy

Subject: Arkansas Nuclear One - Unit 1
Docket No. 50-313
License No. DPR-51
Alternate Code Repair for the ANO-1 Hot Leg Level Nozzle RC-1071/1072

ENTERGY OPERATIONS, INC.
ARKANSAS NUCLEAR ONE – UNIT 1
3rd TEN YEAR INTERVAL
REQUEST NO. 00-1-001, Revision 0

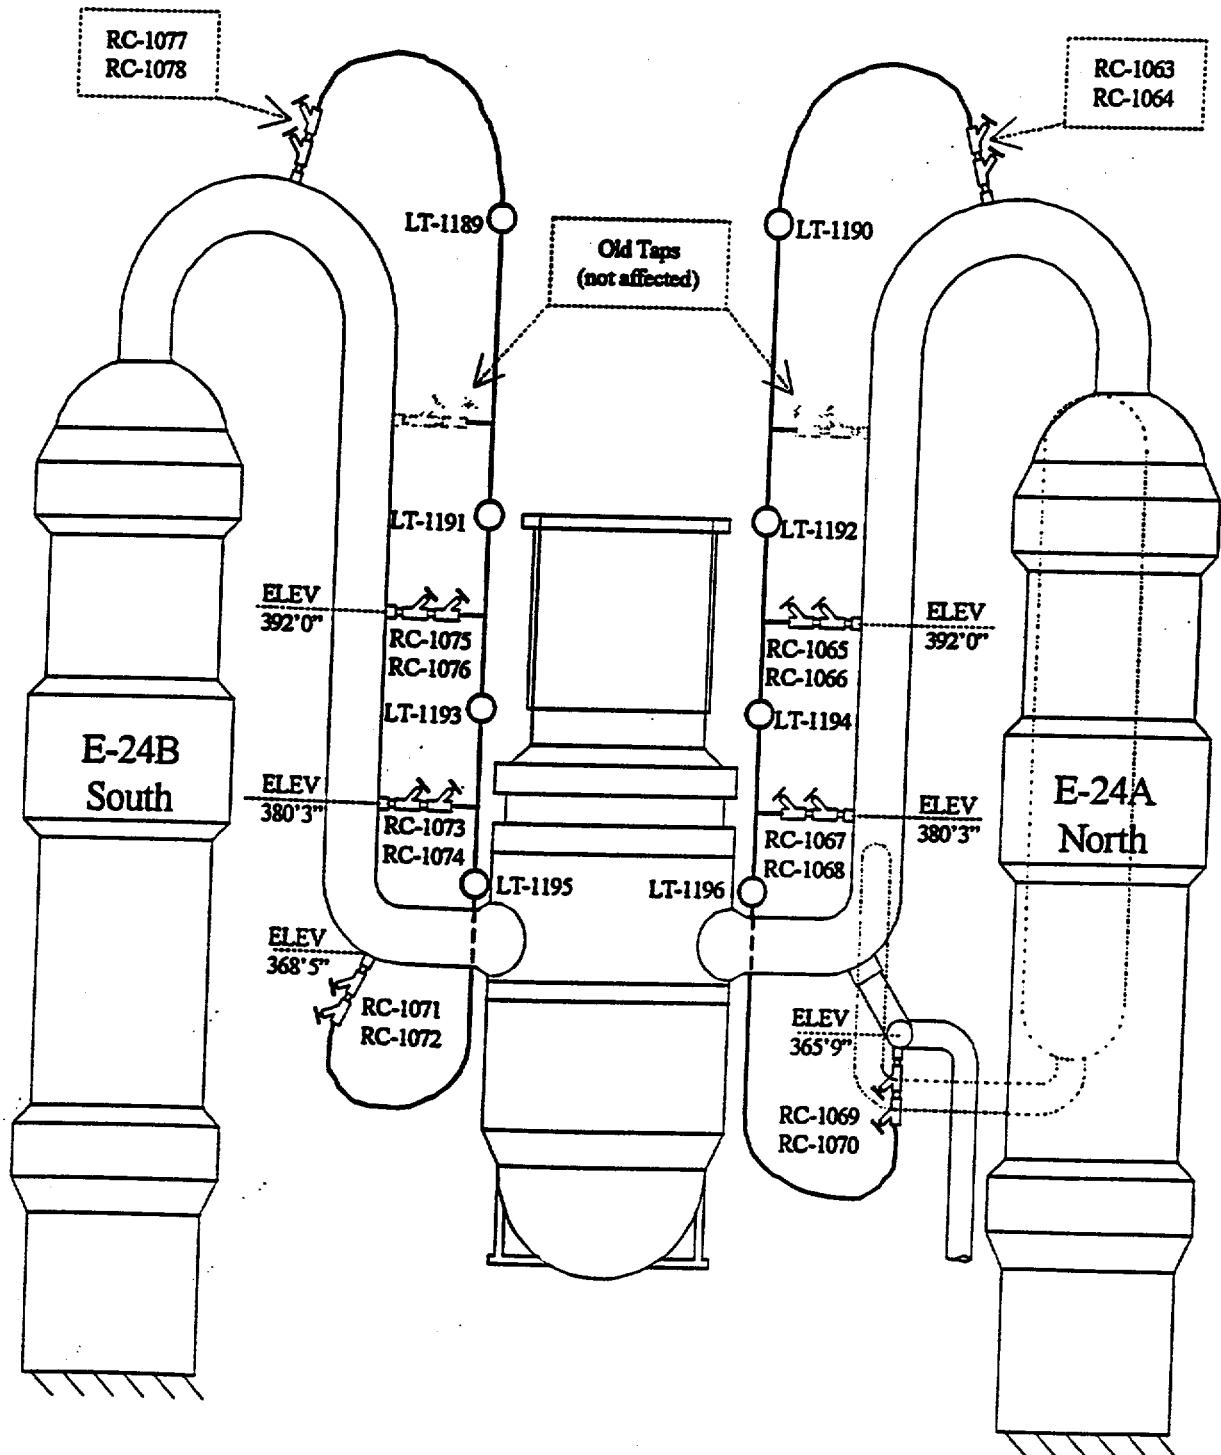
Figure 1

During maintenance activities at Arkansas Nuclear One - Unit 1 (ANO-1), a boron build-up was detected around a Reactor Coolant System (RCS) Instrument Tap in the Loop "A" hot leg for root valves RC-1063/1064 (see Figure 1). Upon further investigation, it was determined that the leakage occurred in the branch connection weld that attaches the nozzle to the hot leg. In total, there are 7 nozzles of common design and six have been identified to have had leakage. Five of the nozzles having indicated leakage and the one that had not leaked are being replaced with a new design to prevent recurrence. Replacement of these six nozzles is in accordance with ASME Section XI (Reference 1). However, the remaining nozzle RC-1071/1072 located on the loop "B" hot leg at elevation 368'5" is located sufficiently below the reactor water level to prevent removal of the nozzle without a full core off-load and subsequent drain down. To perform a full core off-load at this time would result in significant impact to the planned outage. An estimated 22 additional outage days would be required to remove and install a replacement nozzle.

RCS Level Instrument Tap Locations

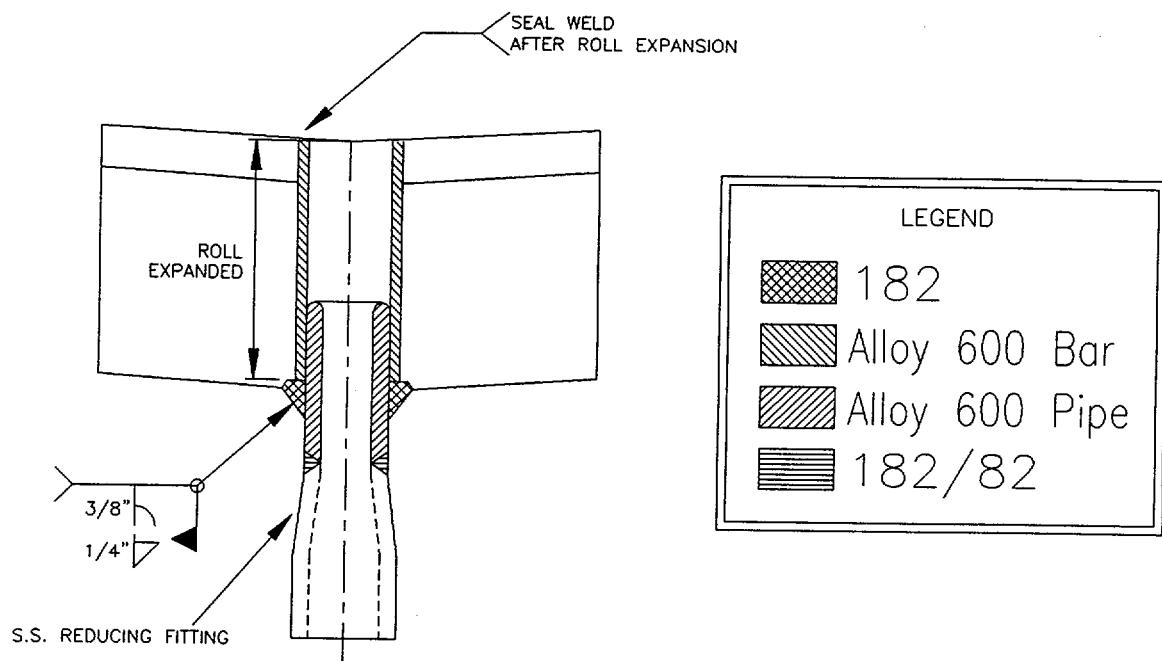
The weld attaching the subject instrument nozzle to the hot leg is designed to be a 3/8 inch partial penetration J-groove with a 1/4 inch fillet weld. The weld connects the nozzle to the outside of the hot leg pipe. Liquid penetrant examinations

confirm the presence of crack-like indications that are oriented in the circumferential and radial direction of the nozzle weld. All indications are contained within the weld material, and there is no evidence of crack propagation into the base material of the nozzle or the hot leg. Analytical evaluations in accordance with IWB-3600 have demonstrated that the worst case assumed flaws do not significantly penetrate the base metal for the remainder of the operating cycle as described later.

The currently installed nozzle was a 1986 field installation (for NUREG-0737) performed in accordance with ASME Section XI complying with the material, design and fabrication rules of Reference 7. The current configuration is illustrated in Figure 2 which is basically an Alloy 600, $\frac{3}{4}$ inch SCH 160 pipe welded to the OD of the elbow. The elbow is ferritic steel consistent with the requirements of SA-516 GR70 formed in two halves and then welded to form the elbow. The nozzle partial penetration weld may lie partly in the elbow base metal and partly in the weld. The exact location does not affect the conclusion of the acceptability of the repair. The attachment to the elbow is a partial penetration weld sized in accordance with Reference 7. The partial penetration and fillet weld material is a NiCrFe alloy commonly known as Inco 182 or 82. The unique feature of the current design was the installation of an Alloy 600 sleeve in the penetration to shield the ferritic elbow material from the primary coolant. This feature was desirable to limit corrosion that could effect the long-term geometric stability of the penetration and add contaminants to the reactor coolant system. This feature has been shown to be desirable but not necessary (Reference 8).

Original Hot Leg Nozzle Configuration

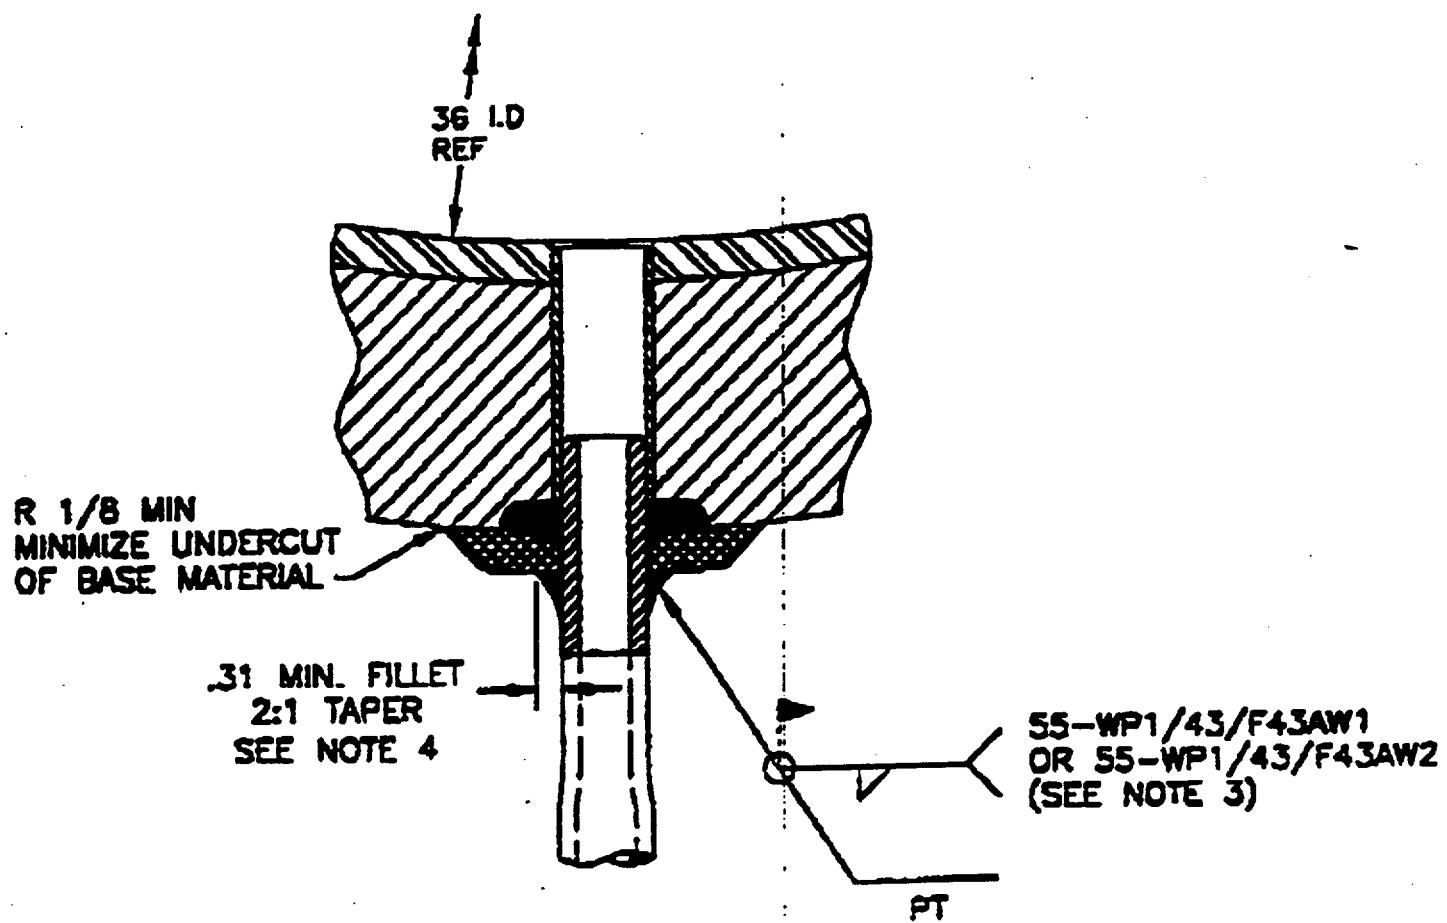
Figure 3

Fillet Weld for Alternate Repair

As an alternative to removing or reducing the flaws to an acceptable size and re-welding in accordance with ASME Section III, it is proposed that a full structural overlay weld be installed over the degraded branch connection weld. The request for alternative is limited for the remainder of the current operating cycle. At refuel outage 1R16, the overlay and nozzle will be replaced with a design change meeting all the requirements of ASME Section III and Section XI.

- C) An initial weld layer will be applied over the existing branch connection weld and base metal to the extent shown in Figure 3. This weld layer will be ground sufficiently to permit a liquid penetrant examination to verify the absence of defects in accordance with Reference 4.
- D) The remainder of the overlay including the fillet weld transition will be applied to meet the requirements of Reference 4. Final weld examination will include an ultrasonic and liquid penetrant examination, and a dimensional verification for compliance with design requirements.
