February 28, 2000

1CAN020008

Subject: Arkansas Nuclear One - Unit 1
Docket No. 50-313
License No. DPR-51
Supplemental Information Regarding Hot Leg Nozzle RC-1071/1072

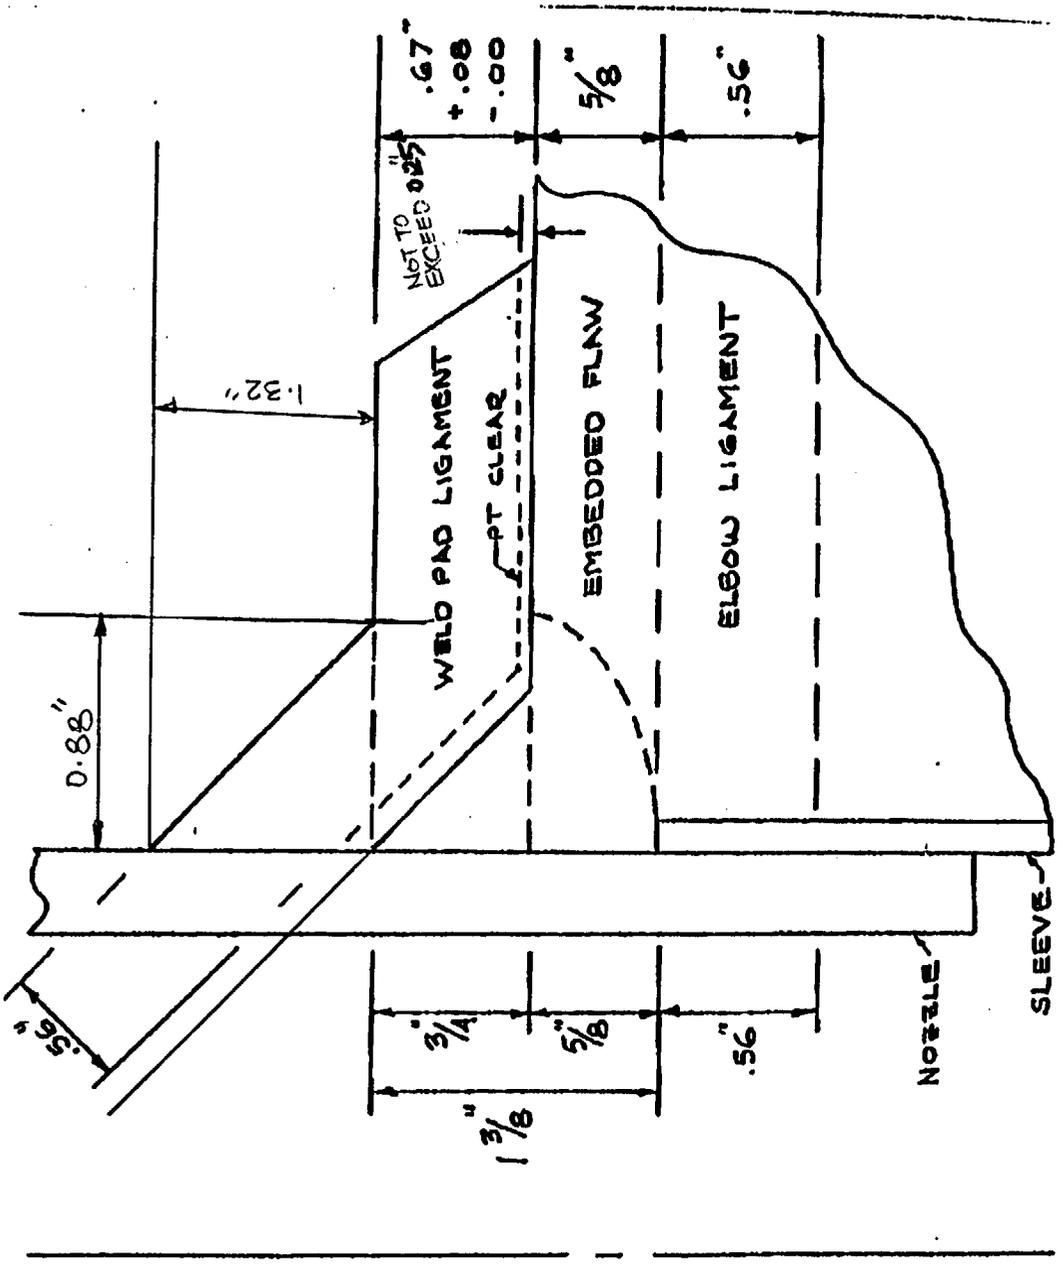
Figure C-1. Embedded Flaw Model for Weld Pad

that was performed was the same as that process previously considered for the initial flaw evaluation considered by the NRC staff. The results of the additional flaw analysis resulted in the weld pad and the new fillet weld dimensions increasing. A diagram of the dimensions for the new weld is shown on Figure C-1, which is enclosed in the flaw evaluation details of Appendix C to Framatome Report 32-5007242-02 (Enclosure 2). There have been no indications that cracks exist in the nozzle itself. The inside diameters of two nozzles removed from other locations have been inspected with no indications identified.

The weld pad design proposed in our February 24 and February 25, 2000 submittals increased from 0.62 inch to 0.75 inch and the fillet weld increased from 0.5 inch weld with a 2:1 taper to an approximate 0.88 inch weld with a 1.5:1 taper. The weld pad buildup, and the increased weld height (along the nozzle axis) will serve to stiffen the nozzle. This taper is considered acceptable based on the same EPRI report (EPRI Report TR-107455) that provides a quantitative estimate of the improvement with a 2 to 1 taper and notes that any increases in the length of the axial leg improve vibration resistance. The EPRI study did not quantify the amount of improvement for increases over 1 to 1, other than to note that they exist, and to suggest further quantification of the amount as one of the areas for potential further study. Entergy did not credit either the initial 2:1 taper or the revised 1.5:1 taper in the quantitative vibrational analysis. Prior to weld pad buildup, the assembly exhibited a first bending mode at 25.5 hertz and a torsional mode was also experienced at 21.7 hertz. After welding was completed, the first bending mode had increased to 31.9 hertz and the torsional mode increased to 22.5 hertz. This moves the frequency further away from the motor running speed vibrations present at approximately 20 hertz, and will reduce the vibrational stresses accordingly.

An embedded flaw is postulated to be present between the elbow and the weld pad. This flaw can be considered to be a compound flaw formed by the 5/8" deep J-groove flaw, analyzed for the carbon steel elbow material (Table 1), and the triangular shaped area inside the PT clear profile shown in Figure C-1 [1,12]. The PT clear line, which is outside the original fillet weld, is truncated by the line along the top of the weld pad at 3/4" above the elbow surface. The total depth of the postulated flaw is the sum of the 5/8" deep J-groove and the 3/4" high triangular void, or 1 3/8". The specified thickness of the weld ligament in the region is 0.56", and since the design thickness of the pad is 1/2", there is a 0.060" allowance for crack growth. Although there is about 3" of elbow base metal below the flaw, only 0.56" will be credited to create a symmetric center cracked panel (CCP) model.
