LaSalle County Station, Unit 2  
Facility Operating License No. NPF-18  
NRC Docket No. 50-374

Subject: Licensee Event Report

NRC FORM 366 (5-92)		U.S. NUCLEAR REGULATORY COMMISSION				APPROVED BY OMB NO. 3150-0104 EXPIRES 05/31/95								
<b>LICENSEE EVENT REPORT (LER)</b>										ESTIMATED BURDEN PER RESPONSE TO COMPLY WITH THIS INFORMATION COLLECTION REQUEST: 50.0 HRS. FORWARD COMMENTS REGARDING BURDEN ESTIMATE TO THE INFORMATION AND RECORDS MANAGEMENT BRANCH (MNBB 7714), U.S. NUCLEAR REGULATORY COMMISSION, WASHINGTON, DC 20555-0001, AND TO THE PAPERWORK REDUCTION PROJECT (3150-0104), OFFICE OF MANAGEMENT AND BUDGET, WASHINGTON, DC 20503.				
FACILITY NAME (1): LaSalle County Station Unit Two						DOCKET NUMBER (2) 05000374			PAGE (3) 1 of 7					
TITLE (4) Discovery of a Broken Fuel Rod in the LaSalle Unit 2 Spent Fuel Pool														
EVENT DATE (5)			LER NUMBER (6)			REPORT DATE (7)			OTHER FACILITIES INVOLVED (8)					
MONTH	DAY	YEAR	YEAR	SEQUENTIAL NUMBER	REVISION NUMBER	MONTH	DAY	YEAR	FACILITY NAME	DOCKET NUMBER

General Electric - Boiling Water Reactor

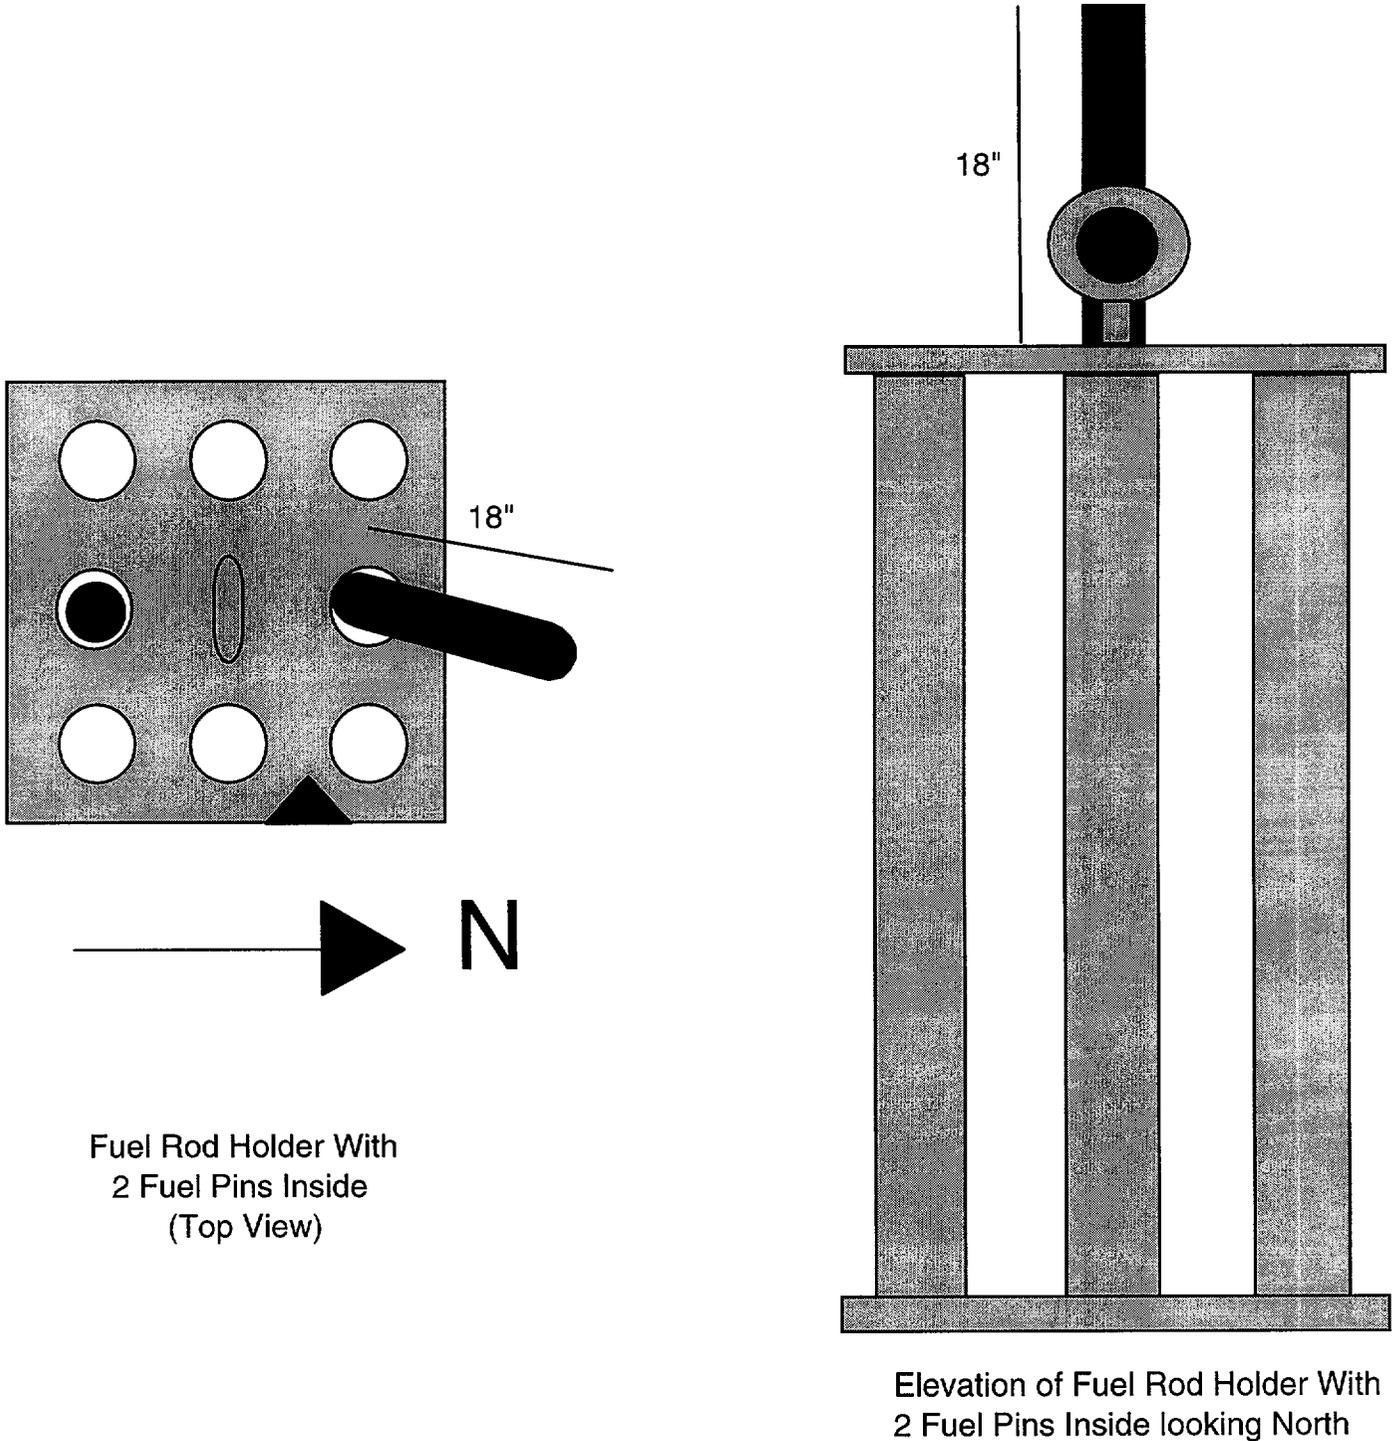
**FIGURE 1**

Cell SR3-A-2 is approximately three feet away from a defective fuel storage cell (SR3-B-0), which contained a fuel rod storage canister. The canister originally contained two fuel rods that had been removed from a fuel bundle (LYF289) during a fuel bundle reconstitution campaign in May, 1989 (see Figure 1 for an as-found drawing of the canister). The broken fuel rod section was the upper portion of one of these two rods. The storage canister has since been moved to cell SR3-B-1. This is the only storage location that contains individual fuel rods at LaSalle.

At the time that the broken rod segment was discovered, the storage canister contained one fuel rod protruding approximately 18 inches from the canister, while the other one was sunken further inside the canister with a broken end visible some distance below the surface. The second rod was known to have a severed lower end plug, therefore the exposed broken end was expected and not considered abnormal during quarterly inventories of Special Nuclear Material (SNM). It was believed at the time of the inventories that the rod was originally placed in the canister upside down.

The canister is configured to hold each rod in a separate, enclosed tube. The lower section of the intact rod, and the entire failed rod (except the very top) are obscured from view. With the discovery of the broken section in the nearby cell, it has now been verified that the second rod was originally placed in the canister with its broken lower end plug at the bottom and an intact upper end plug at the top. Consultations with General Electric confirm that the container is designed such that a rod will protrude approximately 18 inches from the top. At sometime after being placed in the container and moved to the Unit 2 pool, it is believed that the section was broken off and landed in the nearby cell where it was later discovered. It is not known how long the condition in the canister (with one rod protruding and the other depressed) existed.

Although it cannot be verified, it is postulated that the section was broken off during fuel handling activities sometime after the canister was transferred from the Unit 1 fuel pool to the Unit 2 fuel pool. The protrusion of the fuel rods from the canister may have contributed to the segment being broken off. It is not known whether the use of the extension can was a conscious decision on the part of fuel handling and/or reactor engineering at the time that the canister was transferred. It may have been used in an effort to facilitate the performance of future fuel pool piece counts.

In order to perform adequate inspections of the storage cells, the fuel storage canister had to be withdrawn from its cell location. It was subsequently discovered that the storage canister had been sitting on top of an 18-inch tall extension can. The storage canister was placed back into a cell (SR3-B-1) without the extension can underneath it. The top of the intact fuel rod (that protrudes eighteen inches out of the storage canister) is now flush with the top of the storage racks. There are no longer any fuel rods protruding above the top of the spent fuel pool storage racks.

1. LaSalle SNM procedures were assessed by both LaSalle and corporate personnel to identify any potential weaknesses with the Nuclear Materials program. The results were used as input in revising station procedures, including development of a method to ensure the configuration of partial components is documented and verified. (Complete)
2. Additional visual inspections were performed to scan the eight cell area for stray pellets. No stray pellets were found. (Complete)
3. The broken section was placed into the storage canister in the fuel pool to prevent any future disturbances. All fuel pellets and components have been accounted for. (Complete)
