Subject: Oconee Nuclear Station
Docket Nos. 50-269
Licensee Event Report 269/2000-01, Revision 0
Problem Investigation Process No.: O-00-0611

FACILITY NAME (1) Oconee Nuclear Station, Unit 1	DOCKET NUMBER (2) 05000 - 269	PAGE (3) 1 OF 7
---	----------------------------------	--------------------

TITLE (4)
Shutdown for Unisolable RCS Leak due to Thermal Cycling In Drain Line

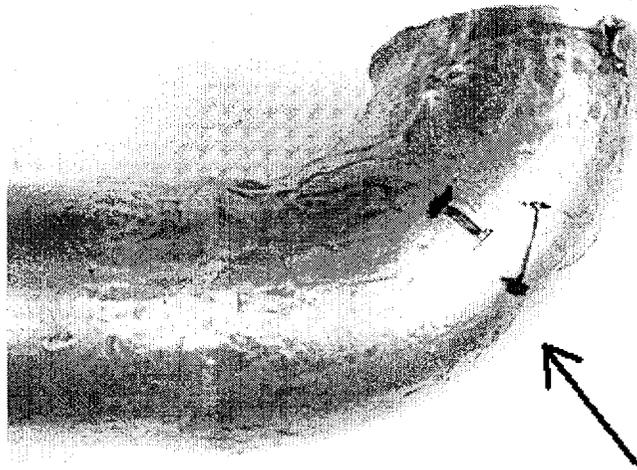
Attachment A
Reactor Coolant System
1B2 Drain Line Leak
90 Degree Elbow 1 1/2 inch Schedule 160

The affected portion of the drain line is 1-1/2 inch schedule 160 piping, which has an outer diameter of 1.900 inches and a thickness of 0.281 inch. See Attachment A. The leaking elbow was found to have two principle flaws in the base metal, approximately 1 inch from the center of the outside radius, and approximately 1.9 inches from the elbow-to-system weld. One of these flaws was a through-wall crack and was the source of the leak. The other flaw was approximately 50% thru wall. Other minor indications existed on the inner surface in the same area.

The Metallurgical Laboratory personnel attributed the flaws to thermal fatigue. The leak was considered to have developed over an extended period of time (i.e. years).

The root cause of this event was thermal fatigue due to cyclical turbulent penetration of hot RCS water into the stagnant drain pipe. This is considered an unanticipated system interaction. These drain lines are currently uninsulated, which may have contributed to the frequency of the thermal cycles and/or the magnitude of the resulting stresses.

Flaw Locations:
Shorter Line is Leak
(100 % Through-wall)

Longer Line is Internal
(50 % Through-wall)

1. The leaking elbow was removed for laboratory examination and was replaced.

1. The equivalent piping on Oconee Units 2 and 3 will be inspected using UT during the next refueling outages on those units (scheduled to begin April, 2000 for Unit 3, and May, 2001 for Unit 2).
2. An appropriate length of the drain lines will be insulated during the next scheduled refueling outage on each of the three units. This is expected to limit the potential for thermal cycling in the future.
