Subject: Clinton Power Station
Licensee Event Report No. 2000-002-00

FACILITY NAME (1)
Clinton Power Station

TITLE (4)
Out-of-Phase Synchronization Results in Damage to Division 3 Emergency Diesel Generator and Inadequate Design of Static VAR Compensator Freeze Circuit Results in Overvoltage of Class 1E Divisional Bus

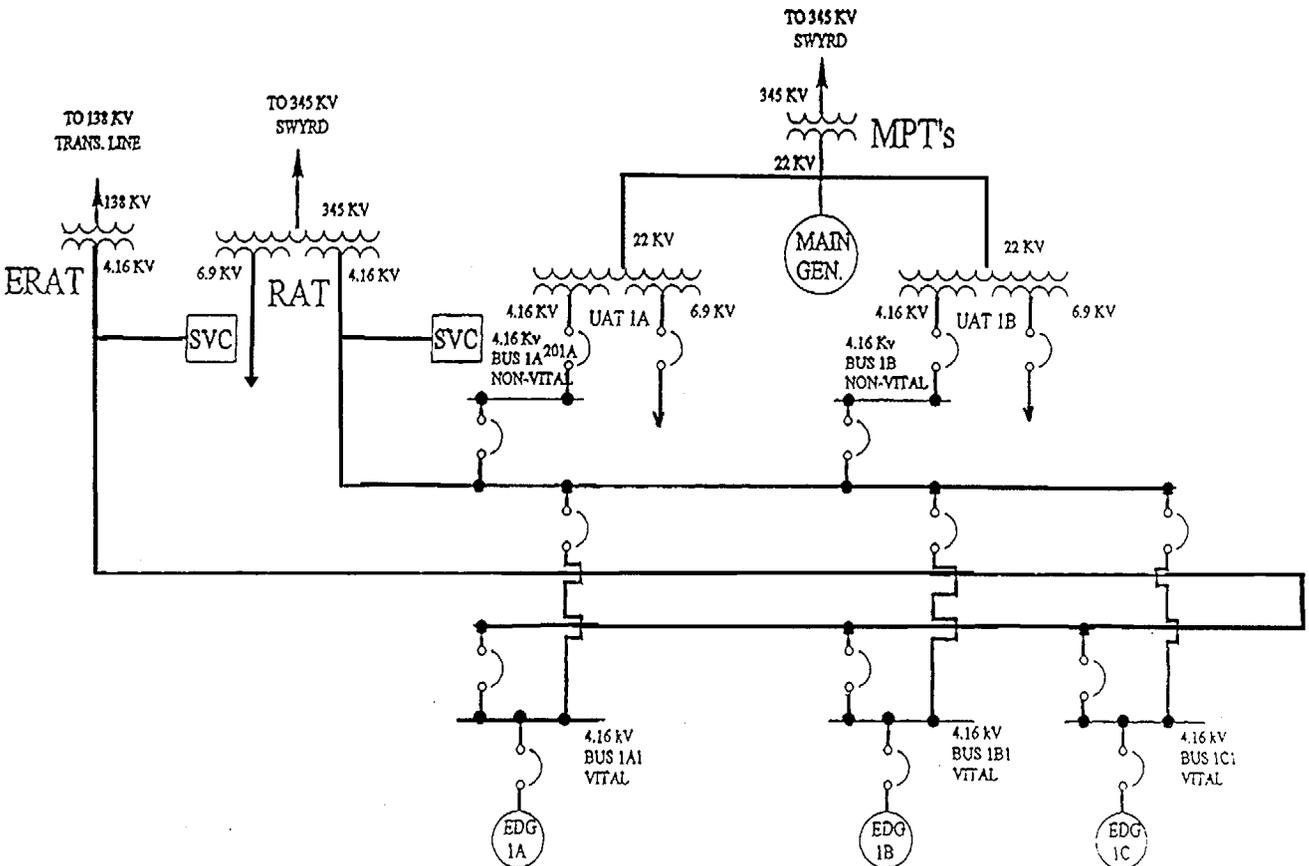
Figure 1

The Clinton Power Station (CPS) Class 1E 4160 VAC electric power system consists of three electrically and physically independent distribution divisions, i.e., the 1A1, 1B1 and 1C1 electrical buses. Each of the three distribution divisions can be supplied with electric power from either of two offsite sources via two physically independent circuits or an EDG that serves as a standby power source, independent of the offsite source. The two physically independent offsite source circuits are the 345 kilovolt (kV) circuit through the Reserve Auxiliary Transformer (RAT) and the 138 kV circuit through the Emergency Reserve Auxiliary Transformer (ERAT). A Static VAR Compensator (SVC) is installed on each of the secondary sides of the RAT and ERAT to assist in maintaining acceptable voltages to the 4160 VAC distribution divisions during normal plant operating conditions and / or accident conditions. Each SVC is rated at +28.5/-14.0 MVAR and includes a thyristor-controlled reactor bank rated at 21.5 MVAR, a thyristor switched capacitor bank rated at 21.0 MVAR, and a capacitive harmonic filter bank rated at 7.5 MVAR. (Figure 1 on page 9 contains a simplified diagram of the 4160 VAC electrical power system.)
