VIRGINIA ELECTRIC AND POWER COMPANY
NORTH ANNA POWER STATION UNIT 1
ASME SECTION XI RELIEF REQUESTS NDE-9 AND NDE-15

ASME Section XI Relief Request NDE-9

North Anna Power Station Unit 1

NES MATERIALS ENGINEERING LABORATORY
FAILURE ANALYSIS REPORT

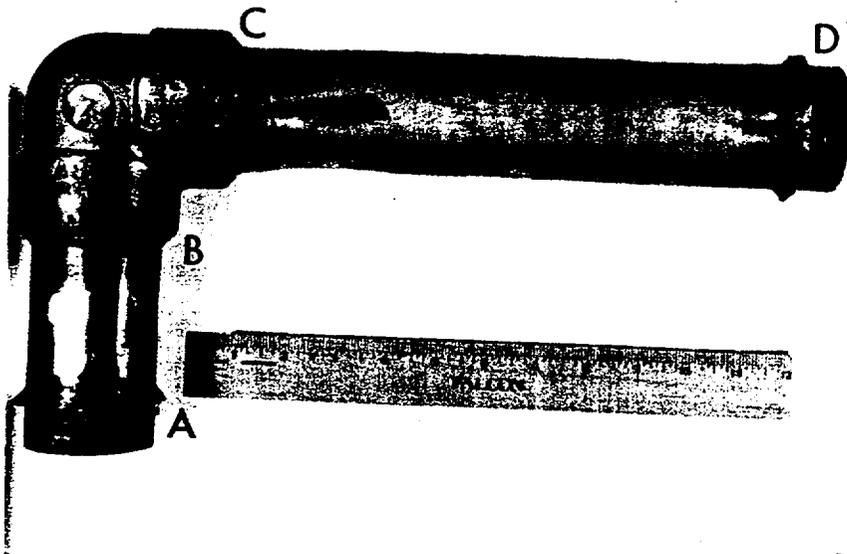
Figure 2:

Visual Inspection: Visual inspection of the O.D. of the failed socket weld revealed a rust colored region at the area of through-wall penetration shown in Figure 2 as joint "C". Inspection of the I.D. surface under joint "C" revealed a circular region of corrosion products, fairly flat but slightly raised above the pipe surface. This region was surrounded by dark black deposits on the pipe I.D. surface. A similar region of corrosion products was observed at joint "A". Figure 3 shows the deposits at joints "A" and "C". Only black deposits were observed at joints "B" and "D".

Through-wall leak location ("C") in elbow socket weld in line 2"-WS-777-163-Q3. Deeply pitted region was observed at location "A", and incipient corrosion pitting at "B".

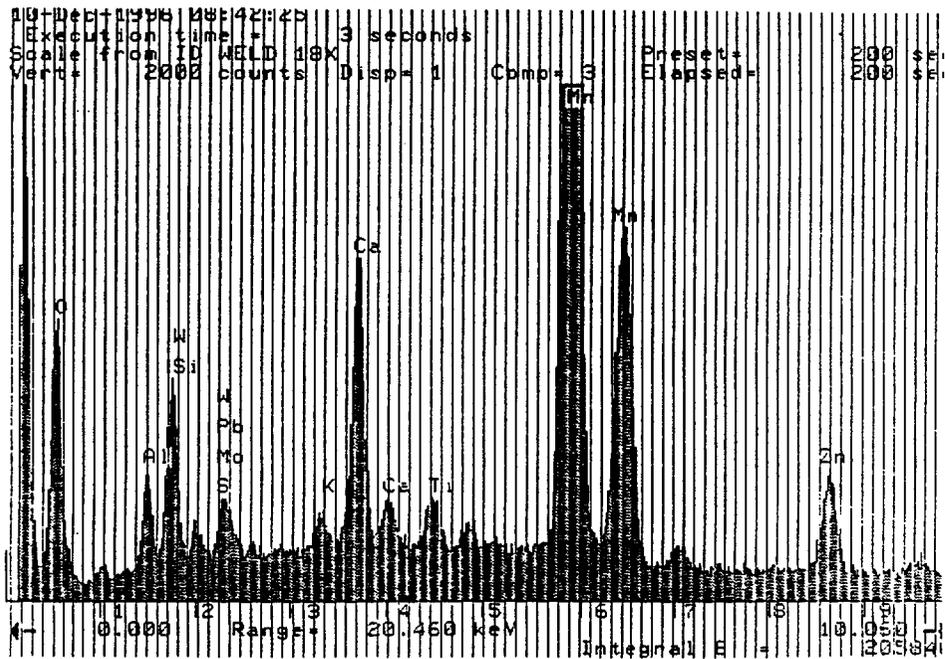
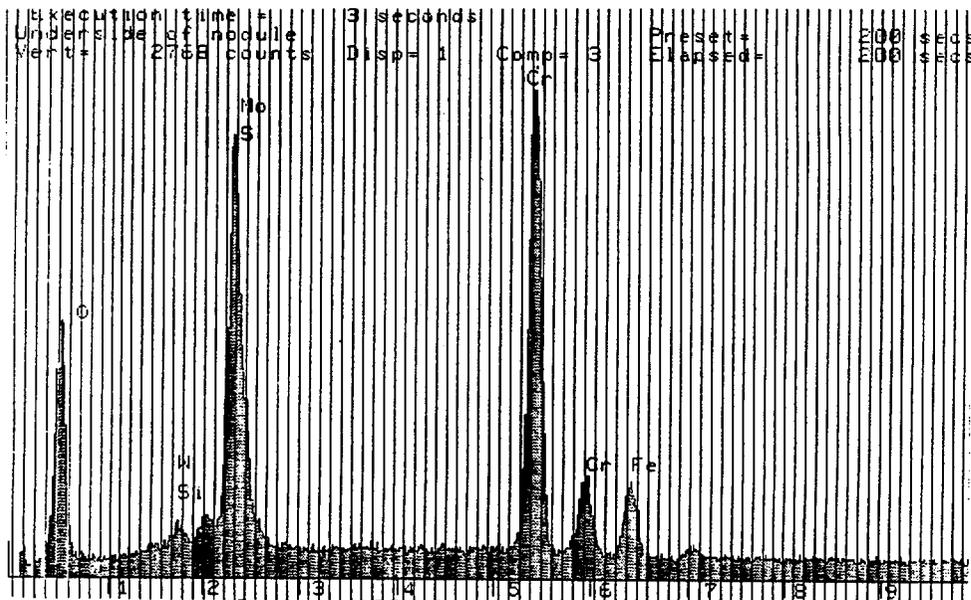
Figure 32: EDS spectrum printouts showing the areas of high manganese (top scan), chromium, and sulfur (bottom scan).

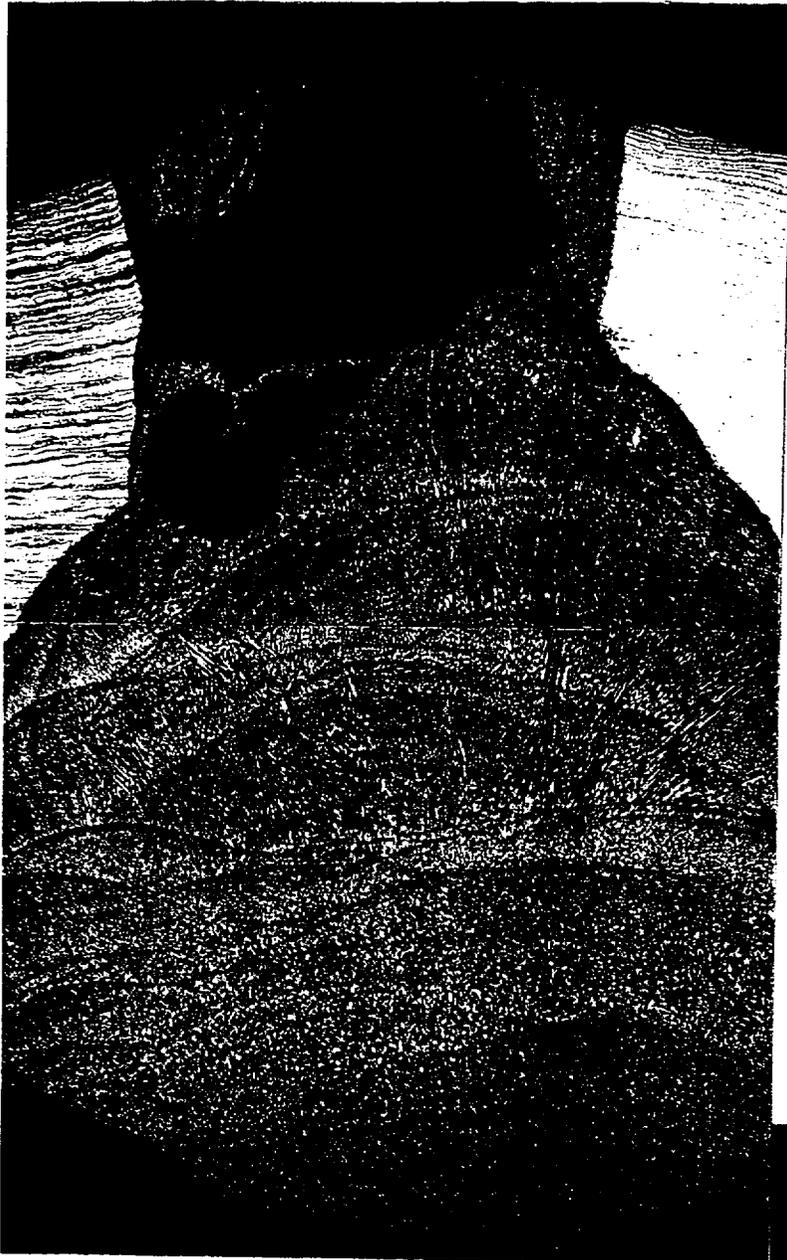
Figure 5: Photomicrographs showing the pitting that was displayed in the previous photo. The top photo was taken after the initial stages of grinding into the sample. The bottom photo was taken after the later stages of examination and shows evidence of the pit branching. The weld is the darker etched area. Mag. 15X. Note: All of the metallographic samples prepared for this report were etched electrolytically with 10% oxalic acid.

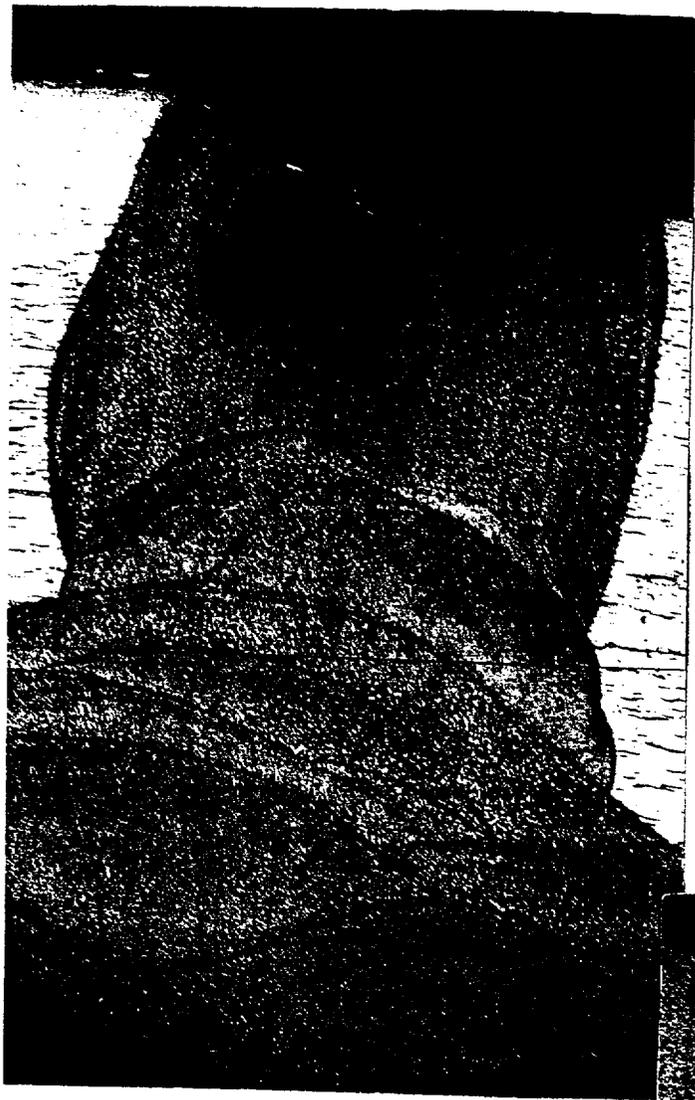
Figure 9: Photomicrograph showing the pit in the previous photo as it was first detected during metallographic examination. Mag. 15X.

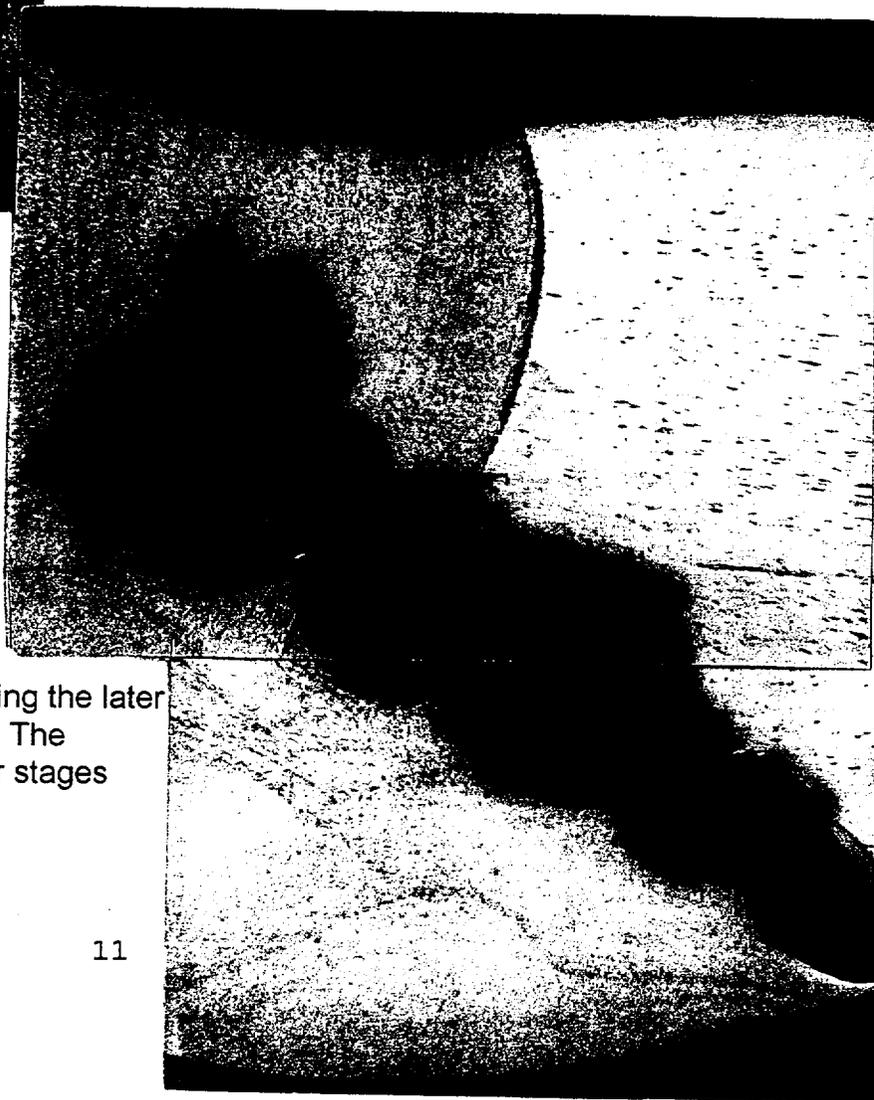
Figure 10: Photomicrograph showing the later stages of metallographic inspection. The lateral extension of the pit in its later stages is clearly evident. Mag. 15X.

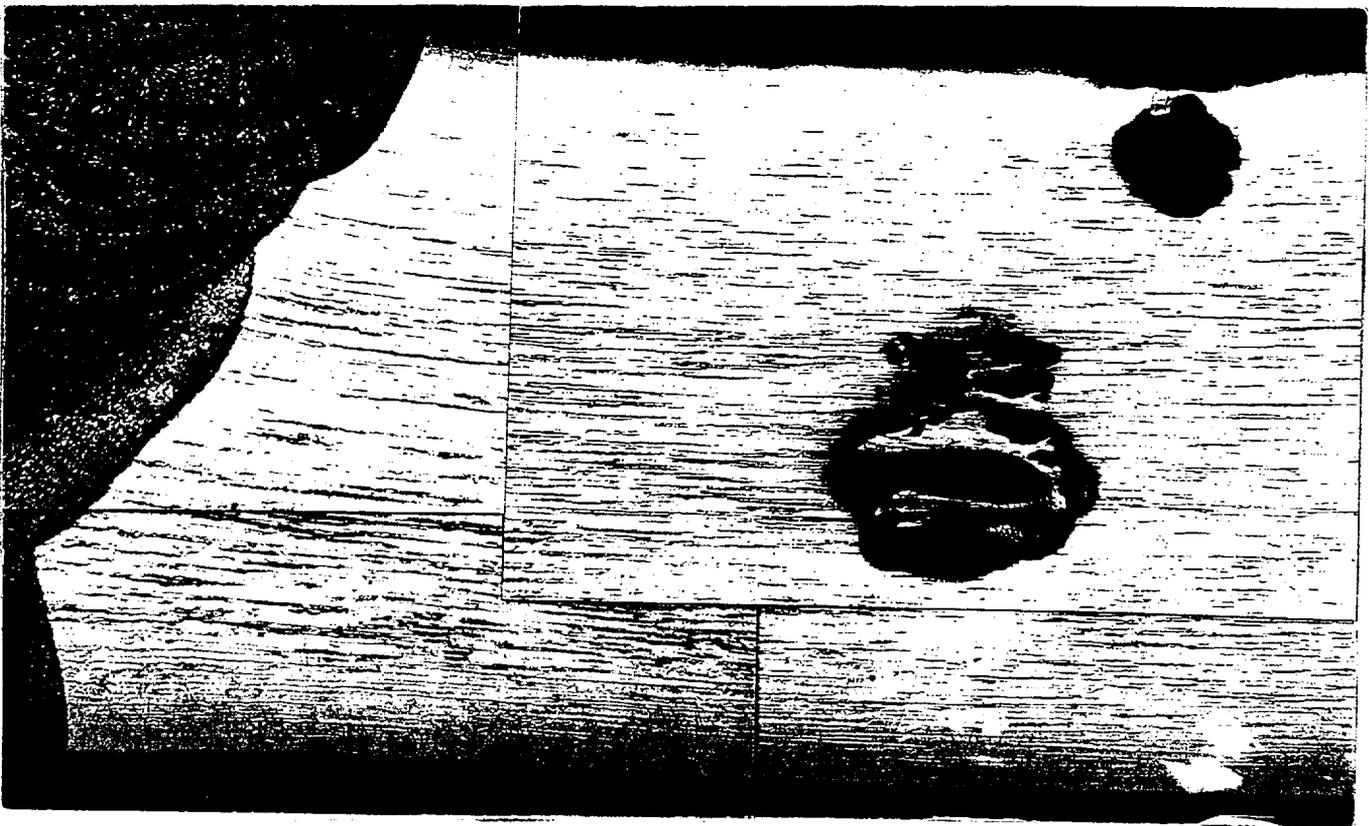
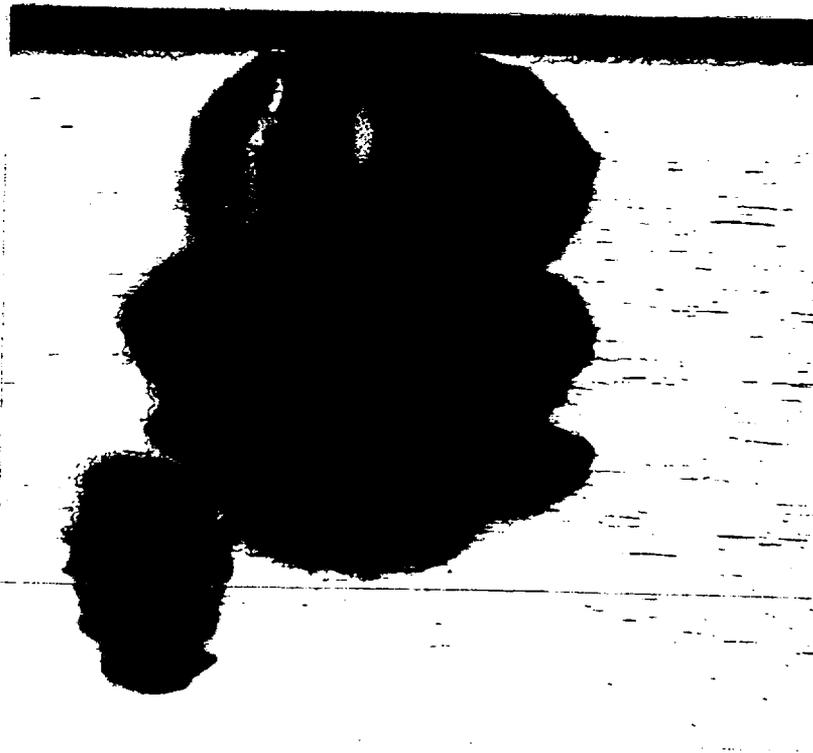
Figure 13: Photomicrographs taken from the metallographic sample prepared through the pit shown in the previous figure. The top photo was taken upon initial discovery of the pitting. The appearance of two pits in the photo indicates branching of the pit. Bottom photo was taken during the later stages of examination after the center of the pit was reached. Mag. 15X.

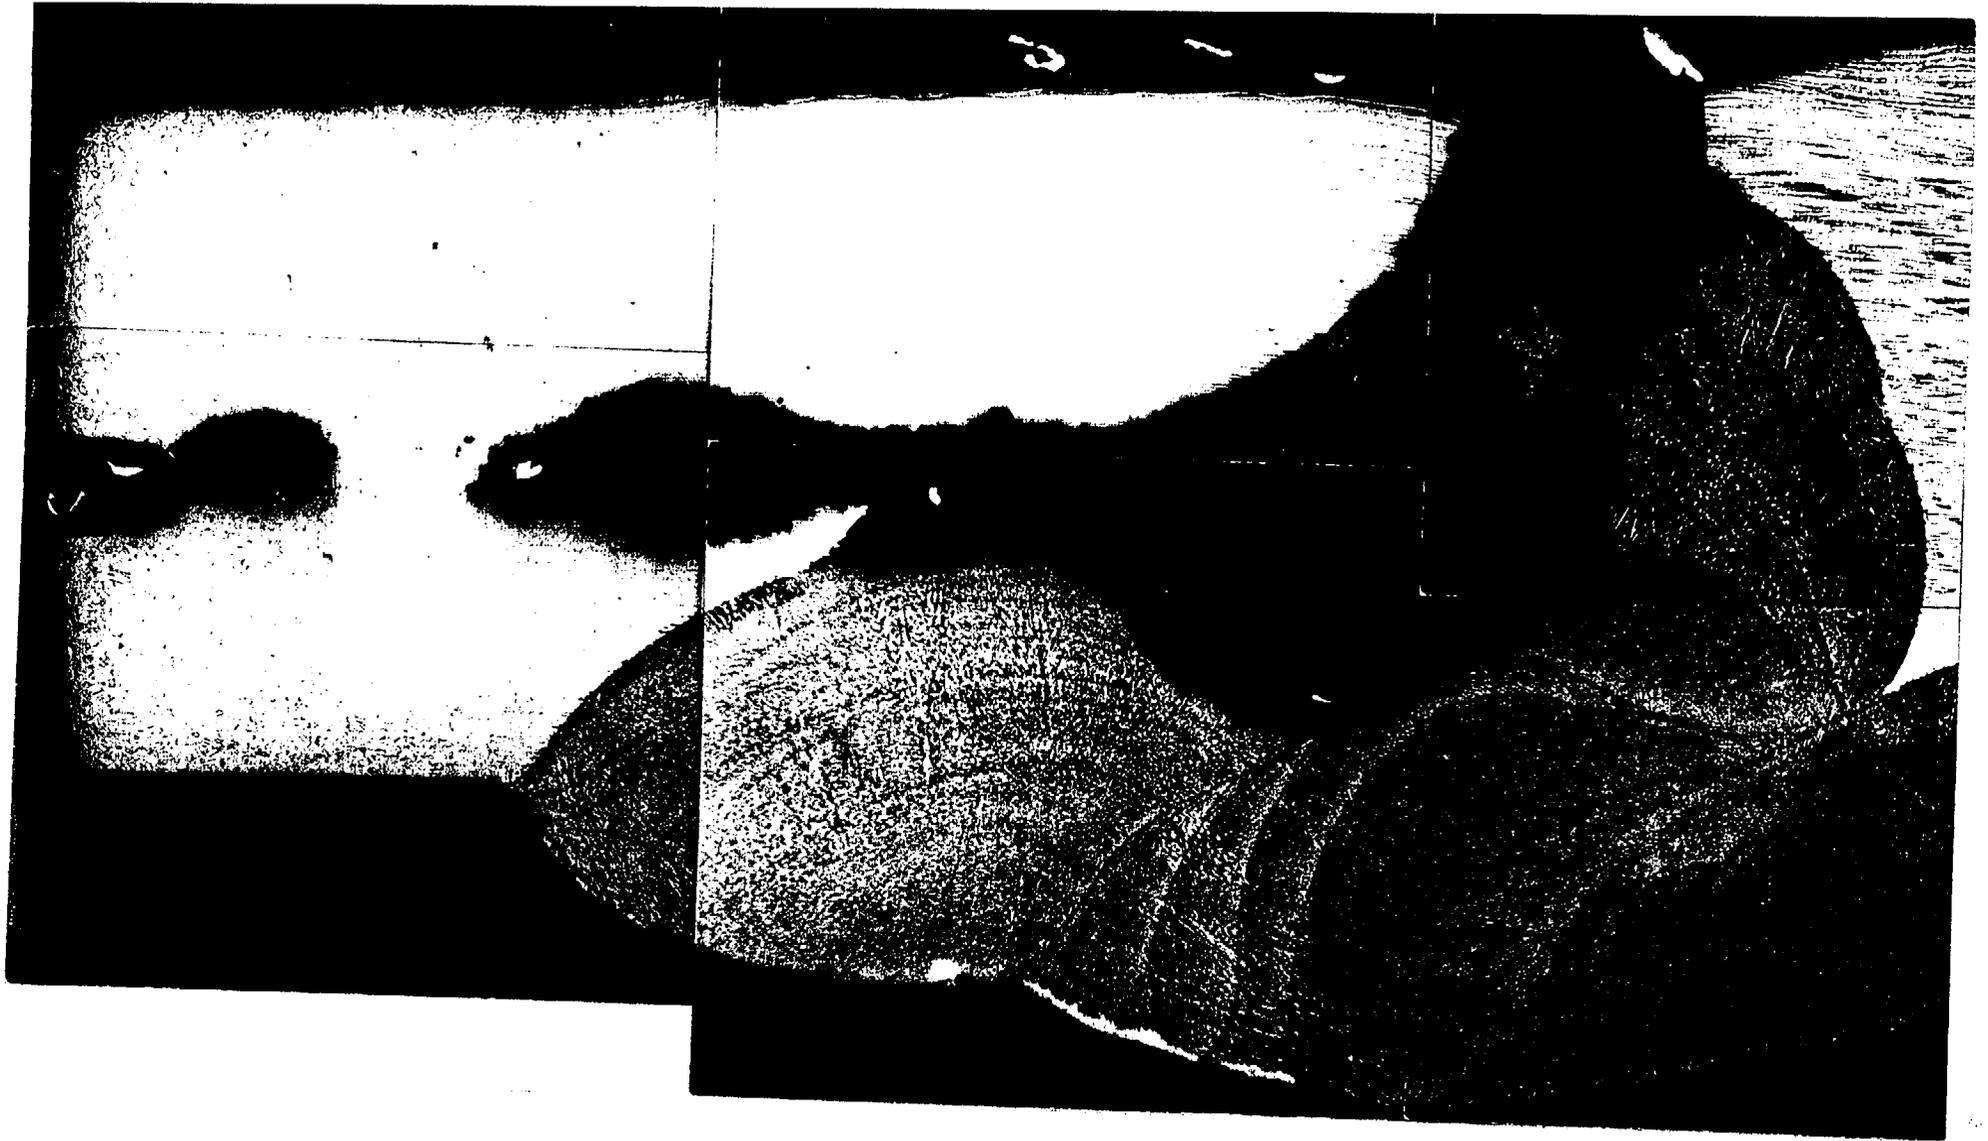
Figure 17: Photographic montage showing the metallographic cross section taken through the area shown in the previous photo. The pitting at this weld shows extensive branching. Mag. 15X.

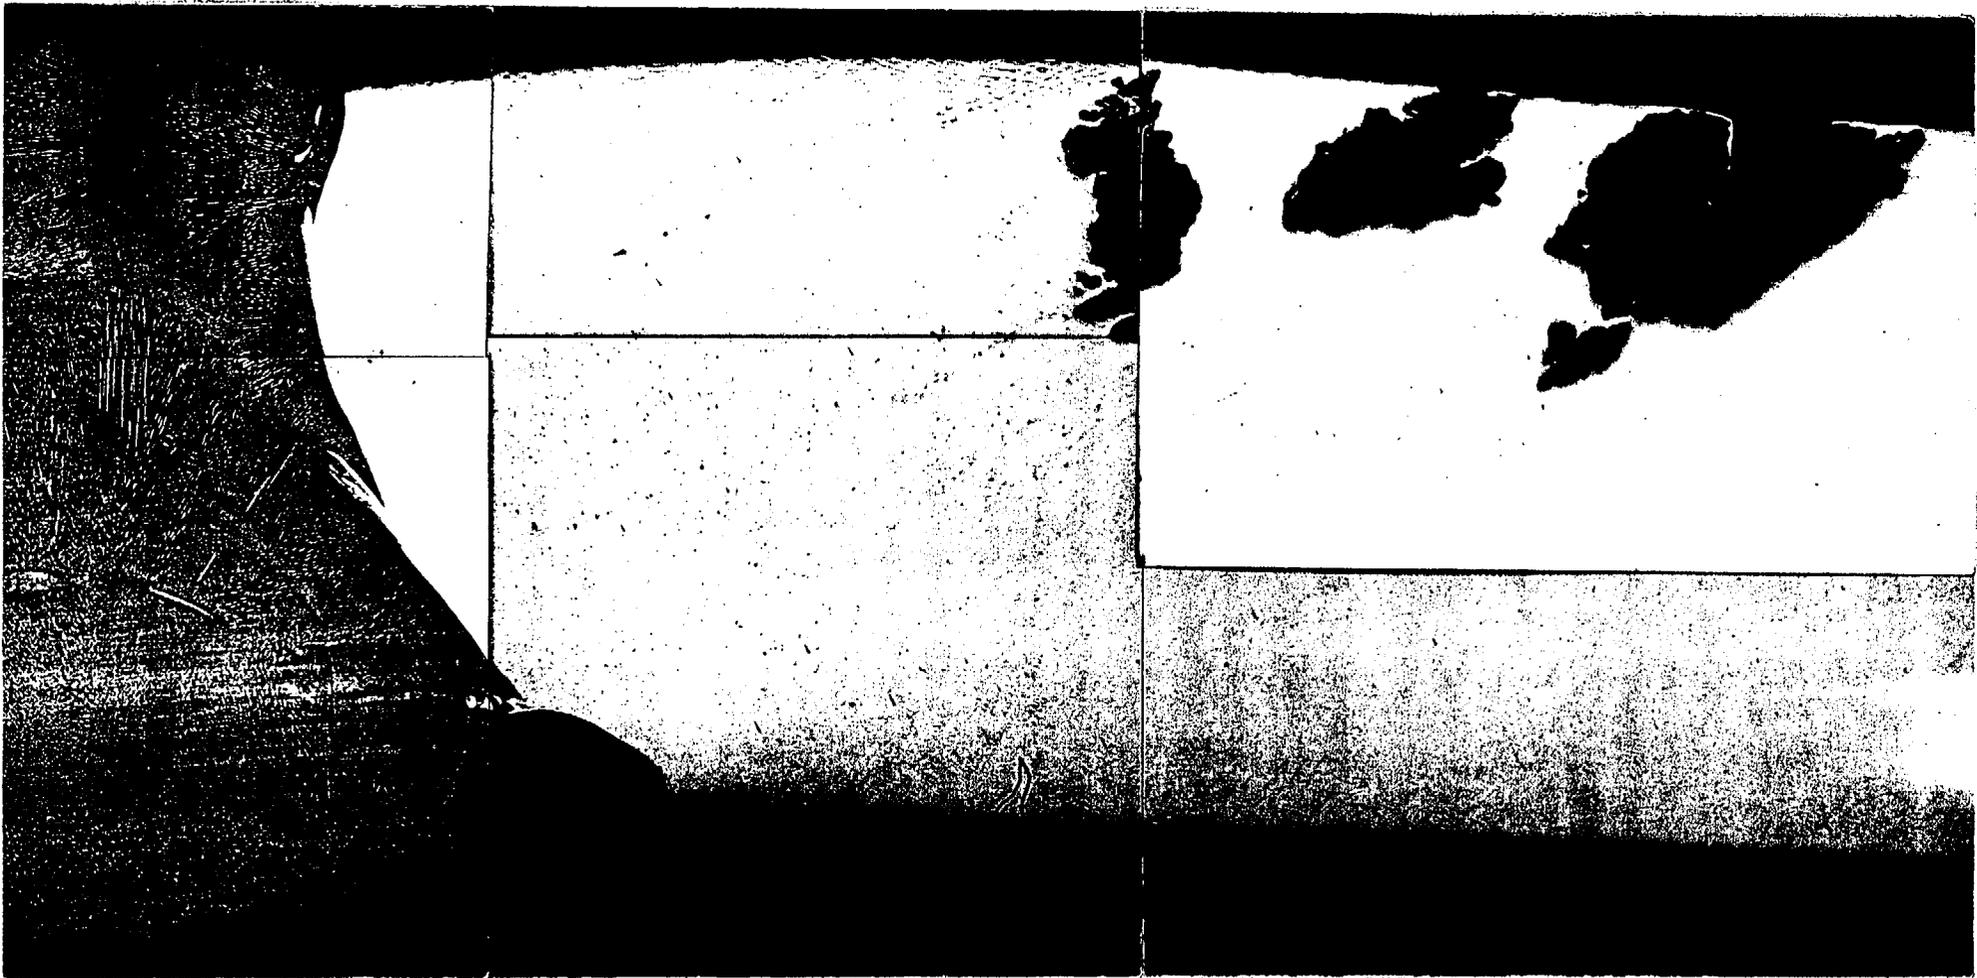
Figure 21: Photographic montage from the metallographic sample prepared through weld 45. The pitting was present only in the stainless pipe and not in the high nickel weld. Mag. 15X.

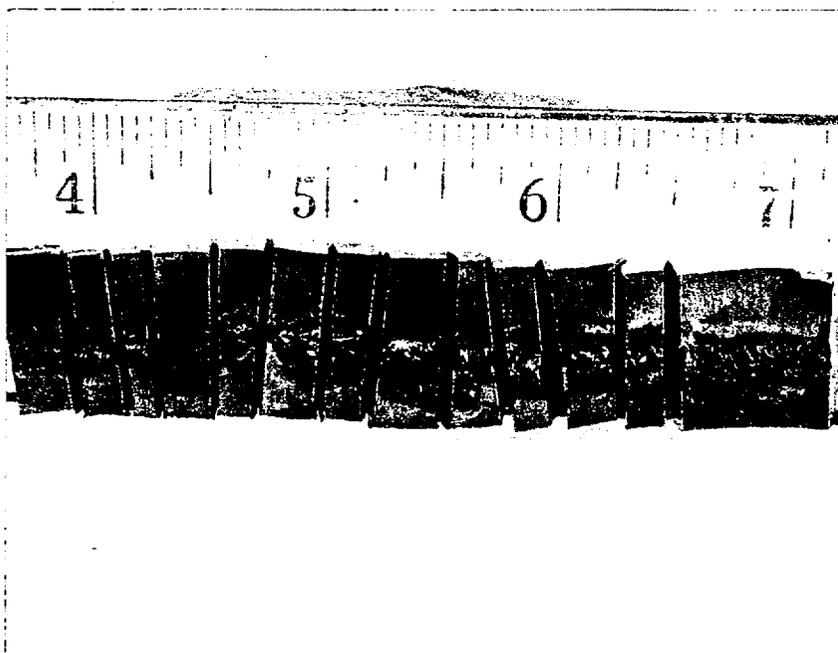
Figure 25: Photograph showing a portion of the weld after cleaning and sectioning approximately every 1/8 of an inch. Notice the very rough appearance of the weld.

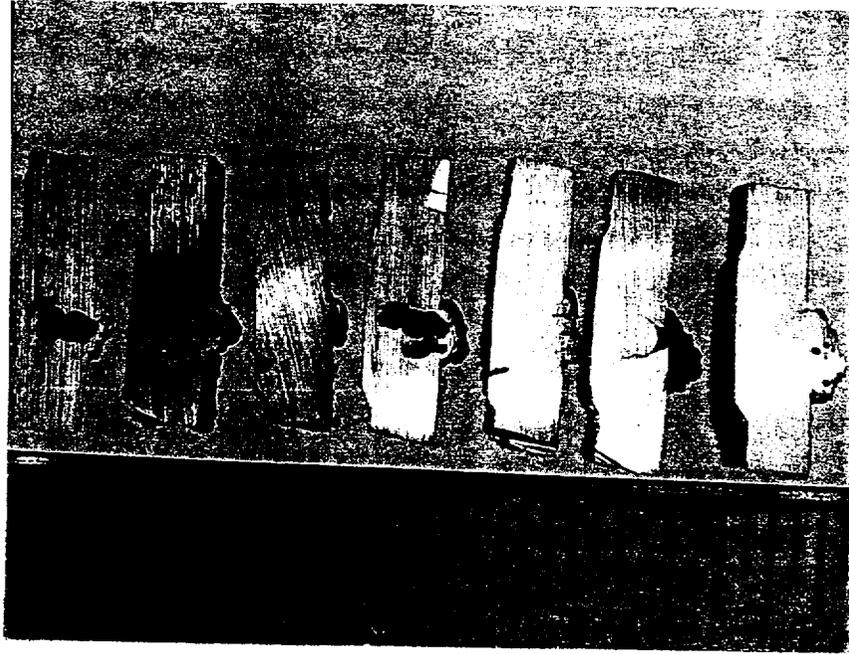
Figure 26: Photograph showing several of the cross sections that were taken through weld 58. Notice the cracking and large amount of porosity in several of the sections. Mag. 2X.

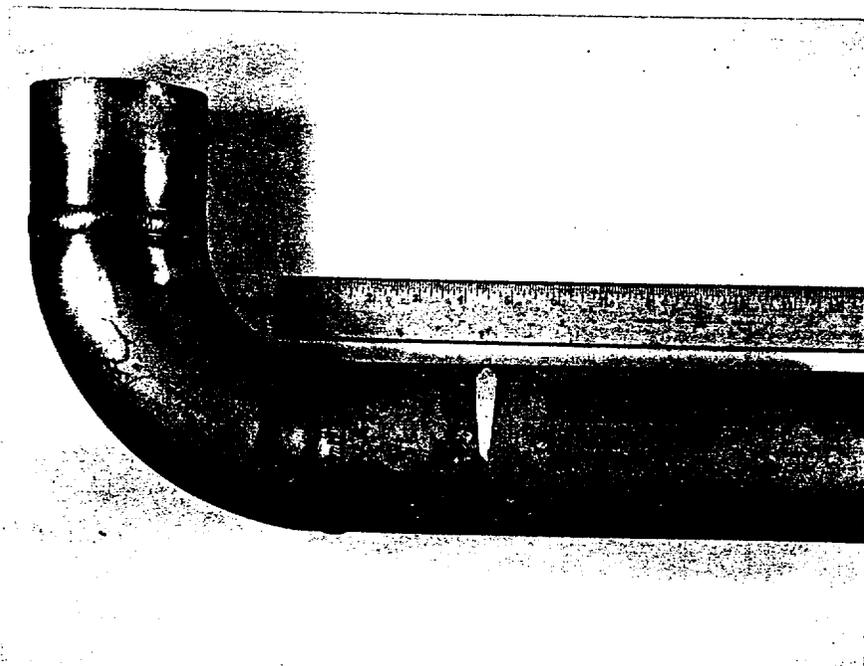
Figure 27: Photograph showing leaking weld 3"-WS-74-163-Q3-FW97 between the straight piece of pipe and the elbow.

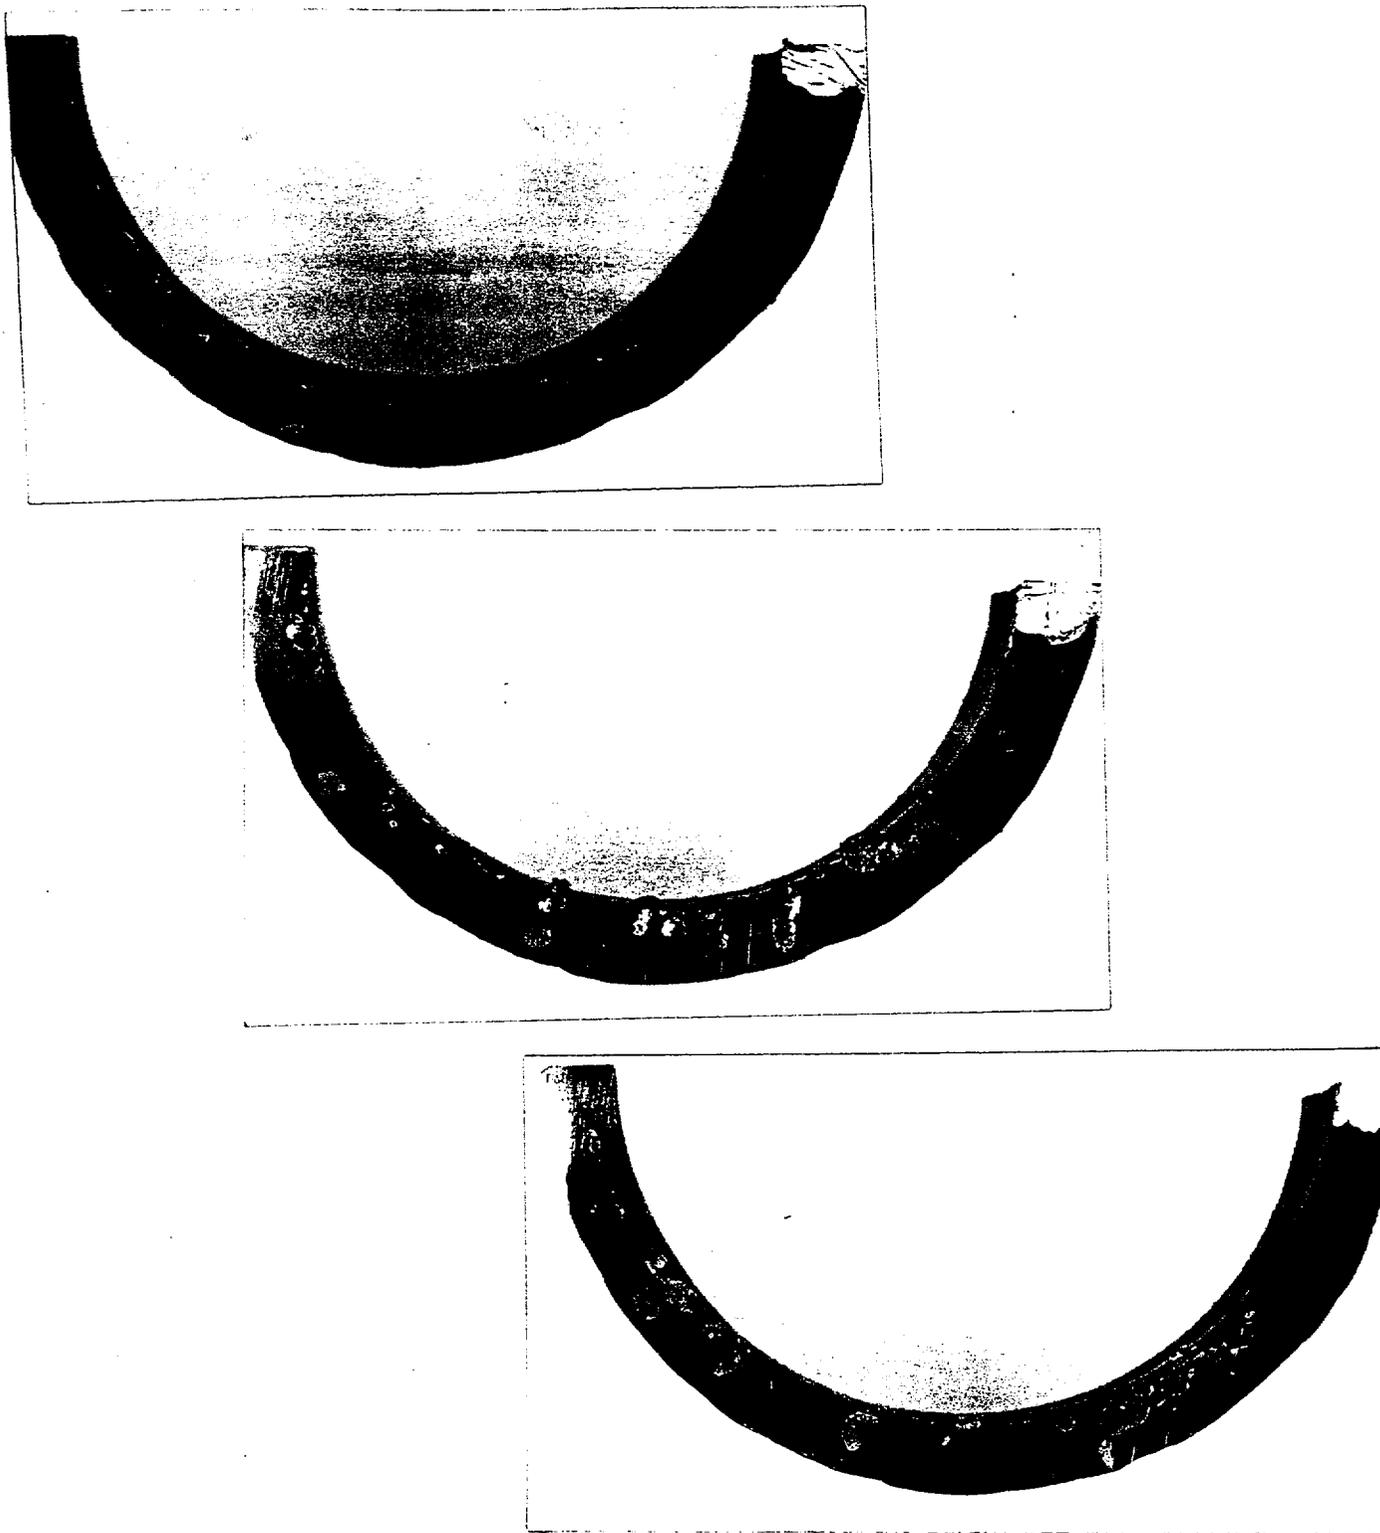
Figure 31: Three photographs showing progressive stages of grinding through FW97 in sample "B". The middle photo is at about the centerline of the weld and the other two are from about 0.080 inches either side of the center line. The extent of the MIC attack is evident. Magnification about 1.5X.

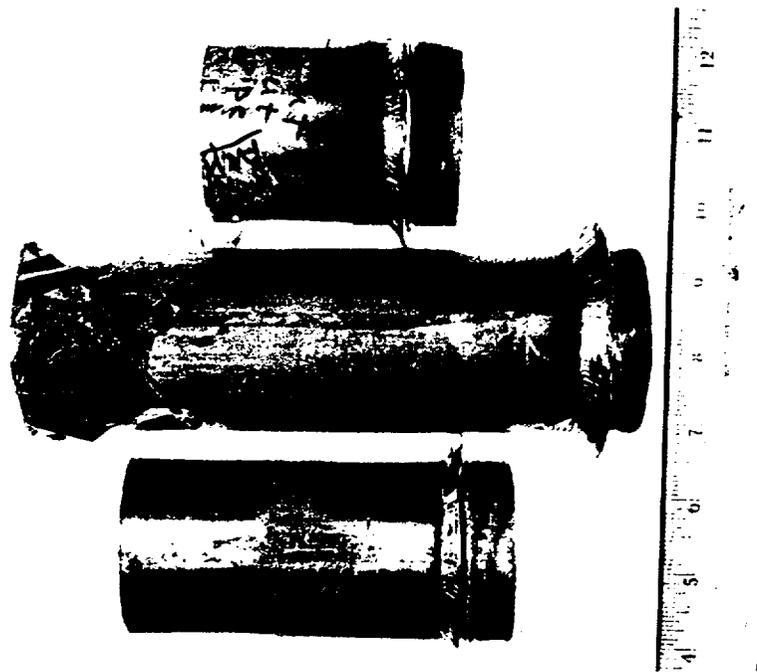
Figure 1: Photograph of welds FW73 (top), FW96 (middle), FW67 (bottom) showing the as received condition of the welds with some staining thought to indicate leakage locations.

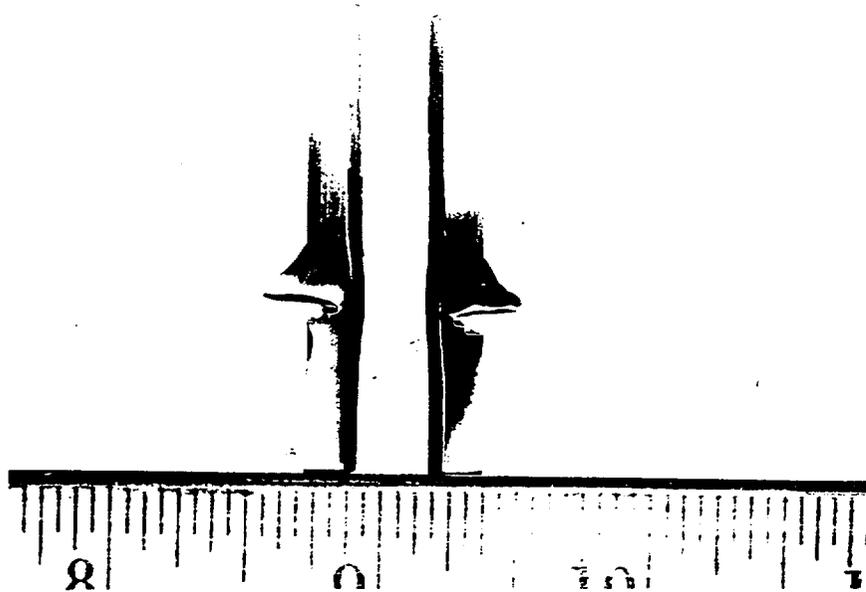
Figure 2: Photograph of a potential leak location identified on FW67. No evidence of MIC attack or weld anomaly is evident.

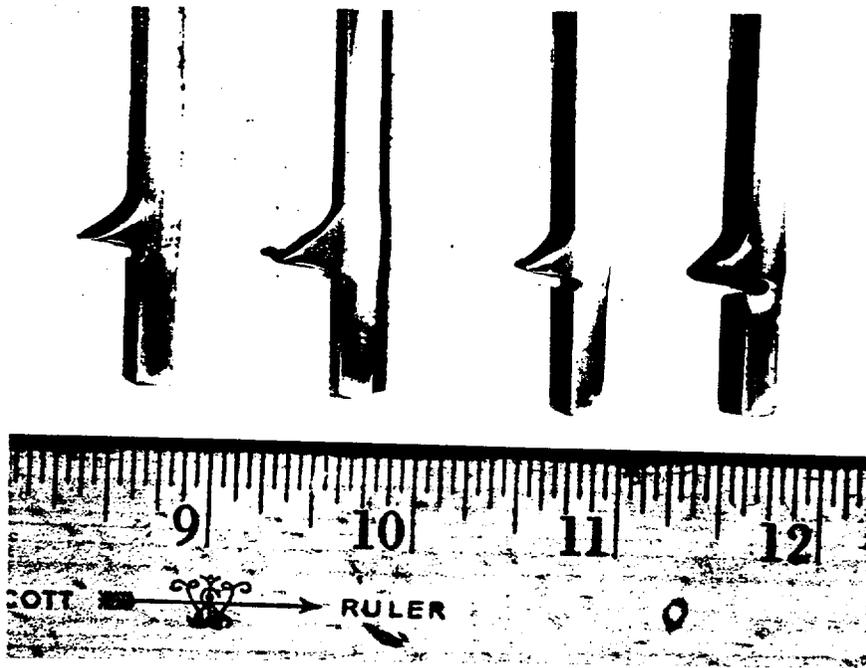
Figure 3: Photograph of four sections of FW73 cut and polished to assess weld condition and identify MIC. No questionable looking areas are apparent.

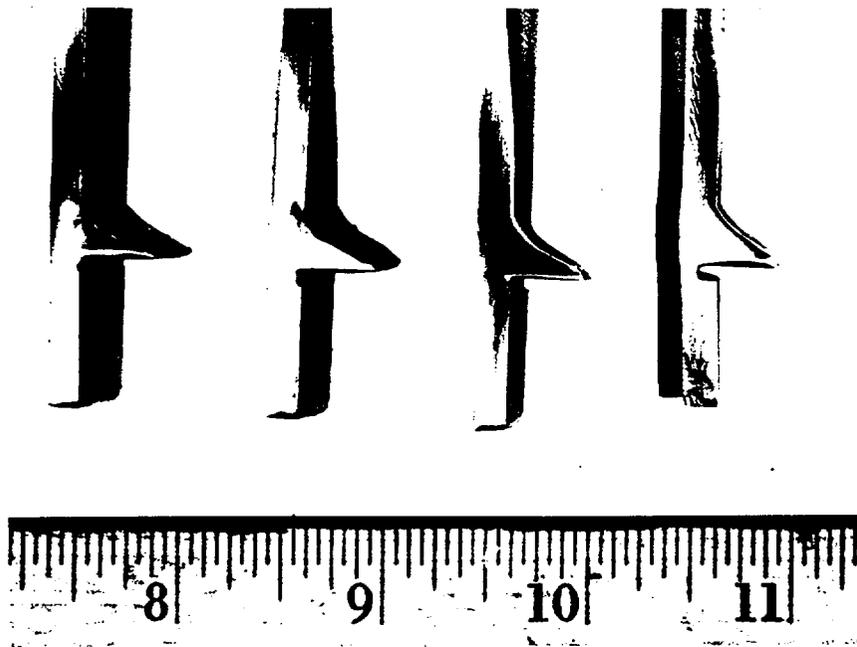
Figure 4: Photograph of four sections of FW74 prepared to show weld quality and locate MIC attack. No weld defects or MIC were found.

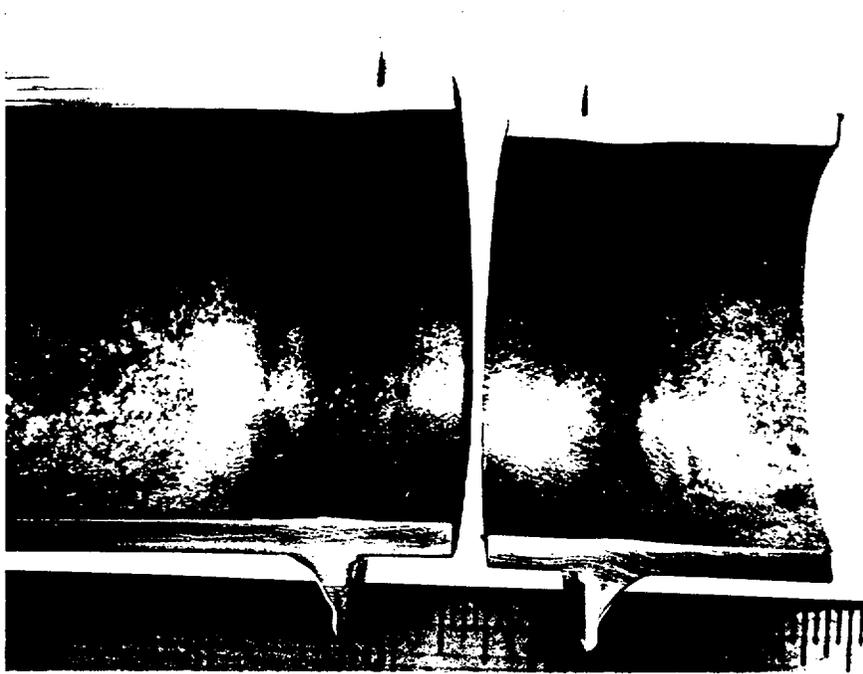
Figure 5: Photograph of a cross section of FW90 showing sound weld with no flaws or apparent MIC attack.

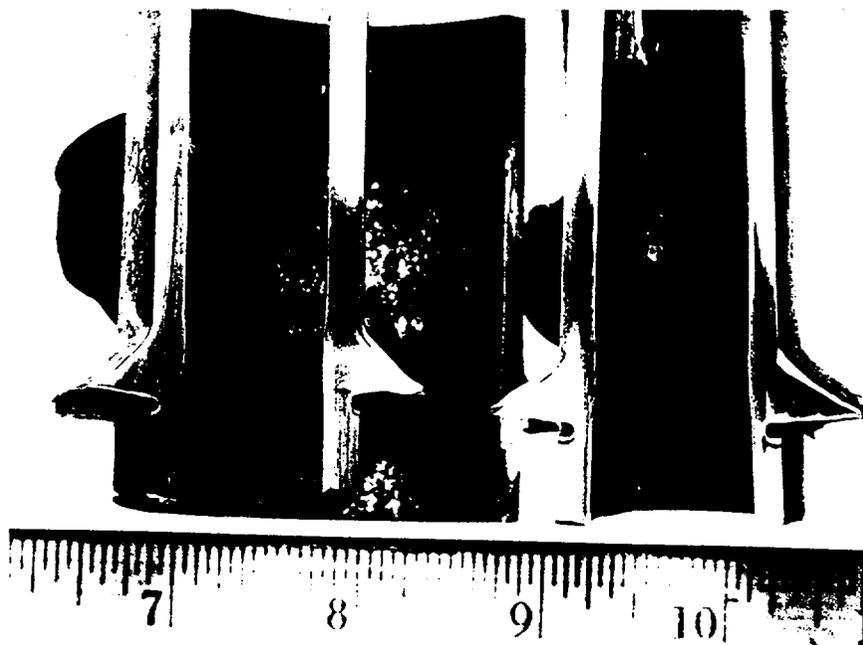
Figure 6: Photograph of four cross sections through suspected leak locations on FW96. No MIC indication or other weld anomalies were found.

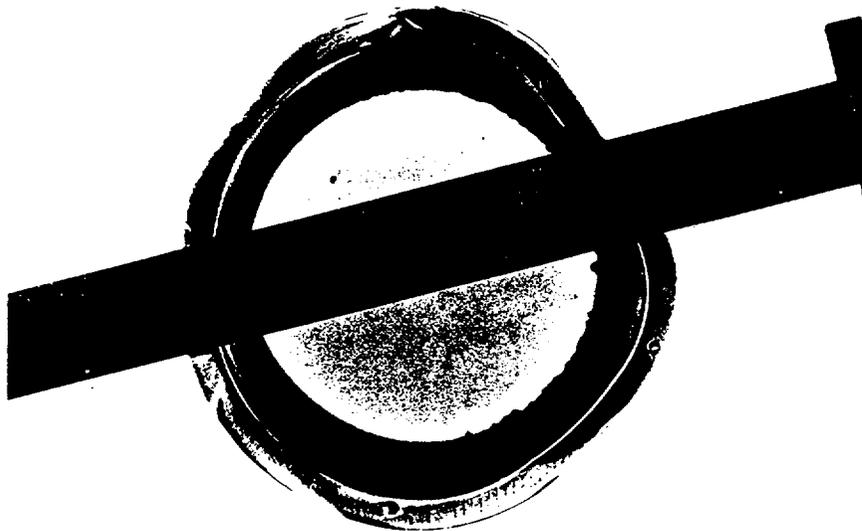
Figure 16: Photograph of the end of the pipe shown in the preceding two figures. Three small voids are visible in the wall of the pipe which may indicate MIC attack.

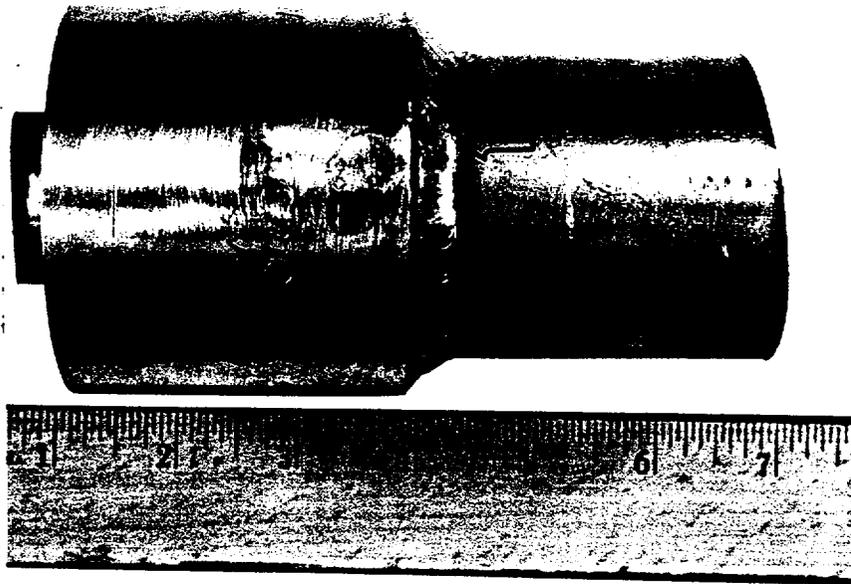
Figure 1: As received view of the reducer and pipe at field weld 9W of line 2"-WS-84-163-Q3. Rust colored staining is evident on the weld and fitting. The apparent source of leakage is indicated by the arrow.

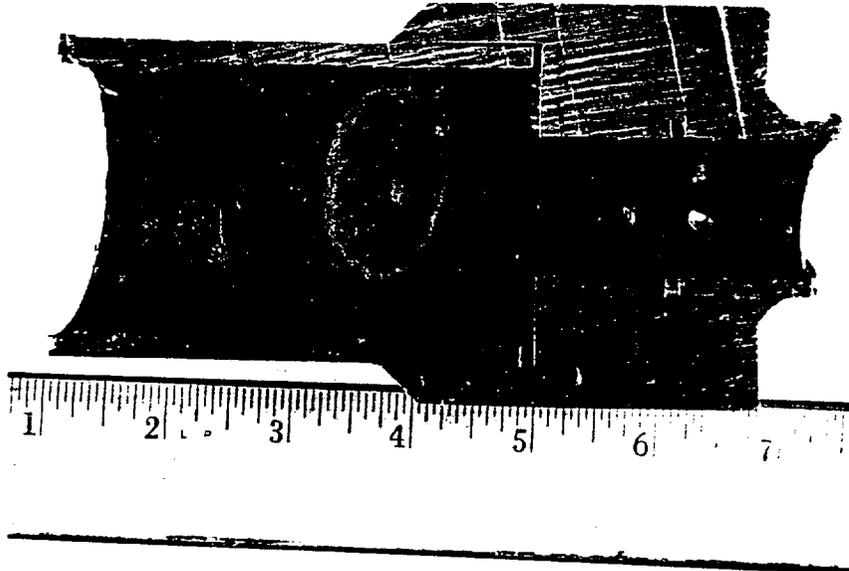
Figure 3: Photograph of a cross section through the pipe and fitting at weld 9W. The build up of debris and corrosion product is evident. The lighter orange spot in the large light orange area is the suspected leak initiation location.

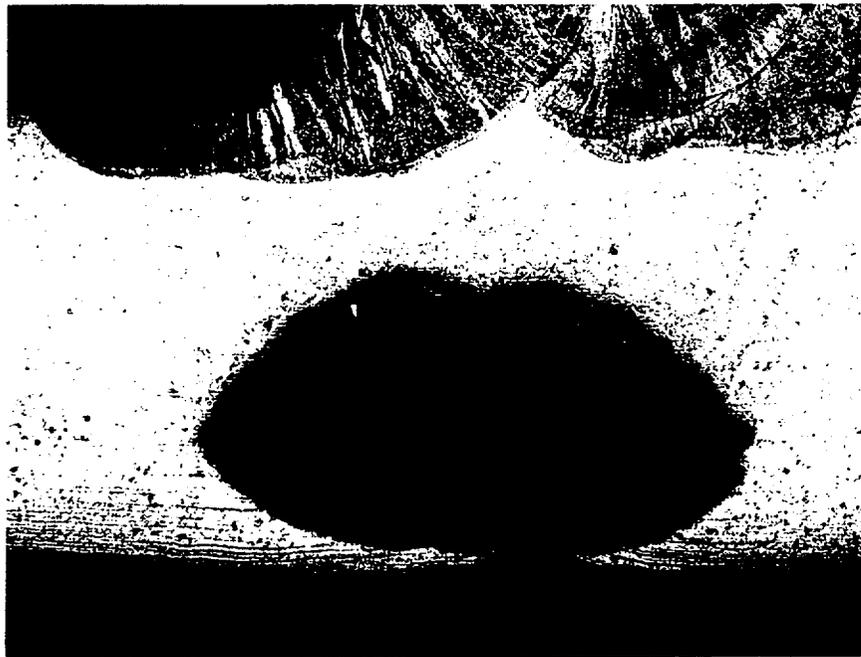
Figure 9: Photomicrograph of a cross section through the pipe and fillet weld at weld 9W. The small size of the pit at the ID surface relative the cavity size is evident and typical of some forms of MIC attack. This is the first of a series of cross sections at the suspected leak location. Magnification 15X. Electrolytic oxalic acid etch.

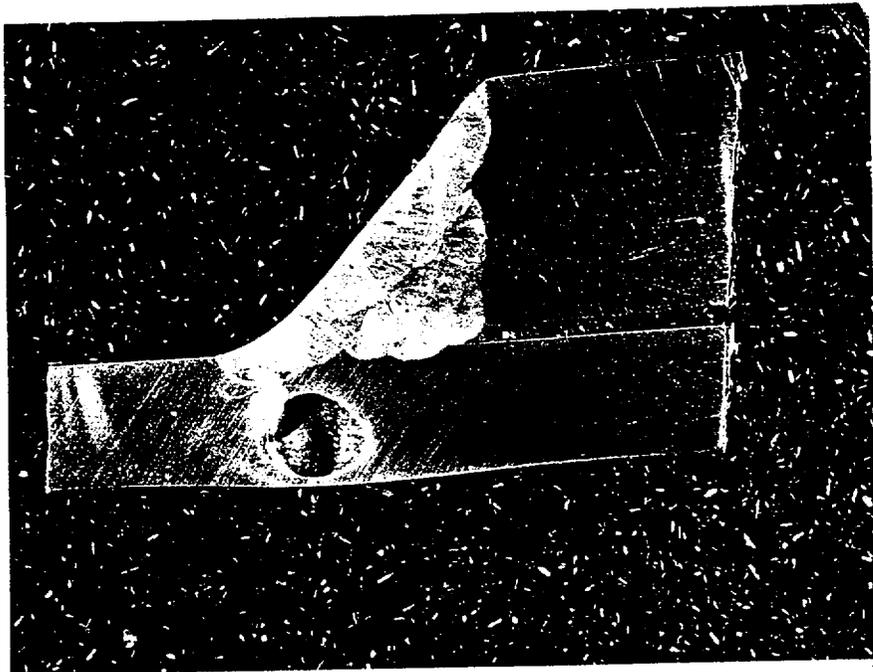
Figure 10: Photograph of the second of the series of cross sections at weld 9W. The larger size of the cavity and its encroachment on the fillet weld HAZ are evident. Magnification about 4X. Electrolytic oxalic acid etch.

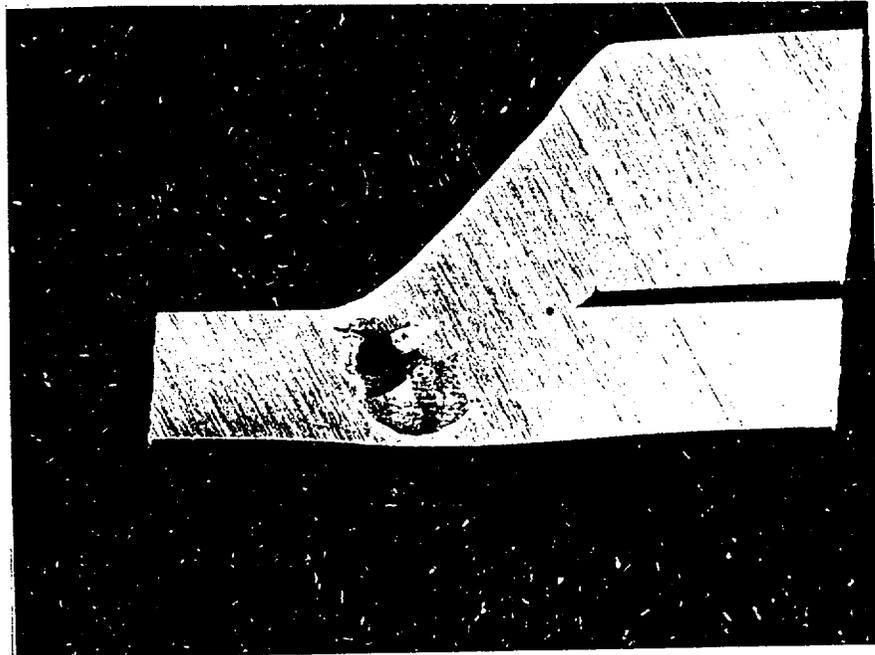
Figure 11: The next in the series of weld 9W cross sections showing the extensive cavity associated with the leak, preferential growth along the weld HAZ, and some weld metal attack. Magnification about 4X.

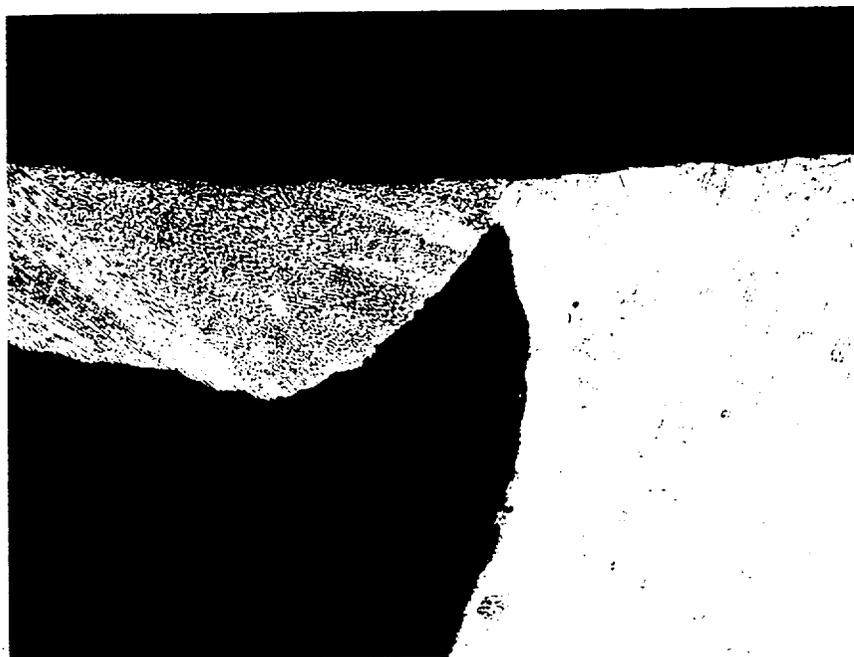
Figure 13: Photomicrograph of the final cross section of the series at the leak location just past the point where the penetration of the OD surface was found, but unfortunately, not photographed. The preferential attack along the HAZ is clearly indicated here, Magnification 100X. Electrolytic oxalic acid etch.
