VIRGINIA ELECTRIC AND POWER COMPANY
NORTH ANNA POWER STATION UNIT 1
ASME SECTION XI RELIEF REQUESTS NDE-9 AND NDE-15

ASME Section XI Relief Request NDE-9

North Anna Power Station Unit 1

NES MATERIALS ENGINEERING LABORATORY
FAILURE ANALYSIS REPORT

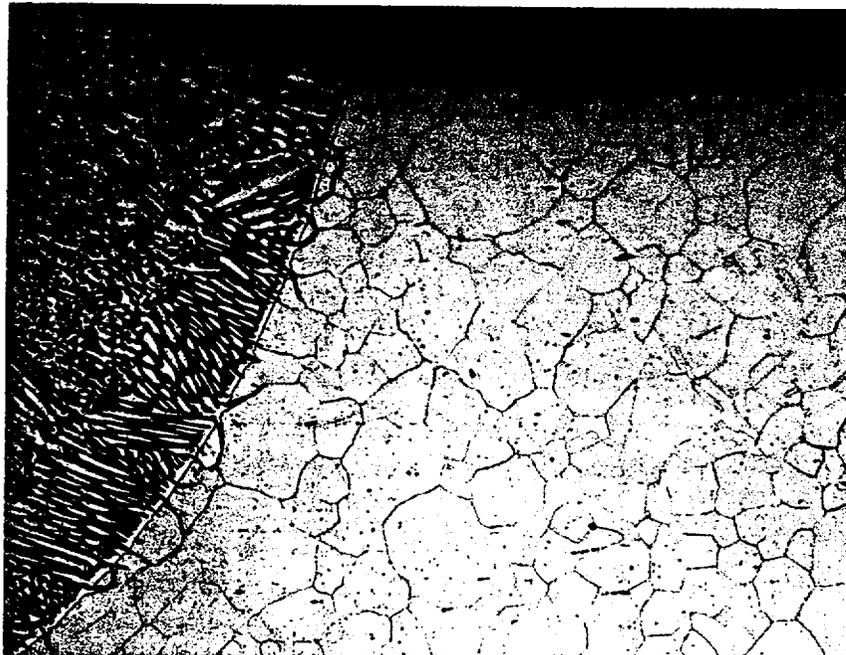
Figure 18: A higher magnification photomicrograph at the weld HAZ of 9W showing the heavy etching of the weld metal indicating an enhanced susceptibility to corrosion. Magnification 200X. Electrolytic oxalic acid etch.
