VIRGINIA ELECTRIC AND POWER COMPANY
RICHMOND, VIRGINIA 23261

VIRGINIA ELECTRIC AND POWER COMPANY
NORTH ANNA POWER STATION UNIT 1
ASME SECTION XI RELIEF REQUESTS NDE-9 AND NDE-15

NES MATERIALS ENGINEERING LABORATORY
FAILURE ANALYSIS REPORT

1. **Station:** North Anna 2. **Unit:** 2
3. **Component:** Line 2"-WS-777-163-Q3, service water discharge from 2-IA-C-1. Socket welded 316L stainless steel schedule 40 pipe.

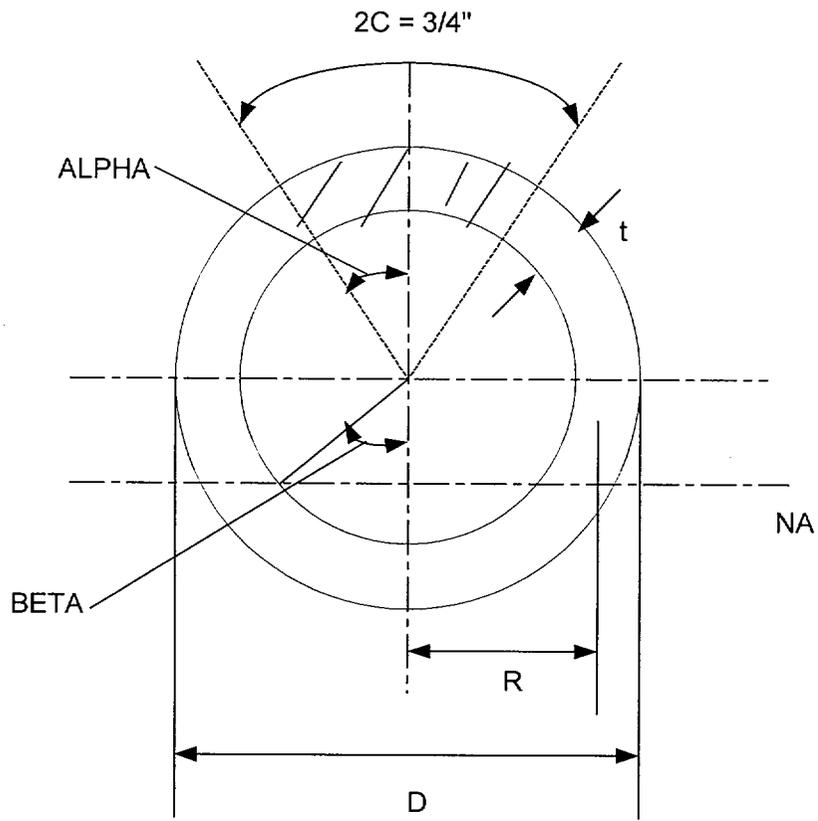
Figure 2
Circumferential Flaw

The analysis will be performed using the guidance from the ASME Code Case N-513 and ANSI B31.1 Power Piping Code paragraph 104.3. The analysis will treat the flawed location as equivalent to the nominal pipe of the same size containing the enveloping flaw. The required margins in the Code Case will be demonstrated using the loadings due to pressure, deadweight, thermal expansion, seismic OBE and DBE conditions as appropriate. A residual stress equal to the yield stress in the material will be used in the analysis to address the influence of the weld. The $\frac{3}{4}$ " hole will be evaluated using the area replacement method of the ANSI B31.1 Code.

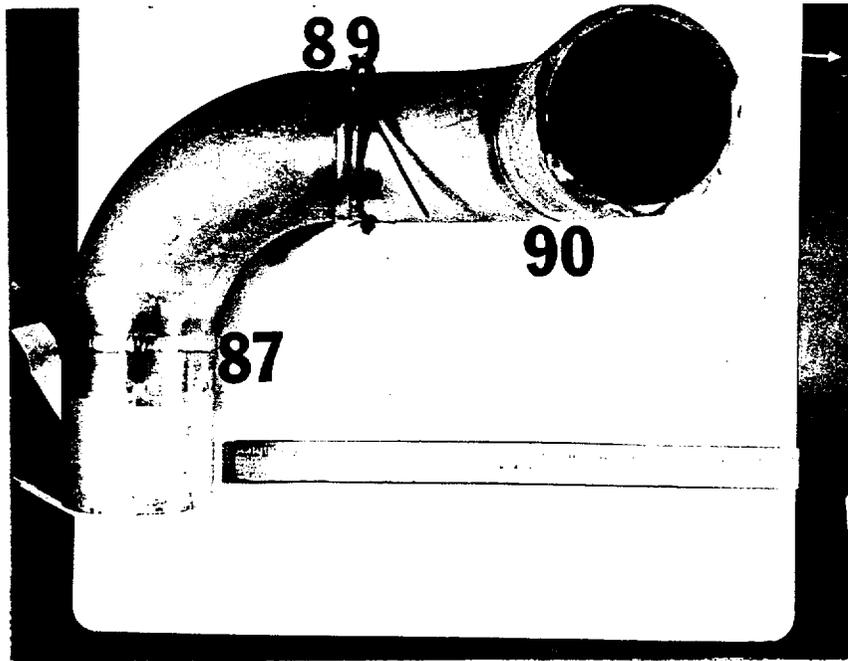
Figure 6: Photograph showing the section of pipe containing field weld 89.

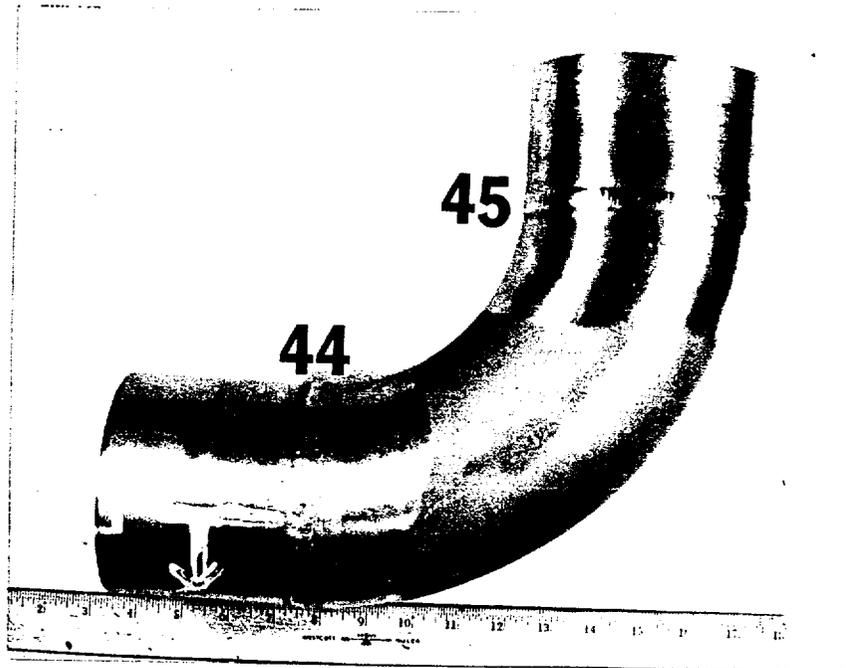
Figure 18: Photograph of the pipe section containing field weld 45.

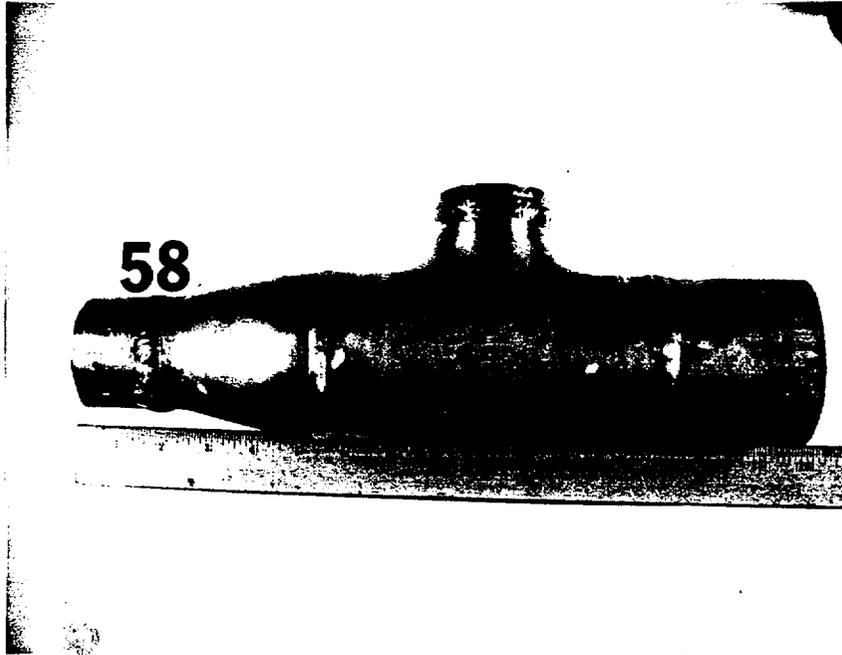
Figure 22: View of the reducer that contained field weld 58.

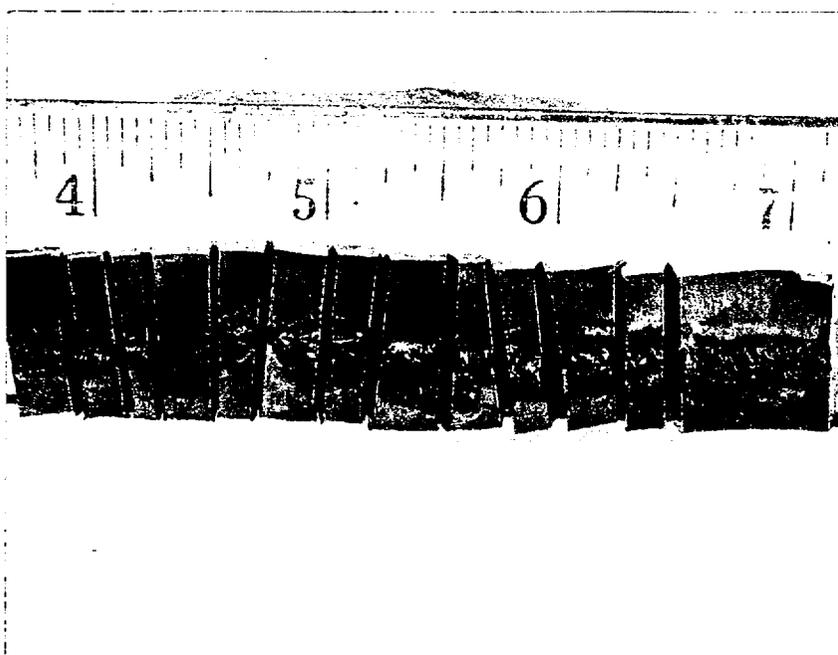
Figure 25: Photograph showing a portion of the weld after cleaning and sectioning approximately every 1/8 of an inch. Notice the very rough appearance of the weld.

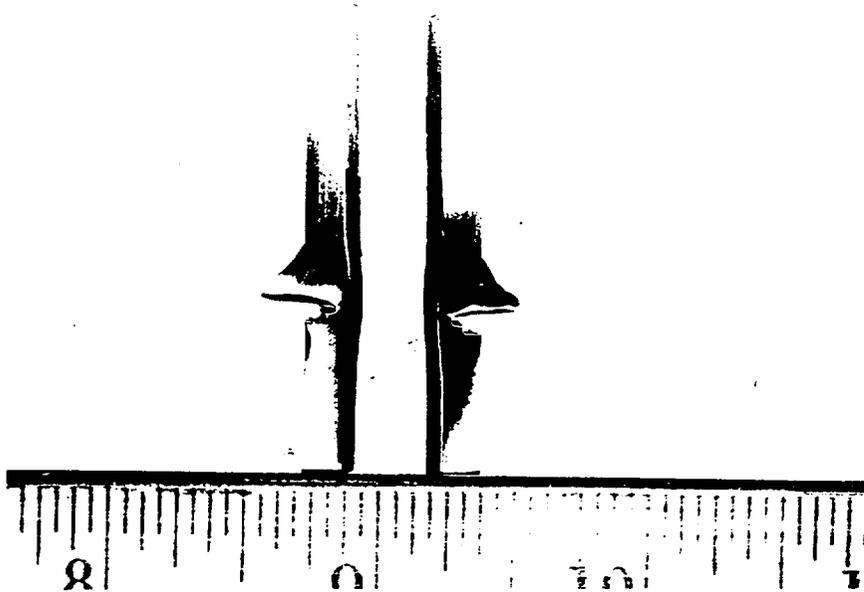
Figure 2: Photograph of a potential leak location identified on FW67. No evidence of MIC attack or weld anomaly is evident.

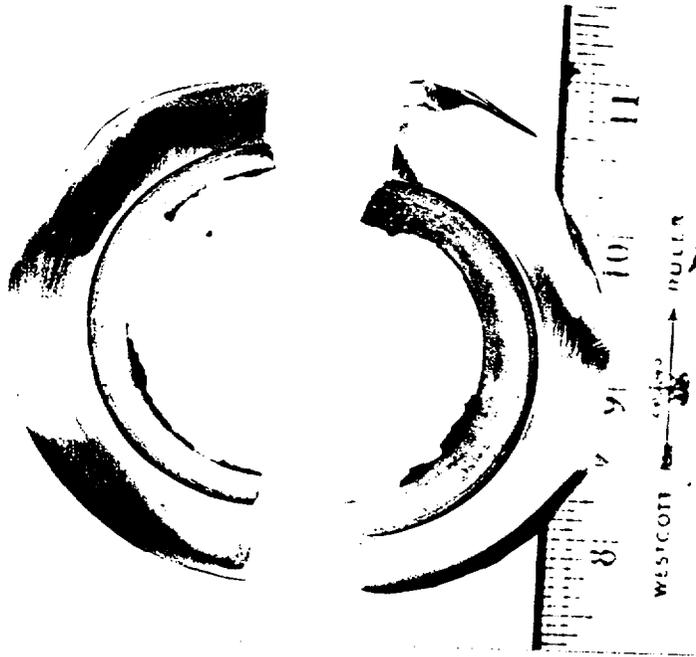
Figure 7: At remaining weld root.

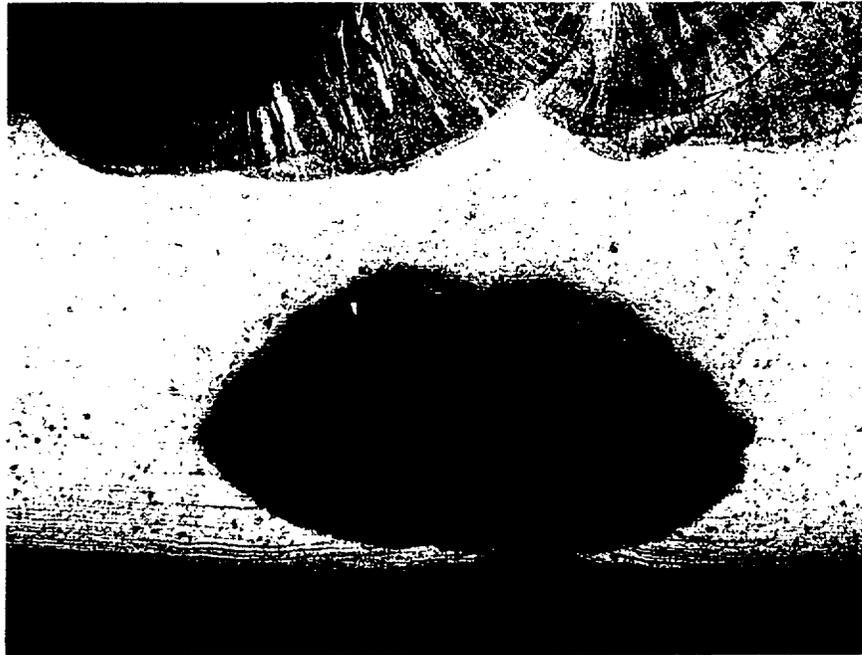
Figure 9: Photomicrograph of a cross section through the pipe and fillet weld at weld 9W. The small size of the pit at the ID surface relative the cavity size is evident and typical of some forms of MIC attack. This is the first of a series of cross sections at the suspected leak location. Magnification 15X. Electrolytic oxalic acid etch.

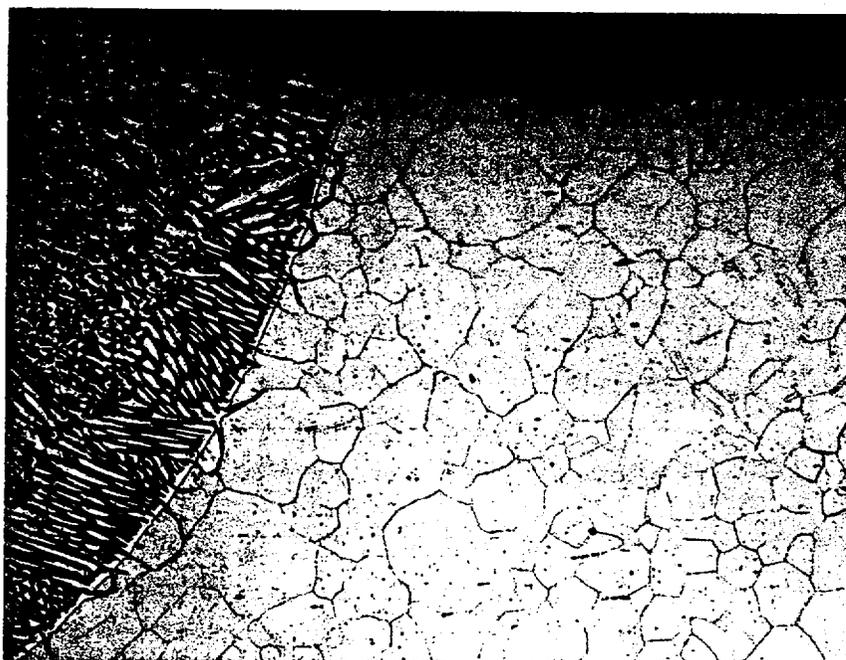
Figure 18: A higher magnification photomicrograph at the weld HAZ of 9W showing the heavy etching of the weld metal indicating an enhanced susceptibility to corrosion. Magnification 200X. Electrolytic oxalic acid etch.
