Dresden Nuclear Power Station, Unit 2
Facility Operating License No. DPR-19
NRC Docket No. 50-237

Subject: Licensee Event Report 1999-005-01, "Inadvertent Reactor Vessel Drain Down Through an Electromatic Relief Valve Caused by Procedure Non-Adherence Due to Inadequate Supervision and Ownership of Work"

LICENSEE EVENT REPORT (LER)

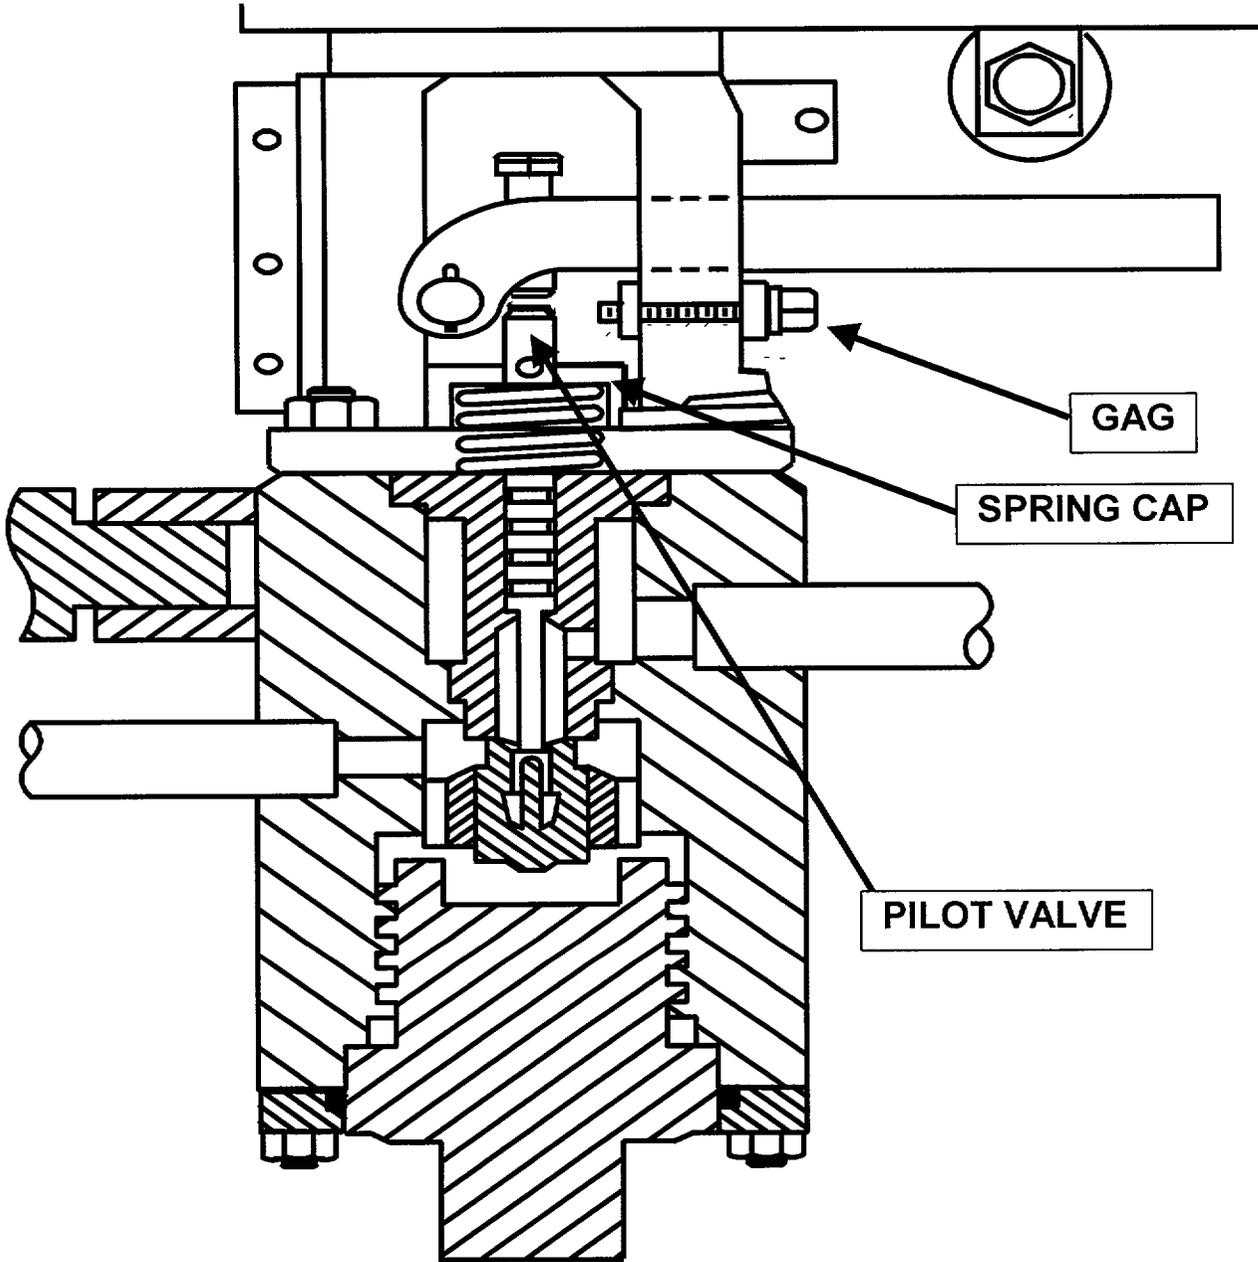
Figure 1
ERV Pilot Valve Diagram

- Each stroke of the valve was smooth and no binding of the pilot valve during operation was observed.
- A general inspection of the pilot valve assembly found that no foreign material was present and the general appearance of the valve was clean. The seating surfaces were in good condition and showed no indication of foreign material induced damage.
- The pilot valve stem had slight galling marks on an otherwise smooth surface.
- The pilot valve seat bushing's outer surface revealed an indication of where a compressed spring had been pressed against the side of the bushing.

- Physical inspection of the ERV pilot valve stem and bushing revealed that the ERV pilot valve spring cap was skewed believed to be due to inappropriate maintenance. Potential causes include contact with the ERV gag, mechanics wrench, or mechanics hands during ERV gag repositioning. The most likely cause is contact with the ERV gag. The ERV gag should have been removed and was not. This was due to failure to follow station procedure as written. The procedure was not followed as written due to inadequate supervision and ownership of the work.
