Trip Report

Visit to Tokyo and Tokai-Mura, Japan

**Information Exchange with
Government of Japan Concerning
The September 30, 1999
Tokai-Mura
Criticality Accident**

**Frank R. McCoy, III
Thomas P. McLaughlin
Leroy C. Lewis**

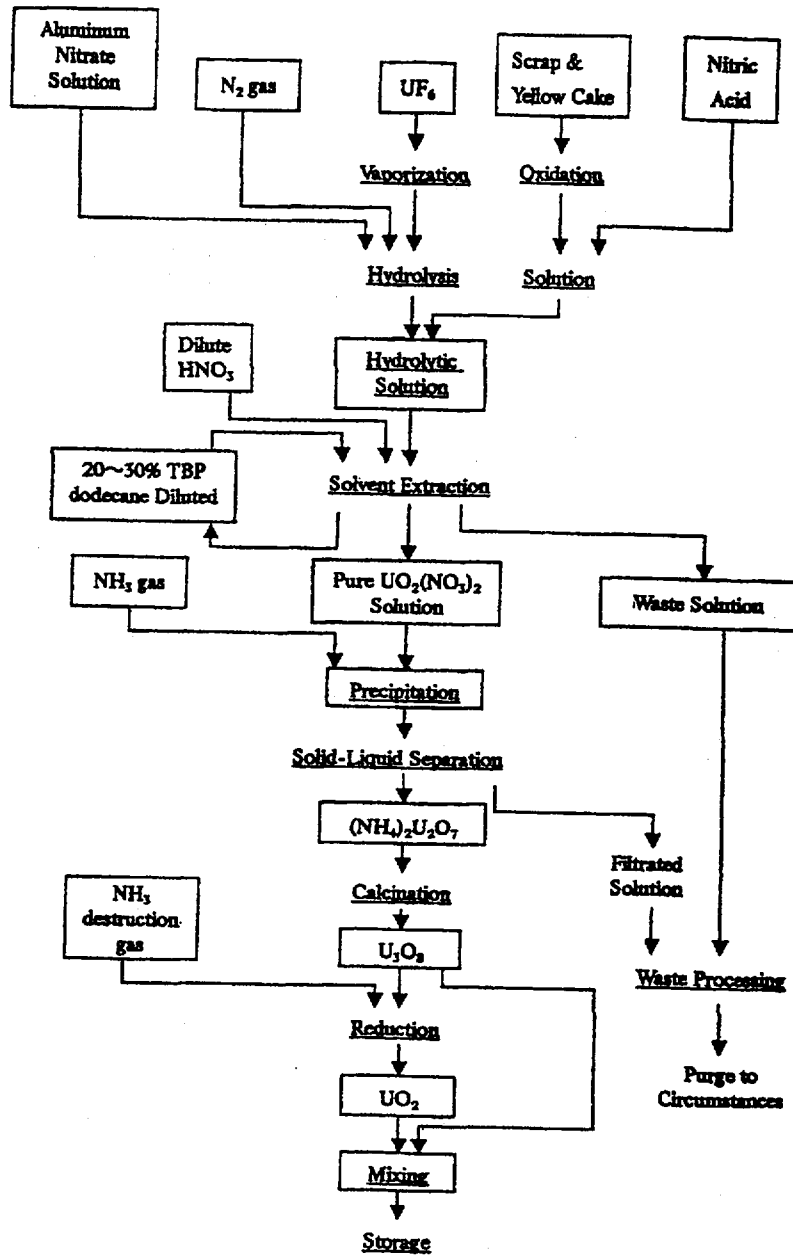
Figure 1. A schematic diagram of the JCO conversion process

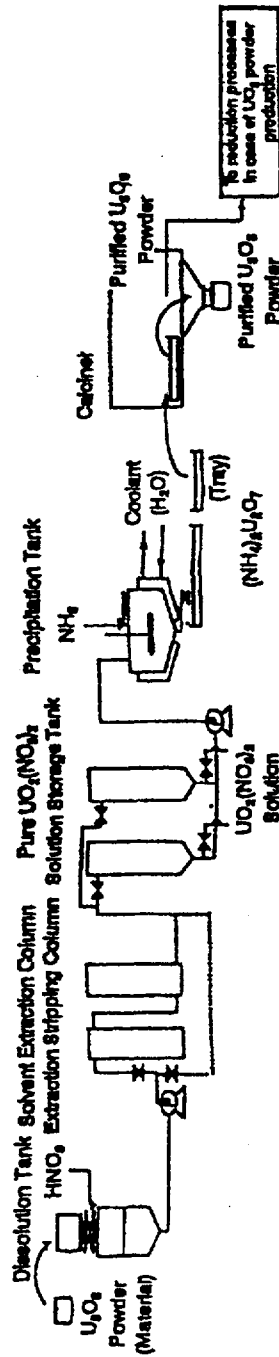
The entire process described above and shown in Figures 1 and 2 of Attachment D was the process approved by the Science and Technology Agency.

Figure 2. The JCO conversion process as it was permitted under the license granted in 1984. This license permitted the dissolution of 2.4 kg U_3O_8 when the enrichment was between 16 and 20 %. It allowed the option of taking off $UO_2(NO_3)_2$, U_3O_8 , and UO_2 as products. It also allowed the feed to be from either the hydrolysis of UF_6 up to 20% enriched, or from the direct dissolution of U_3O_8 up to 20% enriched or of scrap up to 50% enriched.

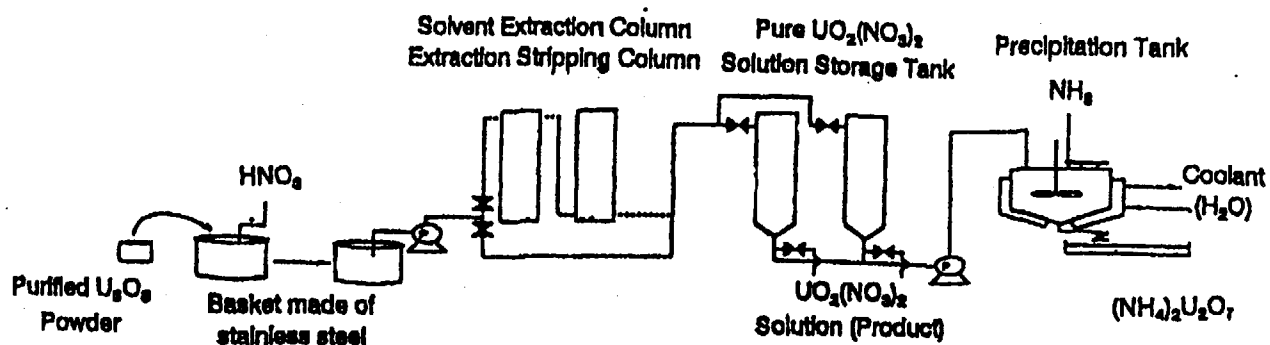
Subsequent to initial operations in the Conversion building for intermediate enriched uranium, in 1986, an unreviewed and unapproved change was made to the flow sheet where the dissolution was carried out in a stainless steel bucket and then pumped into the geometrically favorable storage tanks. This reduced the amount of time needed to complete a processing cycle. A second unreviewed and unapproved change was later made to a company procedure in which the dissolver was formally removed from the process and a bucket for the dissolution put in its place. This procedure still required the dissolved product to be pumped into the geometrically favorable tanks for storage. The procedure and flowsheet, which were provided to the delegation by Japanese officials, indicated that multiple batches (six to seven) containing about 15,000 grams of intermediate enrichment uranium, could have been accumulated in the geometrically favorable storage tanks. This unreviewed provision would have allowed for violation of specified mass limits contrary to the license. These changes are shown Figure 3 of Attachment D.

Figure 3. The modified procedure that allowed the use of a stainless steel bucket as a dissolution vessel. The resultant solution was to be pumped into the system for storage in the geometrically favorable solution storage tanks.

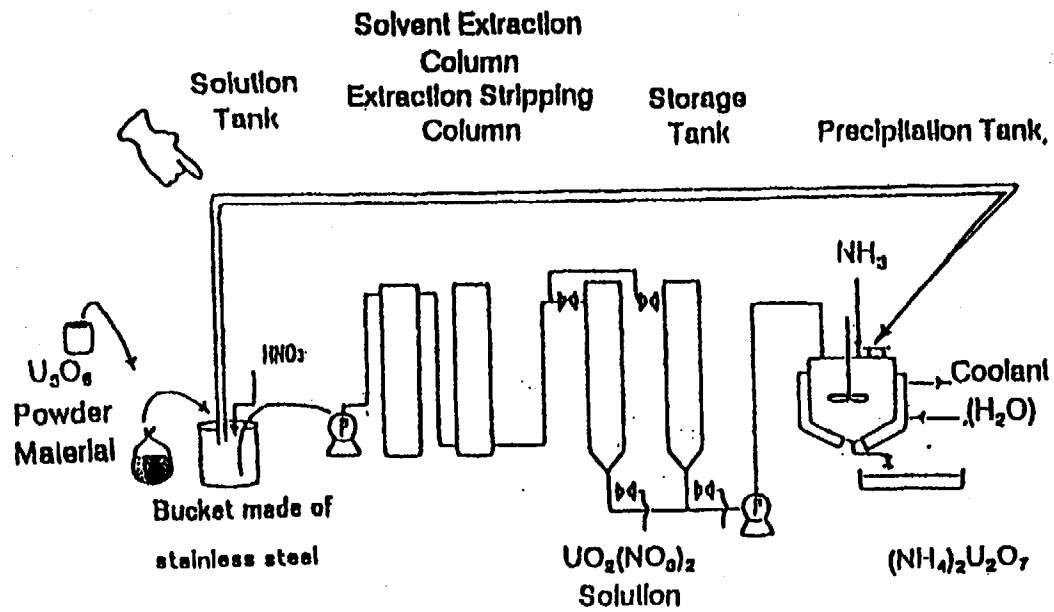
A final unreviewed and unapproved modification to the process was informally made prior to the 1999 conversion of uranium oxide to uranyl nitrate. A decision, apparently made to save time and facilitate ease of handling of the uranyl nitrate solution, provided for continuing dissolution in the stainless steel buckets but, instead of pumping the uranyl nitrate product into the geometrically favorable storage tanks, provided for transferring the solution directly into the precipitation vessel by pouring it through a funnel in the large 10" diameter nozzle in the top of the vessel. This decision also provided for accumulating several batches of uranyl nitrate in the precipitation vessel thereby significantly exceeding specified mass limits established by the license. These activities were conducted contrary to procedures, the license, and established safety controls. This final process modification is shown in Figure 4 of Attachment D.

Based on the information presented, the delegation believes that the cause of this accident was the accumulation of uranyl nitrate, contrary to specified mass limits, directly into a precipitation vessel, contrary to its designed use and contrary to procedure, until a sufficient quantity of intermediate enriched uranium was available to initiate and sustain a nuclear criticality reaction.

Figure 4. The procedure that was used at the time of the criticality accident. Batches containing 2.4 kg U_3O_8 were dissolved in a stainless steel bucket. The batch was then transferred to a 5-liter beaker and then physically transported to the precipitation tank where it was poured through a funnel into the tank. Seven batches of solution were added to the tank before it went critical.
