**Report on the preliminary  
fact finding mission  
following the accident at the  
nuclear fuel processing  
facility in Tokaimura, Japan**

INTERNATIONAL ATOMIC ENERGY AGENCY, VIENNA, 1999

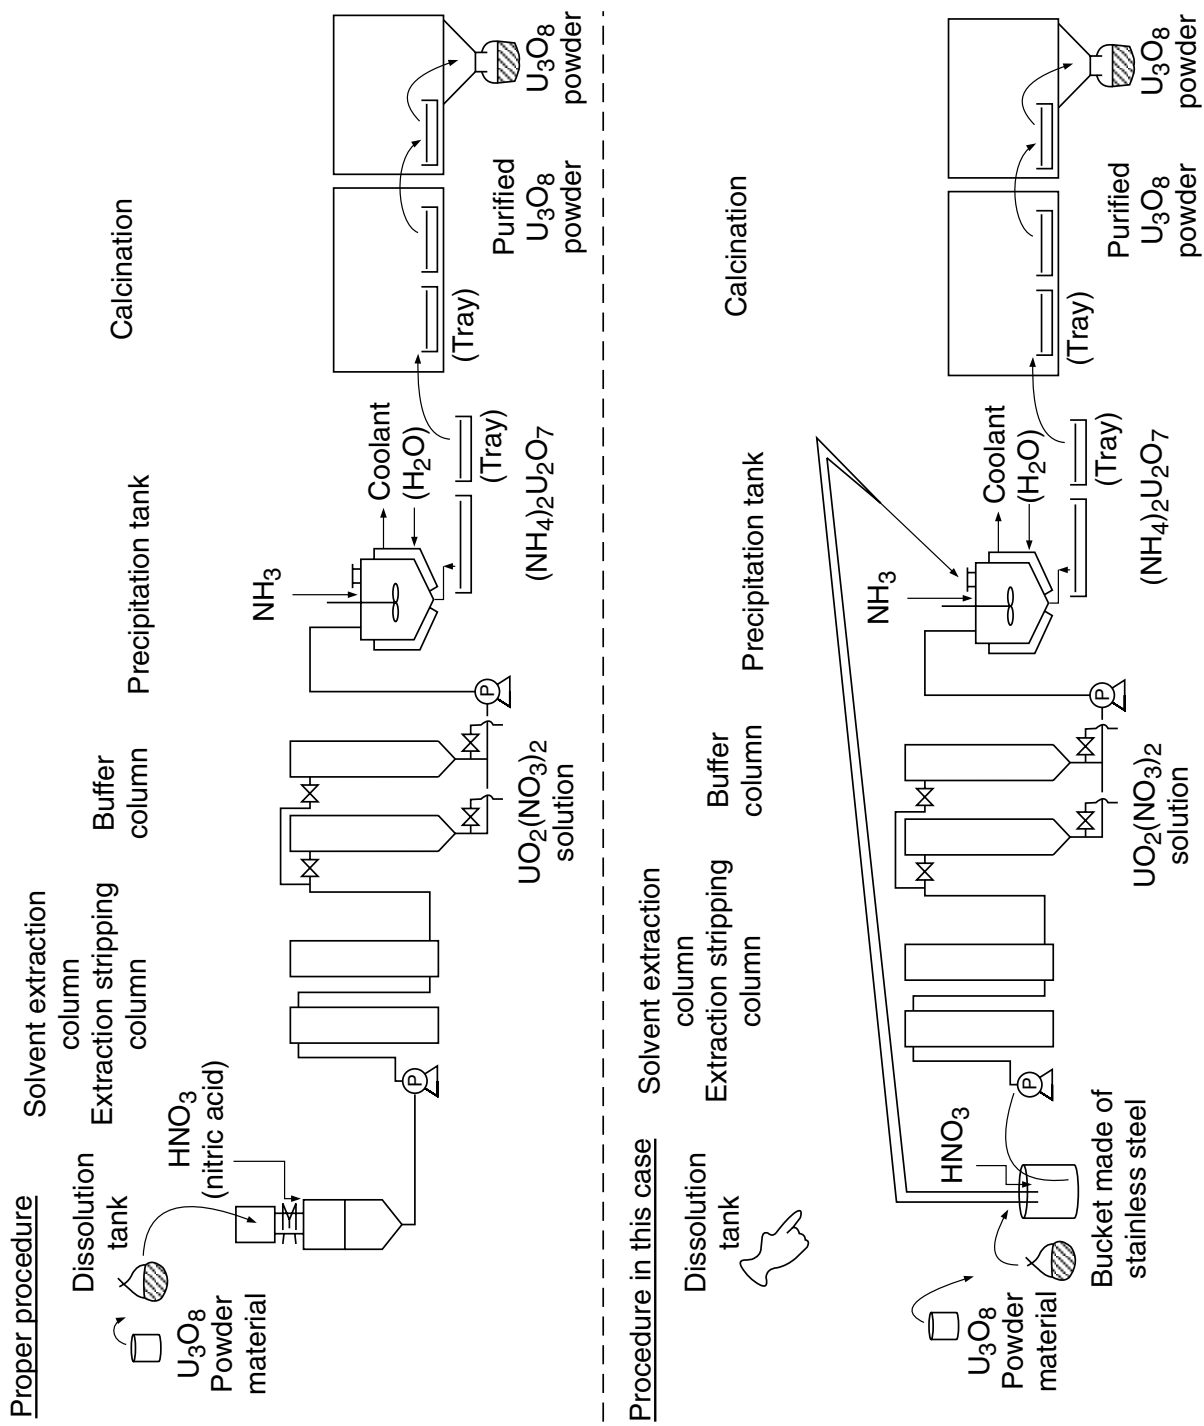
The work procedure was modified in November 1996, without permission for the modification having been given by the regulatory authorities, to allow the dissolution of uranium oxide ( $U_3O_8$ ) to be performed in stainless steel buckets. According to the information provided at the meetings with the IAEA Secretariat team, this new procedure had been followed several times before this accident occurred.

Furthermore, when the criticality event occurred, homogenization of uranium oxide was being performed by mechanical stirring in the precipitation tank instead of in the mass control equipment. This was done by pouring uranyl nitrate solution (made by dissolving uranium oxide ( $U_3O_8$ ) in nitric acid) directly from the steel bucket into the precipitation tank. The tank was not designed with a geometry conducive to preventing criticality, being 450 mm in diameter and 610 mm high (Fig. 8). This means of homogenization in the precipitation tank is not even described in the revised procedure and was a further deviation from the approved procedure.

buckets and poured the solution directly into the precipitation tank. About 26 L of the solution, with uranium enriched to 18.8%  $^{235}U$  by mass, had been poured into the precipitation tank in four batches on 29 September. In the morning of 30 September, the workers continued to prepare uranyl nitrate solution and poured three additional batches into the precipitation tank (Figs 7 and 8).

Fig. 7. Schematic diagram of the proper procedure and the actual procedure used in this case for dissolution and precipitation.

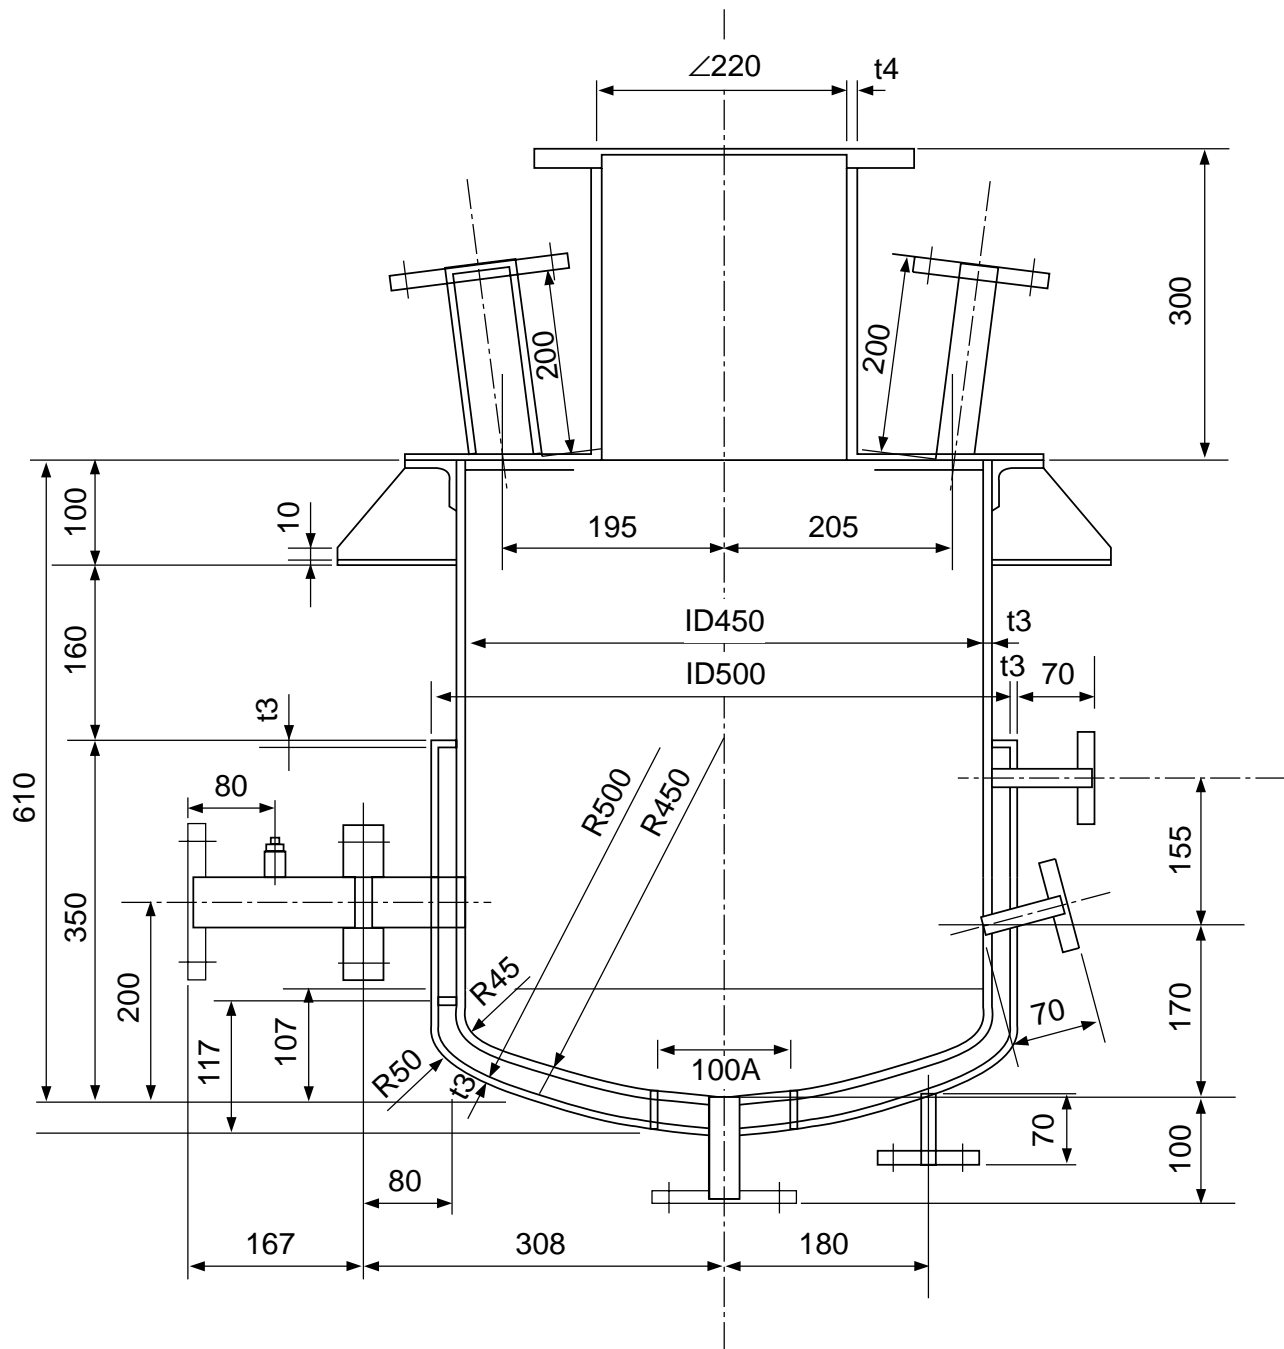
At around 10:35 on 30 September (all times are local times unless otherwise stated), when the volume of solution in the precipitation tank reached about 40 L, equivalent to about 16 kg U, a critical mass was reached. At the point of criticality, the nuclear fission chain reaction became self-sustaining and began to emit intense gamma and neutron radiation [14]. The area gamma monitoring device detected a high level of gamma radiation and the area alarms sounded. The three workers concerned evacuated the building (there was apparently no explosion). They were subsequently given assistance by emergency service workers. The other workers on site assembled in the muster zone (Fig. 4).

removal of water from the cooling jacket could help to terminate the state of criticality. The cooling jacket acted as a neutron reflector, thereby enhancing nuclear fission [14]. At the second meeting at the GACH, held at 23:15 on 30 September, it was concluded that the cooling water should be drawn off from the water jacket surrounding the precipitation tank in order to end the state of criticality and thereby terminate the self-sustaining nuclear chain reaction [13].

Fig. 8. Cross-section of the precipitation tank indicating dimensions (in mm).

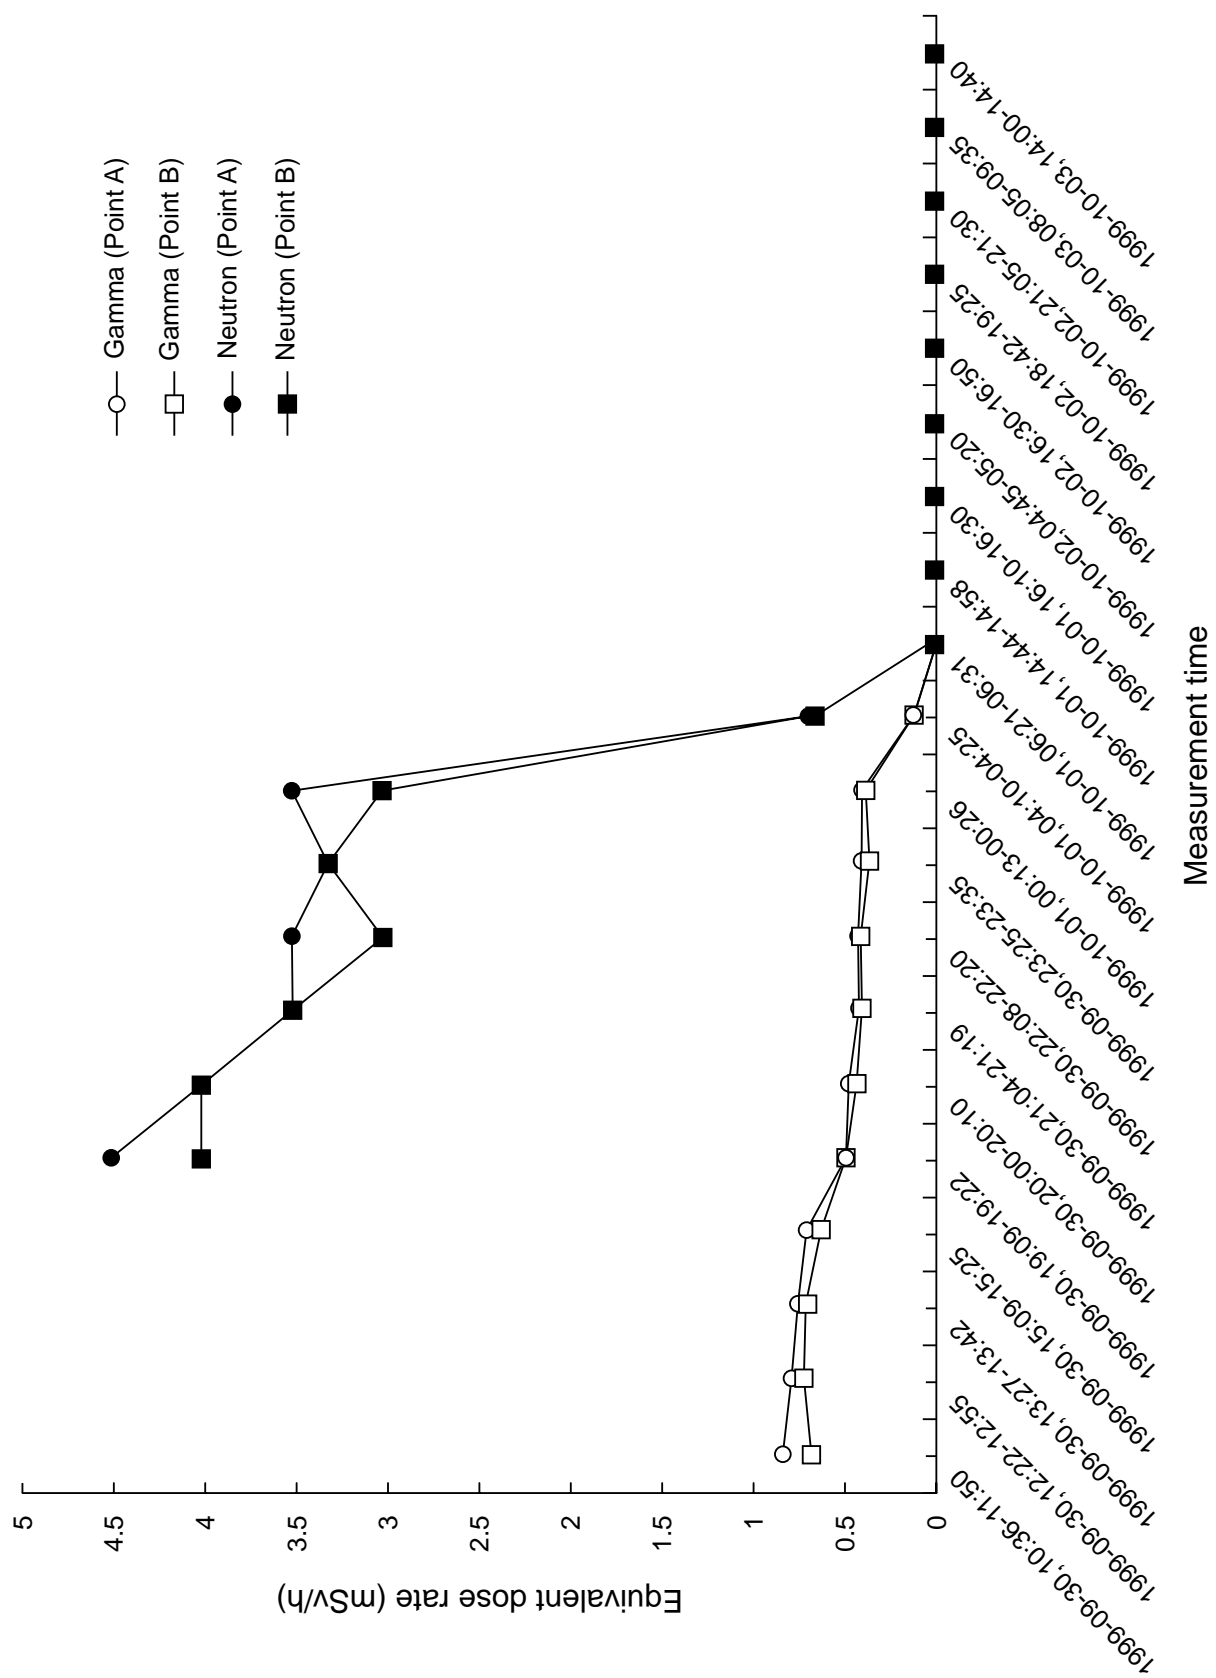
At 11:40, a maximum gamma dose rate of 0.84 mSv/h was measured in an area around the facility [4, 13, 14] (Fig. 9). At around 14:00, the Mito Atomic Energy Office of STA started monitoring gamma dose rates. The results were provided to the LCH and to the Government Accident Countermeasures Headquarters (GACH) which had been established at 15:00.

After 17:00, the maximum neutron dose rates at the site boundaries were measured to be around 4 mSv/h (Fig. 9), which indicated a continuing state of criticality [4, 13].

Fig. 9. Gamma and neutron dose rates at monitoring points A and B (see Fig. 4).

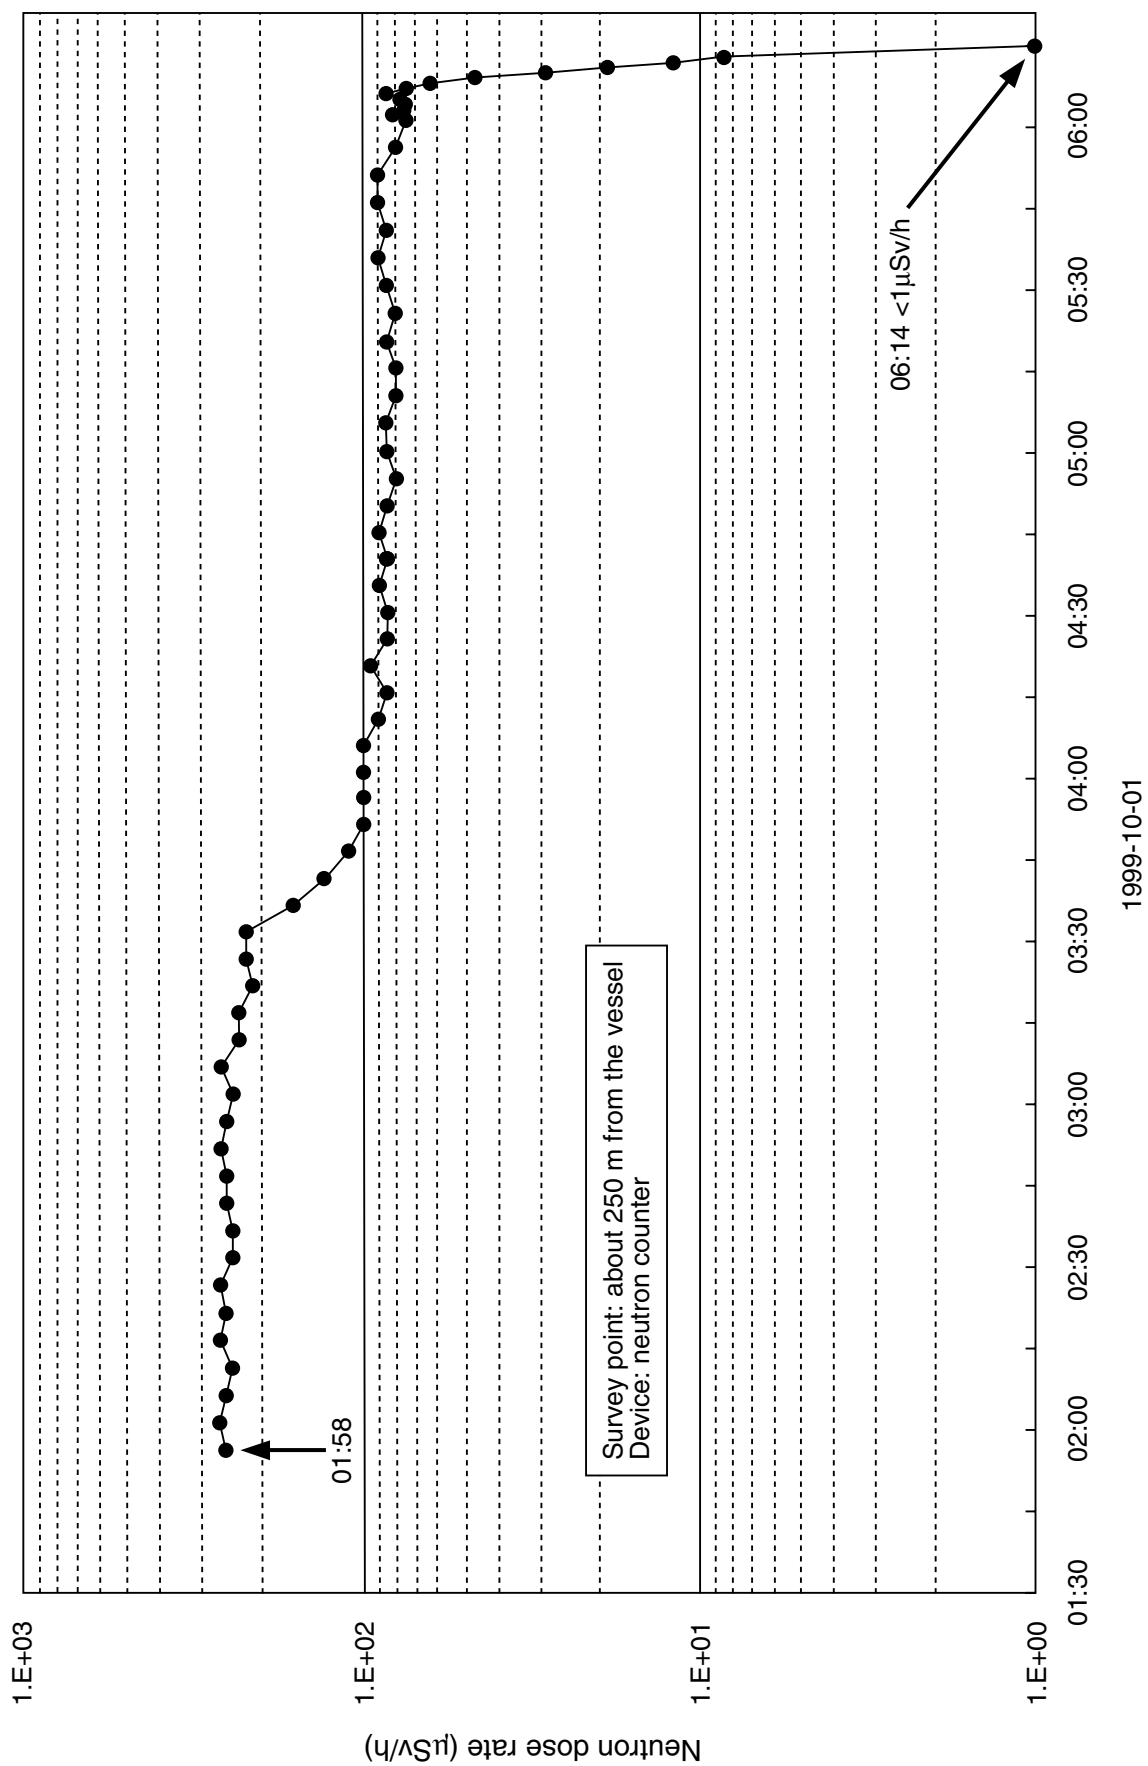
The cooling pump, the valves and the cooling tower were located outside the building, making them easier to access (Fig. 10). Attempts to drain the water were made between 02:35 and 06:04 on 1 October. Ten approaches were made, the purpose of the first being to photograph the cooling tower and pump area. First the cooling tower feed valve (WS4 in Fig. 10) was closed and the drain valve (DR1 in Fig. 10) was opened. At this stage, only a little water was drained, but the neutron dose rate decreased somewhat. The water pipe was then broken and cut to drain the water. Finally, at around 06:15, argon gas was pumped into the water pipe to force out much more water. At around 06:30 the neutron dose rate was below the detection limit [14] (Fig. 11).

Fig. 11. The trend of neutron dose rate during mitigation (measured by JNC).

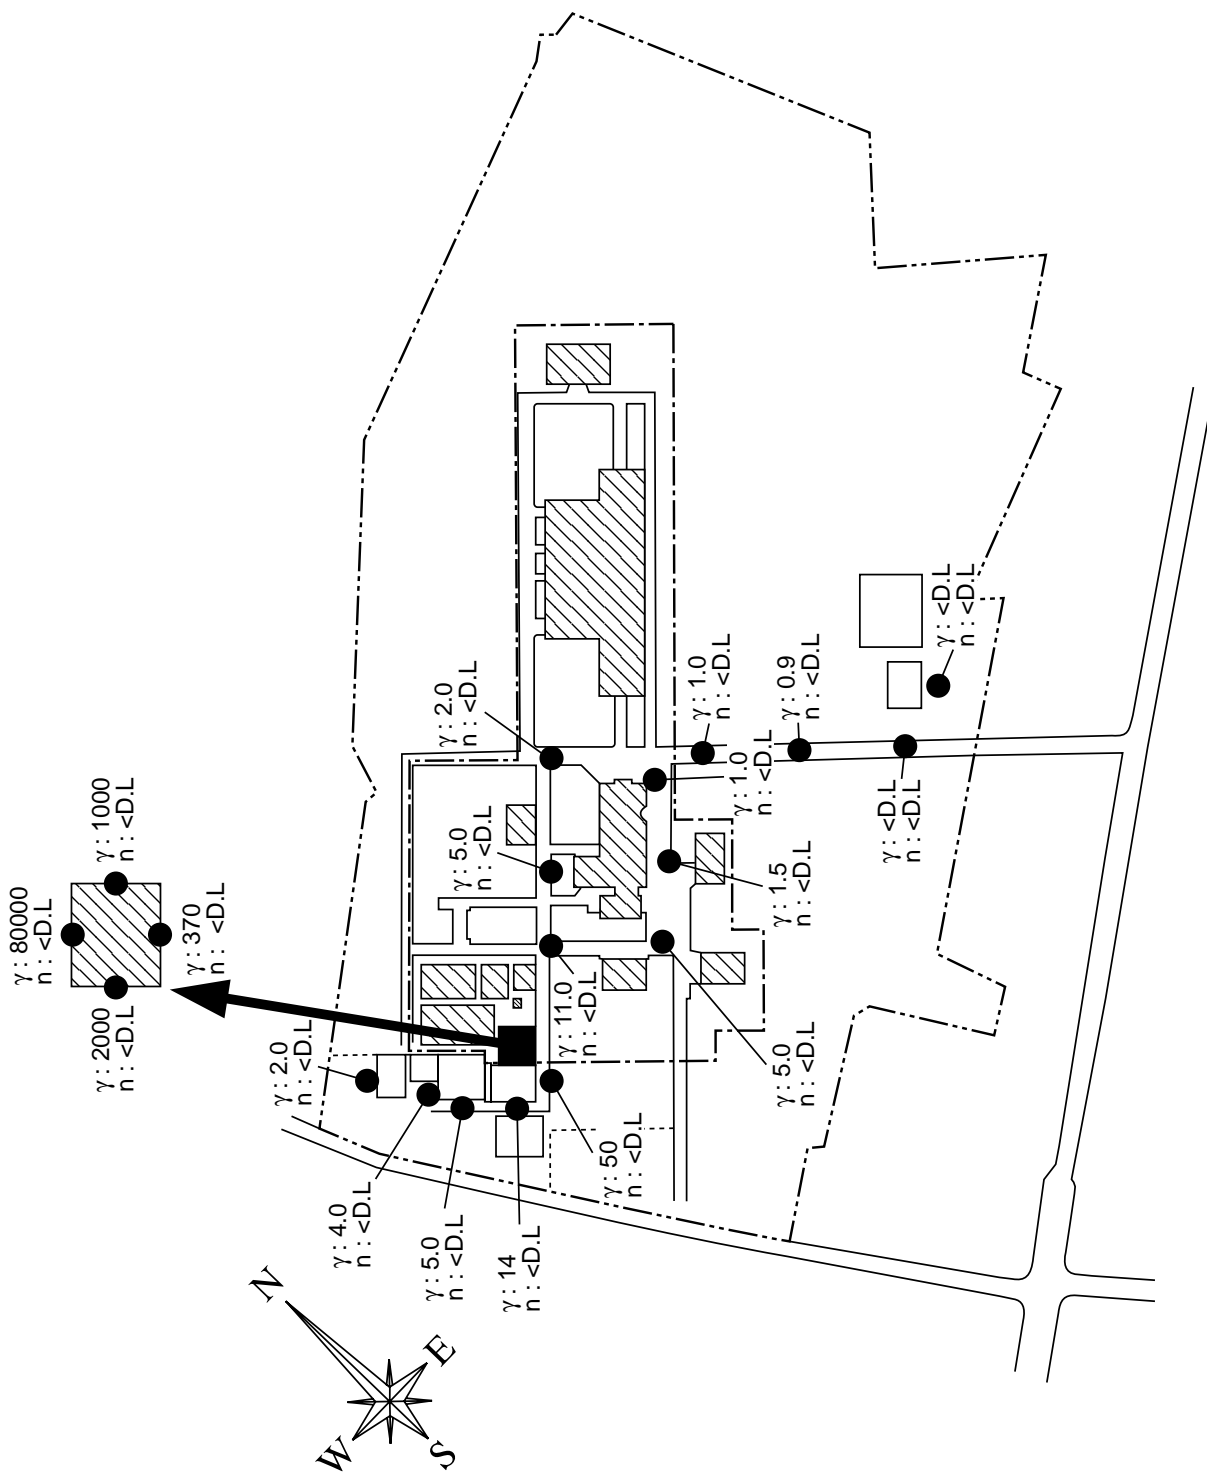
- With regard to the remaining radiation fields, gamma radiation dose rate measurements were performed at 06:20 on 1 October. These measurements yielded gamma dose rates of several millisieverts per hour close to the building and several microsieverts per hour at the boundary of the site (Fig. 12). Shielding material such as sandbags were placed around the building on the morning of 2 October (Fig. 13). Walls made of concrete shielding material were assembled in some places around the facility (Fig. 14).

Fig. 12. Gamma and neutron dose rates after the end of criticality (units:  $\mu\text{Sv/h}$ ). The measurements were made by JNC at 06:20 on 1 October 1999.

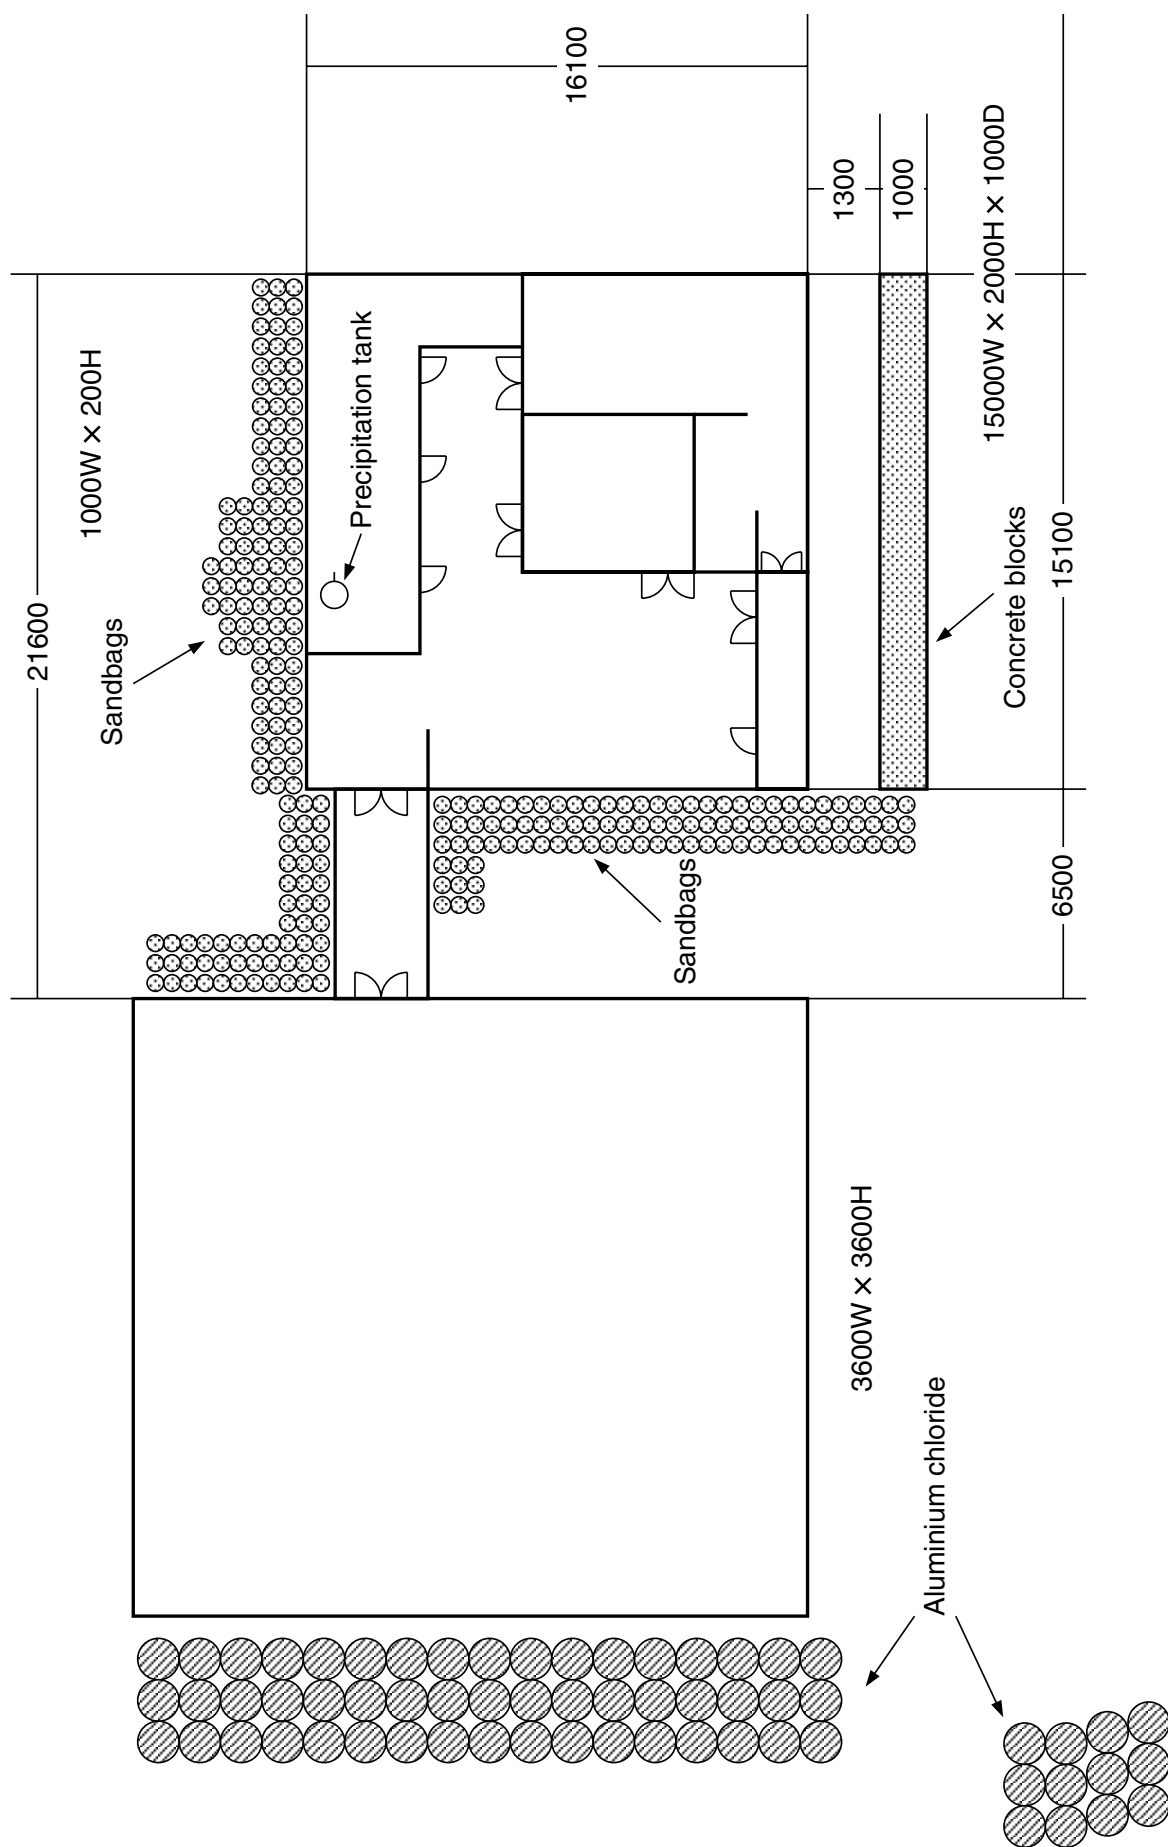
Fig. 13. Detailed plan of the conversion building indicating supplementary shielding arrangements (dimensions in mm).

After the termination of the state of criticality, the immediate remaining safety issues were the need for shielding from gamma radiation resulting from the fission products generated in the precipitation tank and held within the confinement of the building:

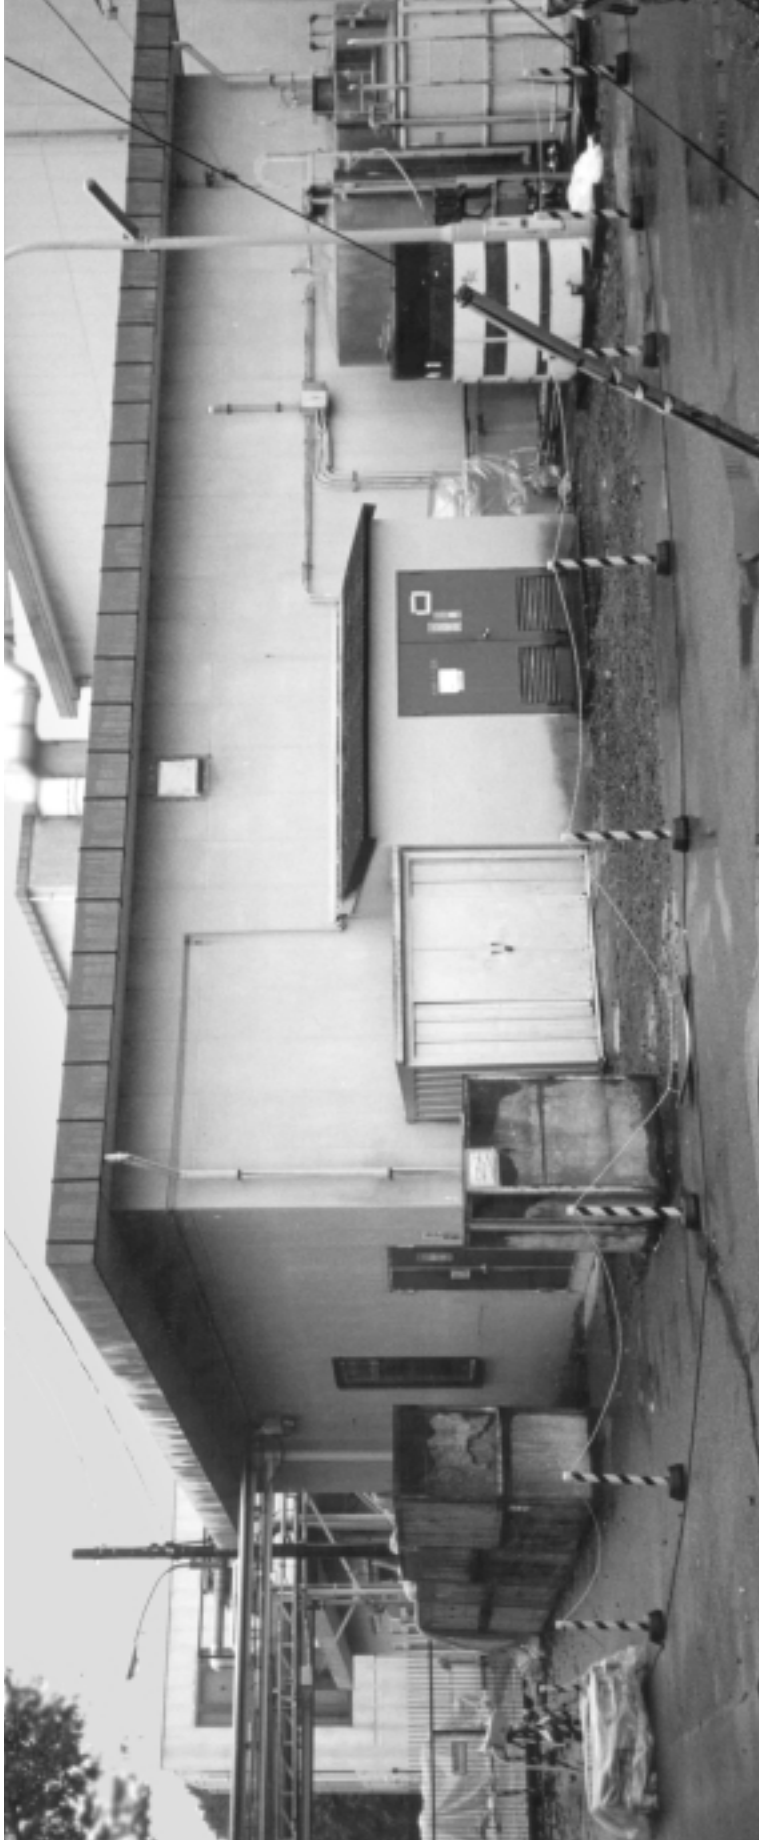
*Fig. 14. The conversion building with supplementary shielding in place.*

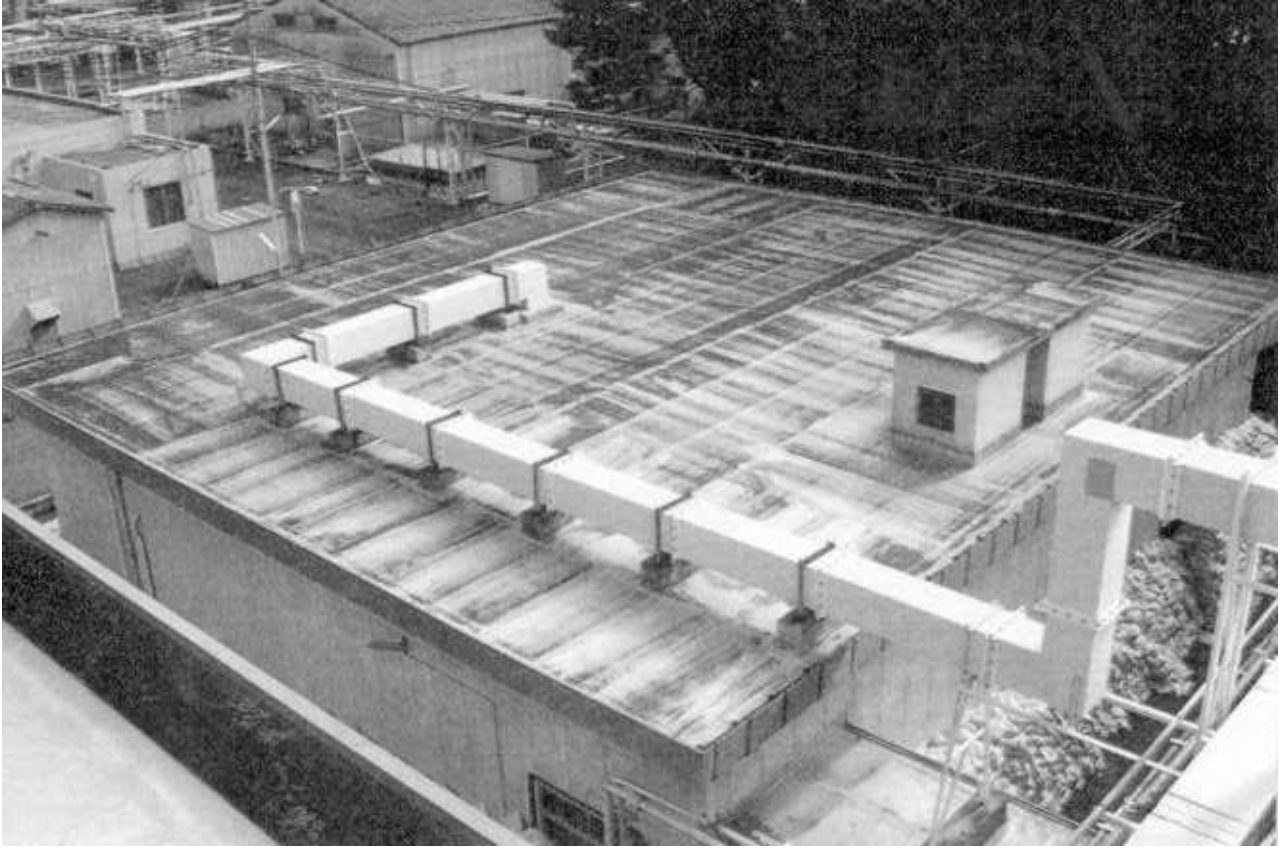
- With regard to radioactive releases, the operator reported that there had been no explosion in the building and there was no overpressure in the ventilation system. The visual check carried out by the workers who fed the boric acid into the precipitation tank showed that there had been no mechanical damage to the installation, and the integrity of the equipment, rooms and building in general had been maintained. During its mission, the IAEA Secretariat team observed that there was no apparent physical damage to the structural integrity of the conversion building. The team examined the roof of the conversion building from two opposite viewpoints (northwest and southeast) and confirmed that it in particular had not been damaged [14] (Fig. 15).

*Fig. 15. The roof of the conversion building.*

understanding of events and the corroboration of published material. The team was able to confirm independently that there was no apparent damage to the structural integrity of the JCO conversion building, and in particular that the roof appeared to be intact, and that gamma dose rate levels outside the JCO site were normal.

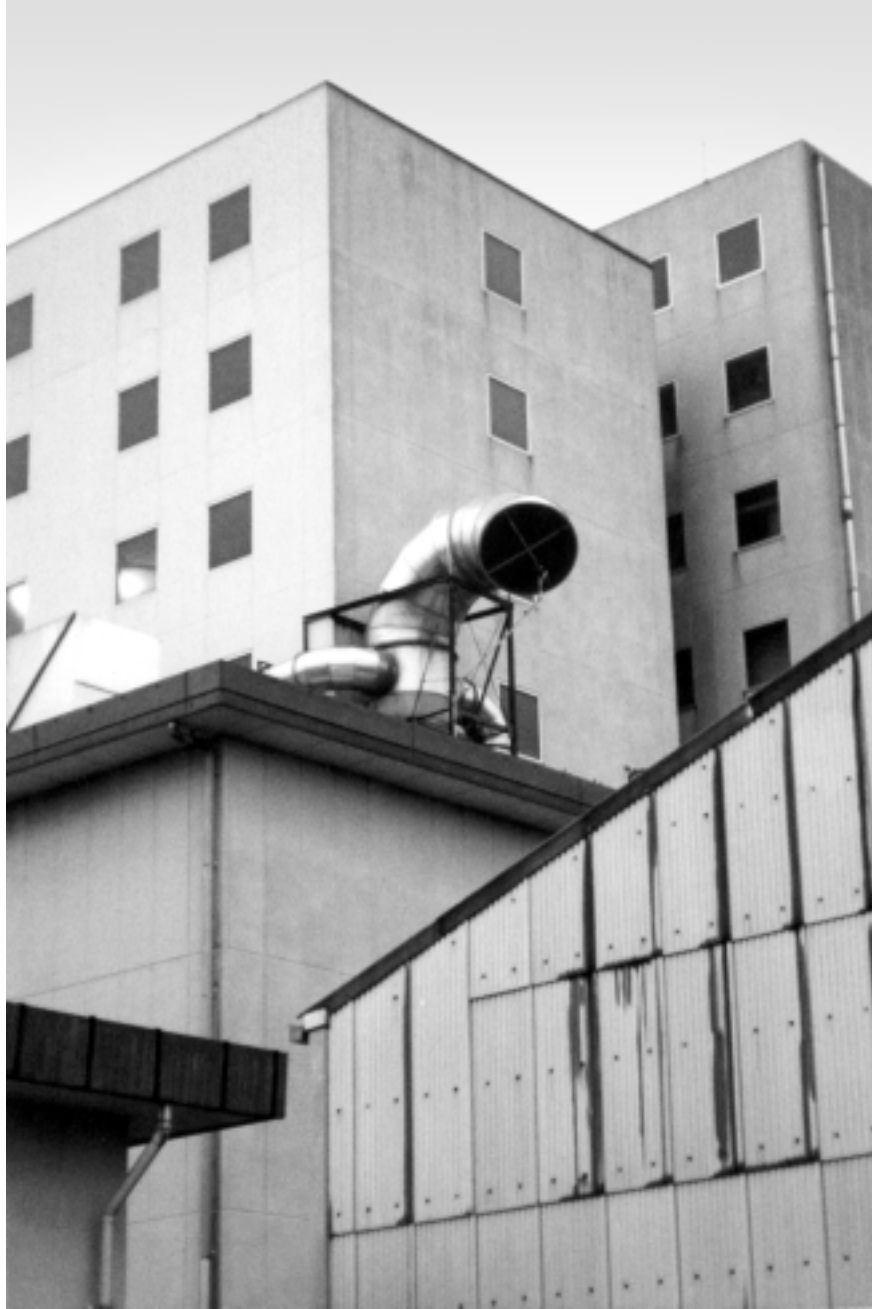
The high efficiency particulate air (HEPA) filters in the conversion building had filtered out particulates collected by the building's ventilation system, whose exhaust is connected to a general ventilation system that also serves other buildings. It had been reported by the workers who injected the boric acid into the precipitation vessel that an underpressure had been maintained, since air flow into the building was found. A smoke test on 5 October confirmed that there was an underpressure and that the ventilation system was working [14]. The integrity of the building confinement had therefore been provided primarily by active maintenance of an underpressure by the ventilation system and by the HEPA filters. However, owing to the detection of  $^{131}\text{I}$  released to the environment on the basis of exhaust point measurements (see Section 4.2.2) (Fig. 16), it was later decided to stop ventilation and to reinforce the passive confinement provided by the building.

*Fig. 16. The exhaust for the ventilation system.*

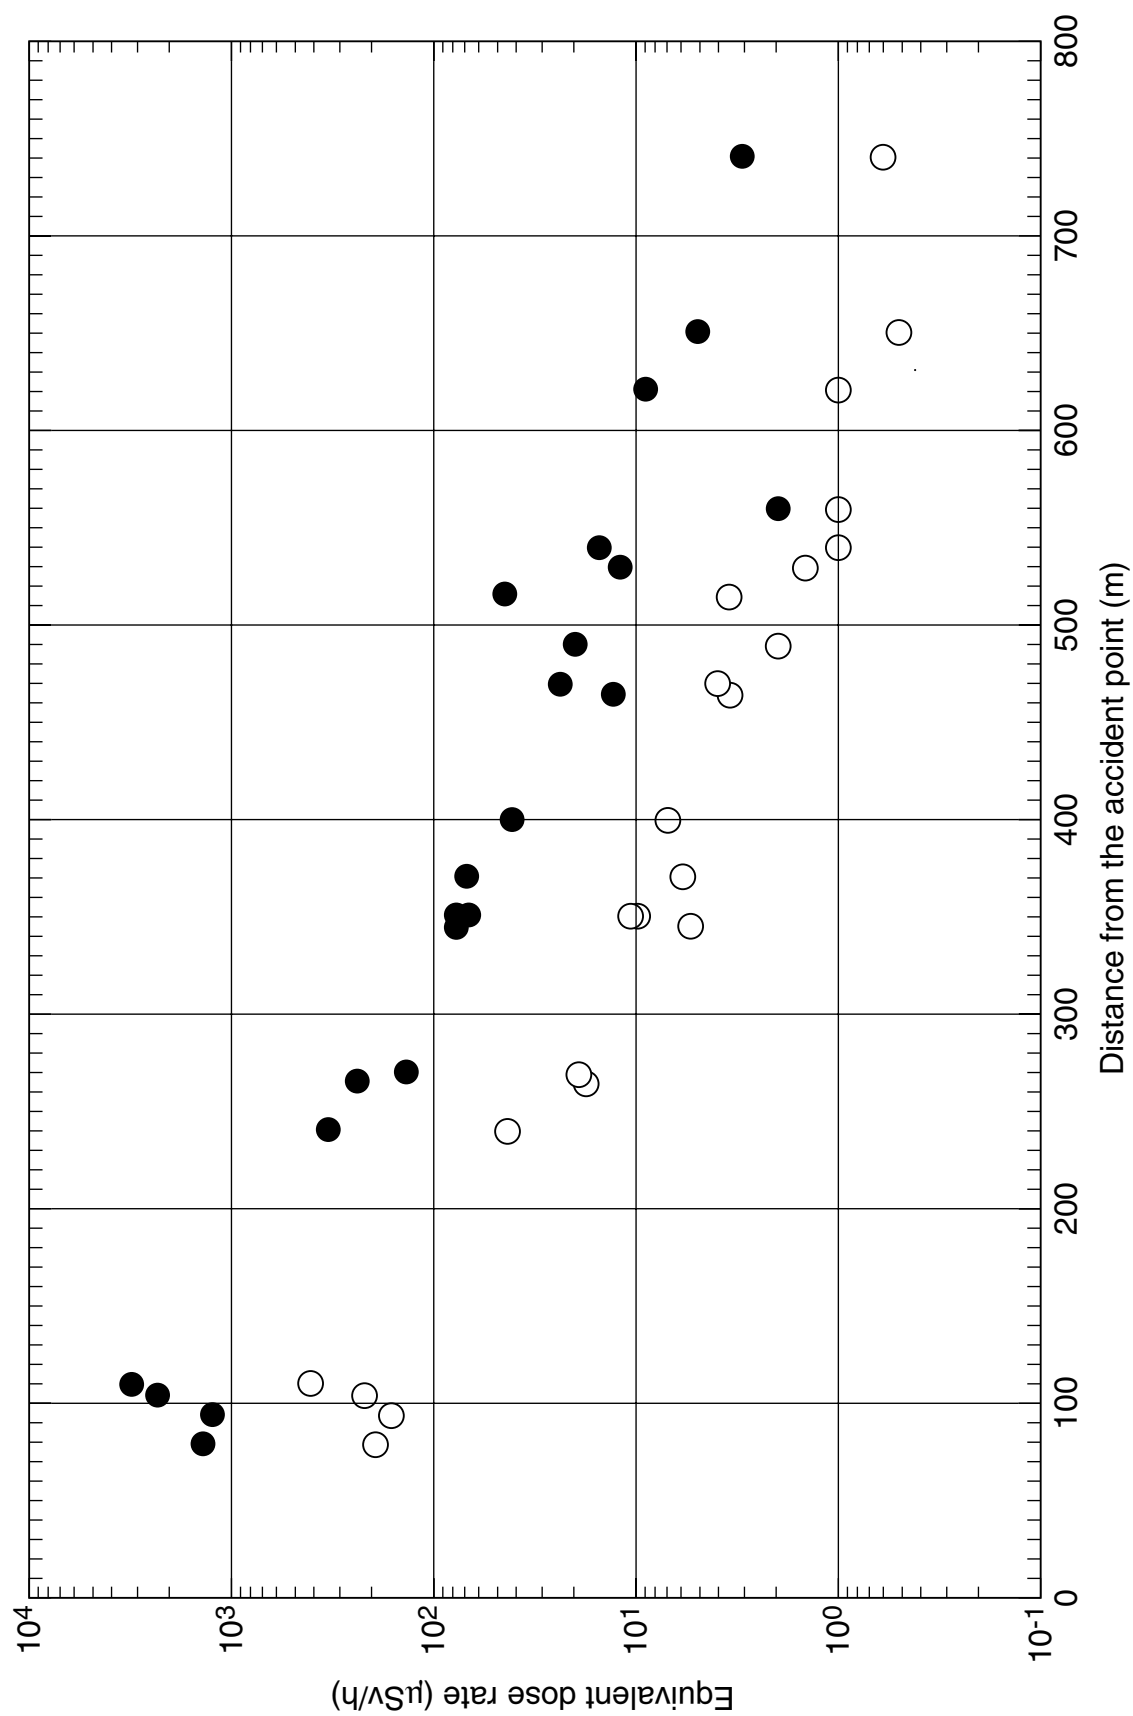
Fig. 17. Gamma and neutron equivalent dose rates around JCO at about 20:45 on 30 September 1999 at the monitoring posts indicated in Fig. 3 as a function of distance. (●: neutron; ○: gamma).

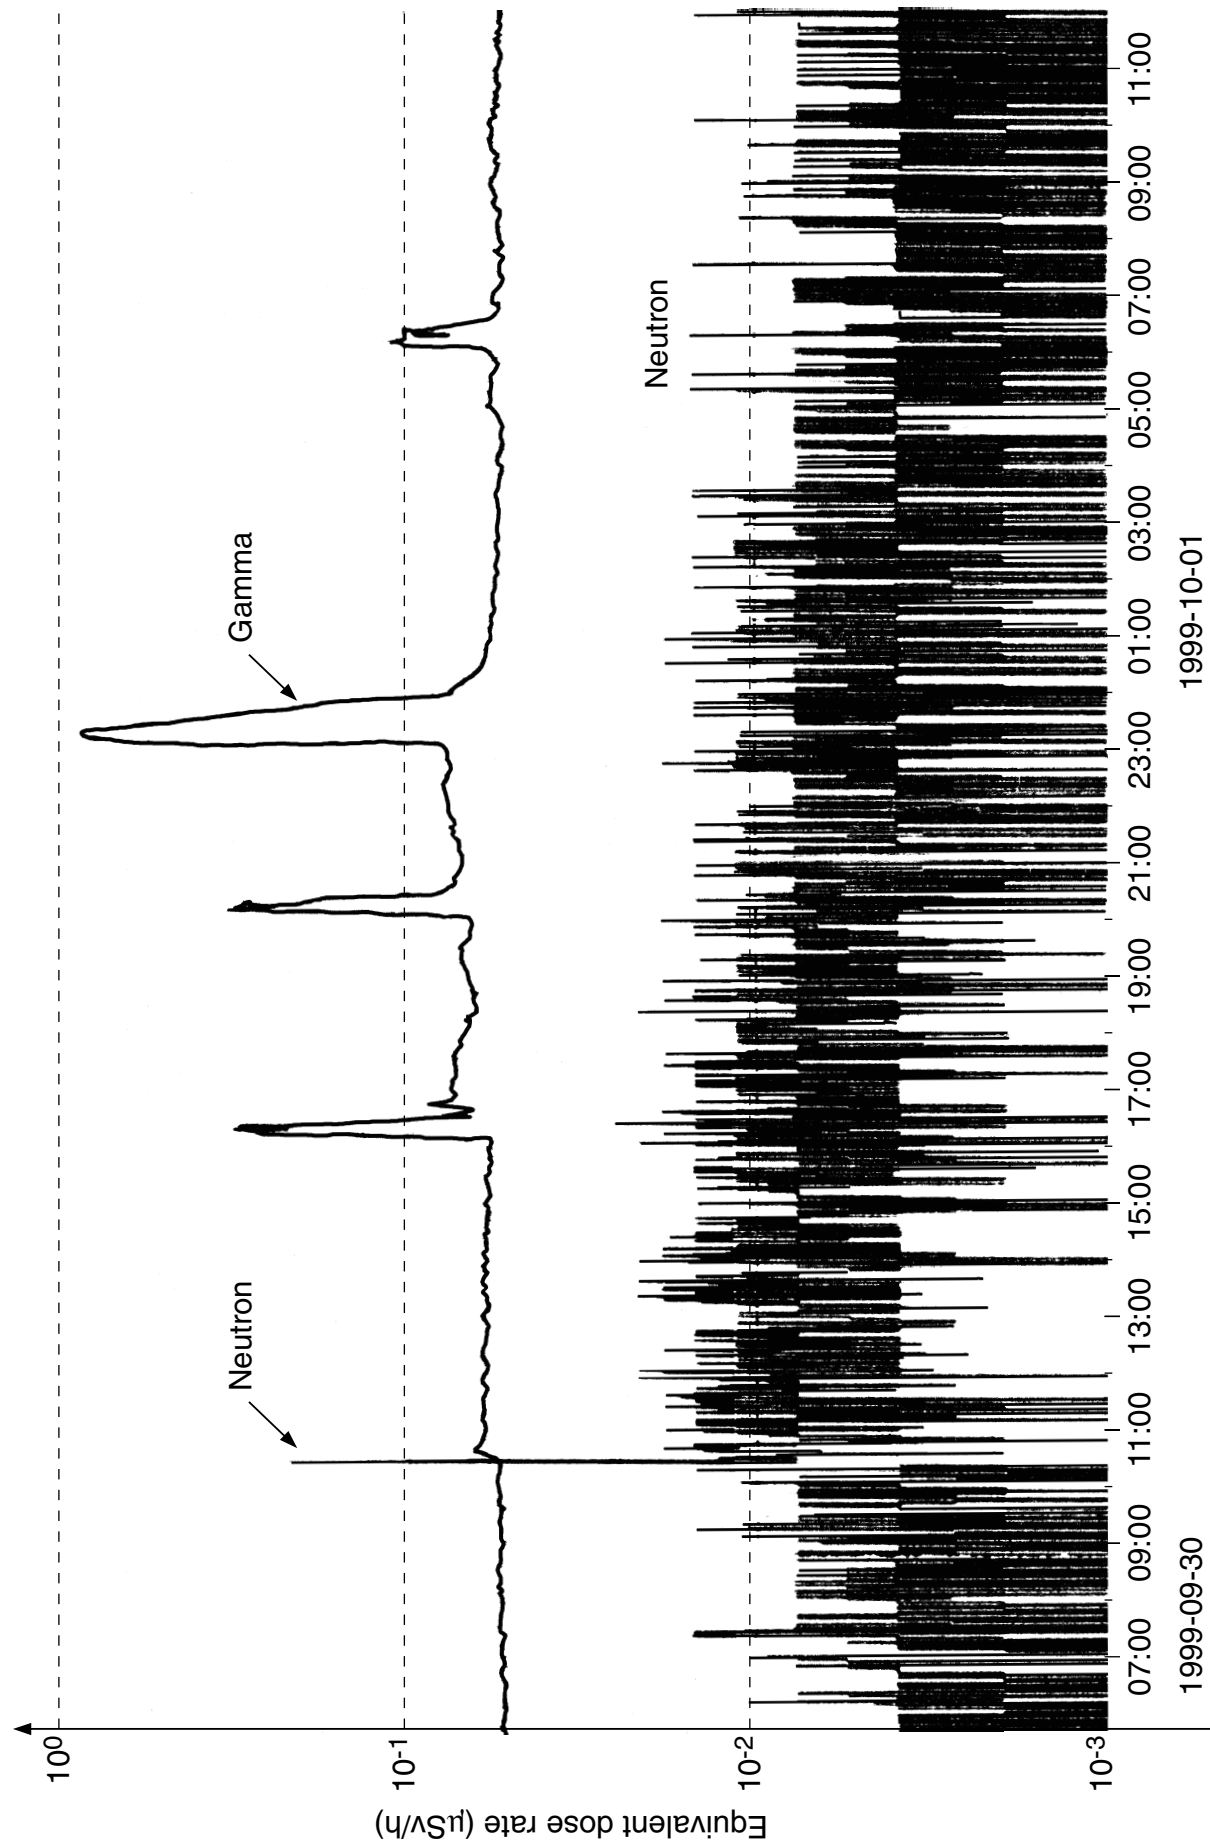
Intermittent increases in gamma dose rates were also observed at MP-1 and MP-2 monitoring posts at the JAERI Naka site after the accident and continued until 00:00 on 1 October (see Fig. 18). The JAERI experts considered that the increase in the gamma dose rate immediately after the accident began was due to direct gamma radiation associated with the criticality reaction, and the subsequent peaks were due to gamma radiation from the plume borne by the wind, which may have contained radioactive noble gases and iodine released into the atmosphere from the conversion building during the criticality event [23].

Fig. 18. Gamma and neutron equivalent dose rates at JAERI Tokai Site monitoring post MP-1 (1.7 km from the conversion building).
