Beaver Valley Power Station, Unit No. 1
Docket No. 50-334 License No. DPR-66
LER 2000-003-00

LER 2000-003-00, 10 CFR 50.73(a)(2)(i), "Failure to Comply with Technical Specifications Due to Inoperability of One Subsystem of the Containment Recirculation Spray System."

TITLE (4)
Failure to Comply with Technical Specifications Due to Inoperability of One Subsystem of the Containment Recirculation Spray System

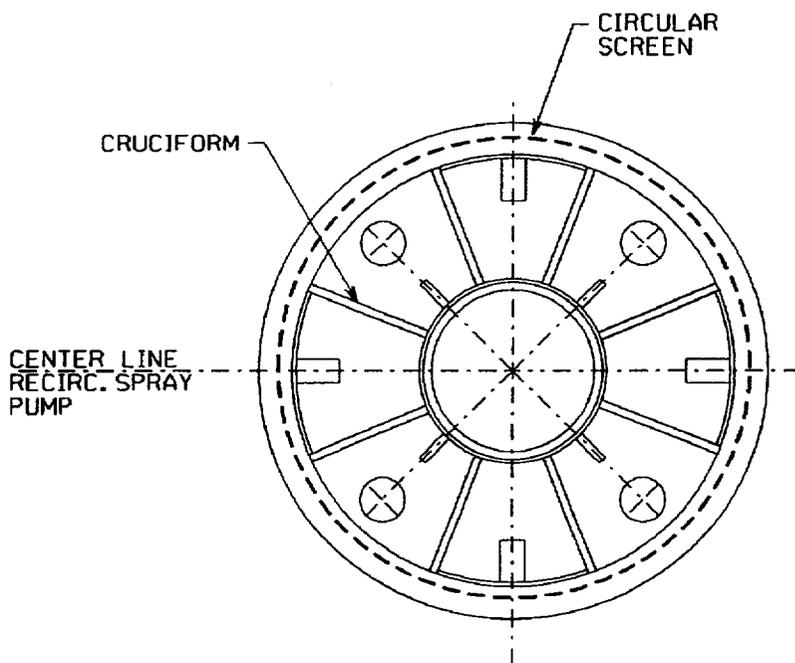
FIGURE 1

The root cause of the wood in the pump suction well and impeller is inadequate foreign material exclusion (FME) control during installation of a design change package (DCP) in February 1982. The DCP added flow anti-vortexing devices (cruciforms) for the inside containment RS pumps RS-P-1A and 1B (see Figure 1), the outside containment RS pumps, and the Low Head Safety Injection (LHSI) pumps. It is believed the wood in RS-P-1A had been used as support cribbing during installation of the DCP. Installation of the DCP required temporary removal of the inner most circular protective screening for the RS and LHSI pumps (see Figure 2 pertaining to RS-P-1A and 1B). However, following completion of the DCP work, the wood was not removed due to inadequate FME control. Due to the presence of the wood inside the pump protective screens since 1982, the possibility exists that pump degradation could have occurred if the pump would have been required to operate following a of Loss of Coolant Accident.

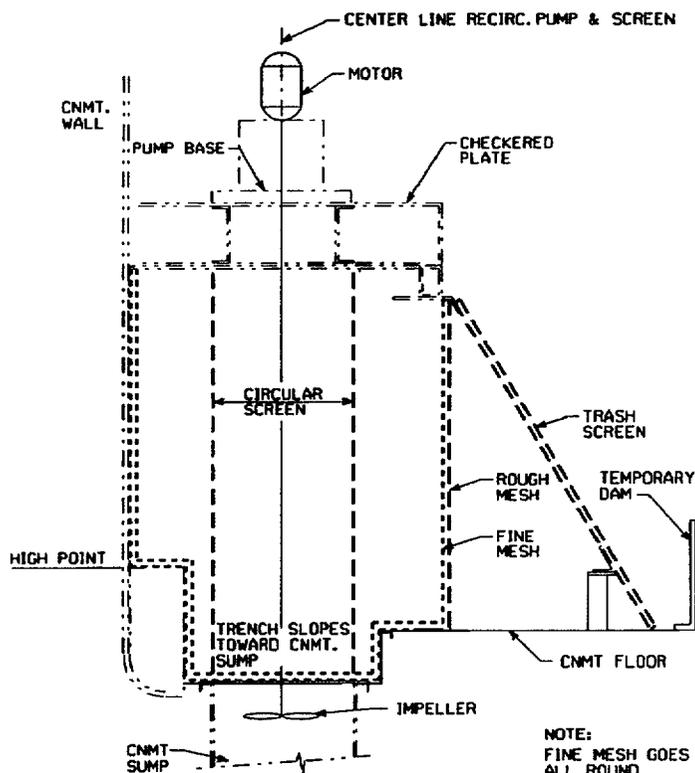
FIGURE 2

The wood was likely drawn into the pump during the performance of the in-service test during 1R13. This in-service test is performed during refueling outages, beginning in October 1984. During this testing, a temporary dam is built and flooded around the pumps to provide a water source for the test (see Figures 2 and 3). The pump flow is circulated through an installed test line and back to the confines of the temporary dam.
