Commonwealth Edison Company  
Dresden Generating Station  
6500 North Dresden Road  
Morris, IL 60450  
Tel 815-942-2920

Dresden Nuclear Power Station, Unit 3  
Facility Operating License No.DRP-25  
NRC Docket No. 50-249

Subject: Licensee Event Report 2000-001-00, "Instrument Root Valve Found Closed During Unit 3 LPCI System Pump In-Service Testing"

<b>TITLE (4)</b> <b>Instrument Root Valve Found Closed During Unit 3 LPCI System Pump In-Service Testing</b>											
<b>EVENT DATE (5)</b>		<b>LER NUMBER (6)</b>		<b>REPORT DATE (7)</b>		<b>OTHER FACILITIES INVOLVED (8)</b>					
MON TH	DAY	YEAR	YEAR	SEQUENTIAL NUMBER	REVISION NUMBER	MONTH	DAY	YEAR	FACILITY NAME	DOCKET NUMBER	
03	24	2000	2000	001	00	04	24	2000	N/A	N/A	
<b>OPERATING MODE (9)</b>		<b>POWER LEVEL (10)</b>		<b>THIS REPORT IS SUBMITTED PURSUANT TO THE REQUIREMENTS OF 10 CFR § (Check one or more) (11)</b>							
1		100		20.2201(b)		20.2203(a)(2)(v)		X	50.73(a)(2)(i)		50.73(a)(2)(viii)

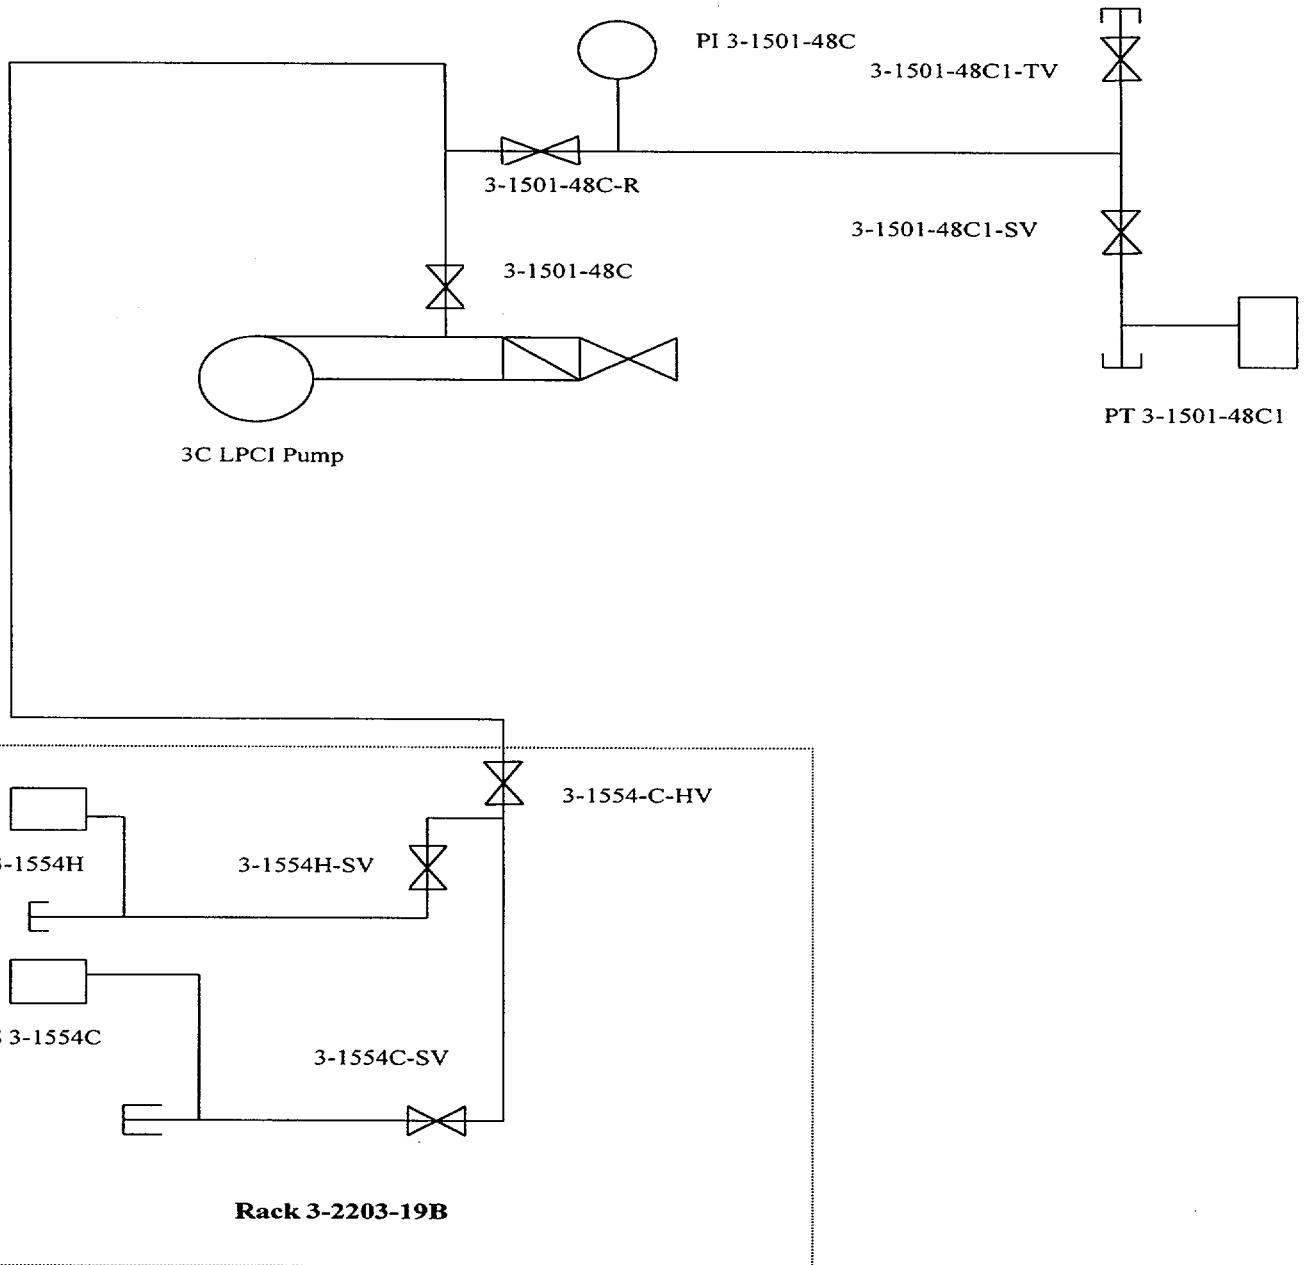
## Instrument Tubing Configuration

A prompt investigation and a root cause investigation were initiated immediately to determine how the event occurred. The 3C LPCI Pump has two (2) ADS 100 psig permissive pressure switches located downstream of the discharge of the ECCS pump. These two (2) switches are piped in a parallel arrangement with individual instrument stop valves and one common instrument header root valve. Each time the 3C LPCI Pump is operated per DOS 1500-10, pump discharge pressure exceeds 100 psig. If root valve 3-1554C-HV is open, then the contacts for the two ADS 100 psig pressure switches (PS 3-1554H and PS 3-1554C) change state providing an ADS permissive.

The SER printouts revealed the last time the ADS permissives indicated as expected (held in) with only the 3C LPCI Pump running was September 28, 1999. Based on these SER printouts, it was determined that root valve, 3-1554C-HV, was closed sometime after September 28, 1999 and prior to December 28, 1999.

Based on the investigation performed, the exact time or group responsible for the loss of configuration control event could not be determined. The most probable root cause for the event is human error involving failure to self-check / verify (NRC Cause Code A). If the valve was unintentionally mispositioned during the performance of DIS 0287-01 prior to November 16, 1999 concurrent verification would not have been performed during the isolation of the ADS Permissive pressure switches (PS 3-1554H and PS 3-1554C) and the valve manipulation would not have been challenged.

1. Implement AD-AA-104-103, Verification Practices, and current Instrument Maintenance Department (IMD) standards in order to ensure concurrent verification is performed during instrument valving both during the isolation of instruments and return of instruments to service. (Complete)
2. IMD will reinforce expectations for procedural adherence and placekeeping, focusing on minimization of configuration control events. Clarification will be made on requirements to have the procedure at the job site, reiteration of the placekeeping methodology, and expectation placed on supervisors to monitor compliance with procedure adherence expectations. (Complete)
3. Surveillance procedure DOS 1500-10, "LPCI System Pump Operability Test with Torus Available and In-Service Testing (IST) Program," will be revised to verify ADS permissive function is intact. (ATI 26096-15)
