**SUSQUEHANNA STEAM ELECTRIC STATION  
STATUS OF FIRE PROTECTION  
CORRECTIVE ACTIONS  
PLA-5172**

**Docket Nos. 50-387  
and 50-388**

**Attachment 1**  
**Update on open FPFi Commitments**

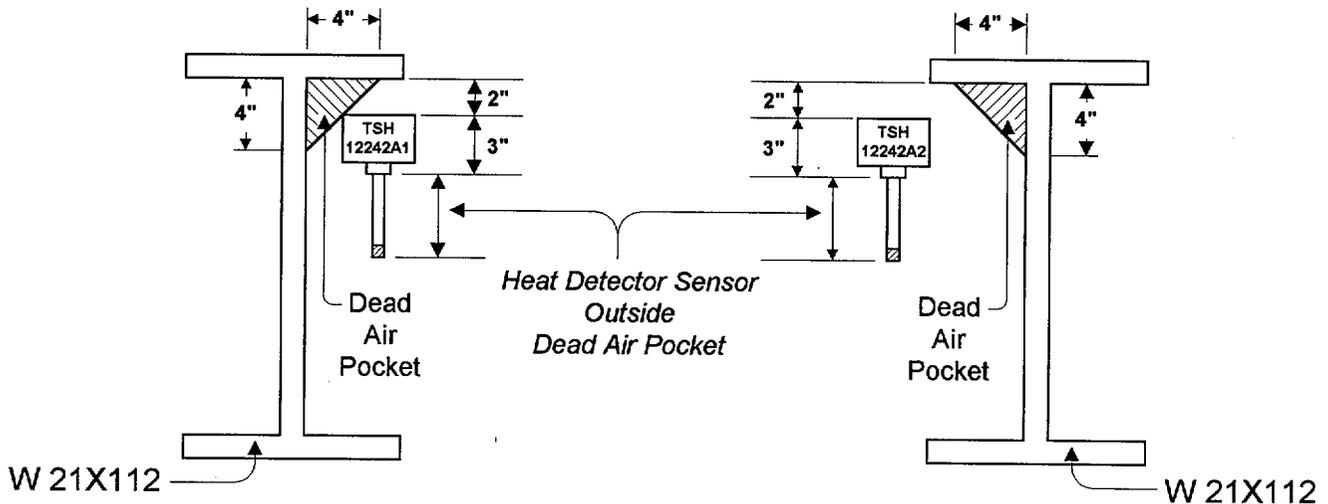
As of November 7, 1997, heat detectors needed to actuate the water spray system which protects the Unit 1 HPCI pump were located in a dead air pocket along structural steel members, contrary to NFPA 72E, Section 3-4, which requires spot type heat detectors to be placed on the ceiling not less than 4 inches from side walls, or on side walls between 4 and 12 inches from the ceiling.

A field walkdown of this item was performed. There are two heat detectors located along structural steel members, which activate the Unit 1 HPCI Pump Water Spray system. Closer inspection verified that these two detectors are not located in the dead air pocket. The exact location of these heat detectors relative to the dead air pocket formed along the W21 x 112 Structural Steel member has been verified under a work order. The following sketch depicts the Unit 1 HPCI Pump water spray system detectors.

From a code compliance standpoint, the existing Unit 1 HPCI Pump Water Spray System Heat Detector locations are in compliance with NFPA Detector location requirements. The Heat Detector Sensor Elements are not located in the Dead Air Pocket formed along the W21 x 112 Structural Steel Beam. No further action is required on this item. This item is considered closed.
