SUBJECT: KEWAUNEE INSPECTION REPORT 50-305/99013(DRP)

Report No: 50-305/99013(DRP)

Facility: Kewaunee Nuclear Power Plant

Dates: December 1, 1999, through January 18, 2000

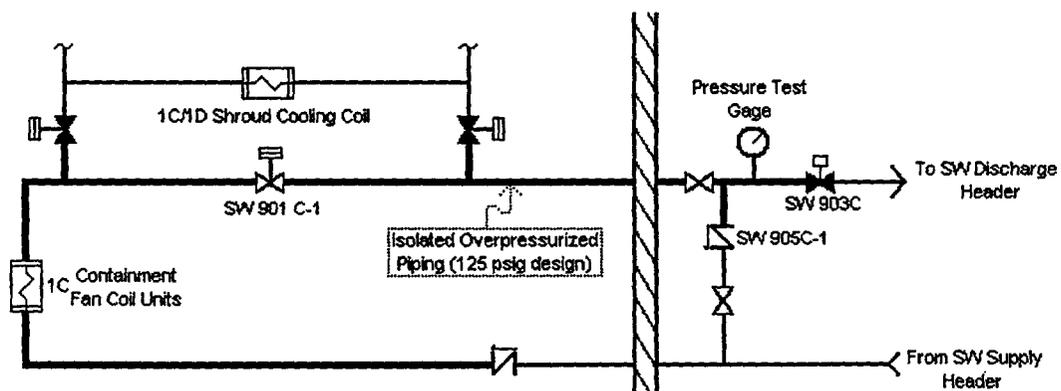
Simplified Diagram

During the performance of motor-operated valve testing on Valve SW-903C, test personnel noted that while Valve SW-903C was closed, the pressure of the isolated portion of the SW piping of Containment FCU 'C' indicated about 150 pounds per square inch gage (psig). The design pressure of that section of piping was 125 psig. The licensee suspected that the cause of the pressure increase was thermal expansion of isolated fluid in the associated SW piping. However, a spring check valve, Valve SW-905C-1, was designed to relieve any pressure increase to prevent exceeding pressure design limits as shown in the simplified diagram below. Valve SW-905C-1 had been originally installed to address GL 96-06 concerns.

The licensee initiated KAP 3723 and WR 217684 to document this condition and to investigate the cause of the failure of Valve SW-905C-1 to relieve pressure as designed. Additionally, the licensee performed an engineering evaluation which concluded that the increased pipe stresses due to the overpressurization were negligible compared to the allowable stresses for the piping material in use. The inspectors reviewed the licensee's operability determination documented in KAP 3723. The inspectors noted that KAP 3723 contained administrative controls for the operation of Valve SW-903C to ensure that GL 96-06 concerns were satisfied. The inspectors did not identify any deficiencies with KAP 3723.

Additional troubleshooting determined that Valve SW-905C-1 was fouled and stuck closed. The valve was then cleaned and reassembled. The licensee subsequently retested Valve SW-905C-1 with satisfactory results. The inspectors noted that the licensee questioned the operability of Valves SW-905A-1, SW-905B-1 and SW-905D-1, which are the spring check valves associated with the other containment FCUs. The licensee subsequently performed testing of the other spring check valves and determined that they were functioning as designed. Additionally, the licensee planned to disassemble and inspect the remaining check valves to ensure proper operation.

During motor-operated valve testing, test personnel observed that the pressure of isolated service water piping exceeded the design pressure. The overpressure condition was the result of a spring check valve that was stuck closed. The inspectors reviewed the licensee's engineering evaluation and administrative controls and did not identify any deficiencies. Additionally, the inspectors noted that the licensee adequately evaluated other similar spring check valves for potential common mode failure mechanisms.
