**NRC Inspection Report No. 50-315/316/97-024, Finding E1.1.b and Inspection
Report No. 50-315/316/99010, Findings M.2.1.b and O1.2.b.1**

Event Description: Lack of a procedure for manually backwashing the ESW pump
discharge strainers

Plant: Donald C. Cook Nuclear Plant, Units 1 and 2

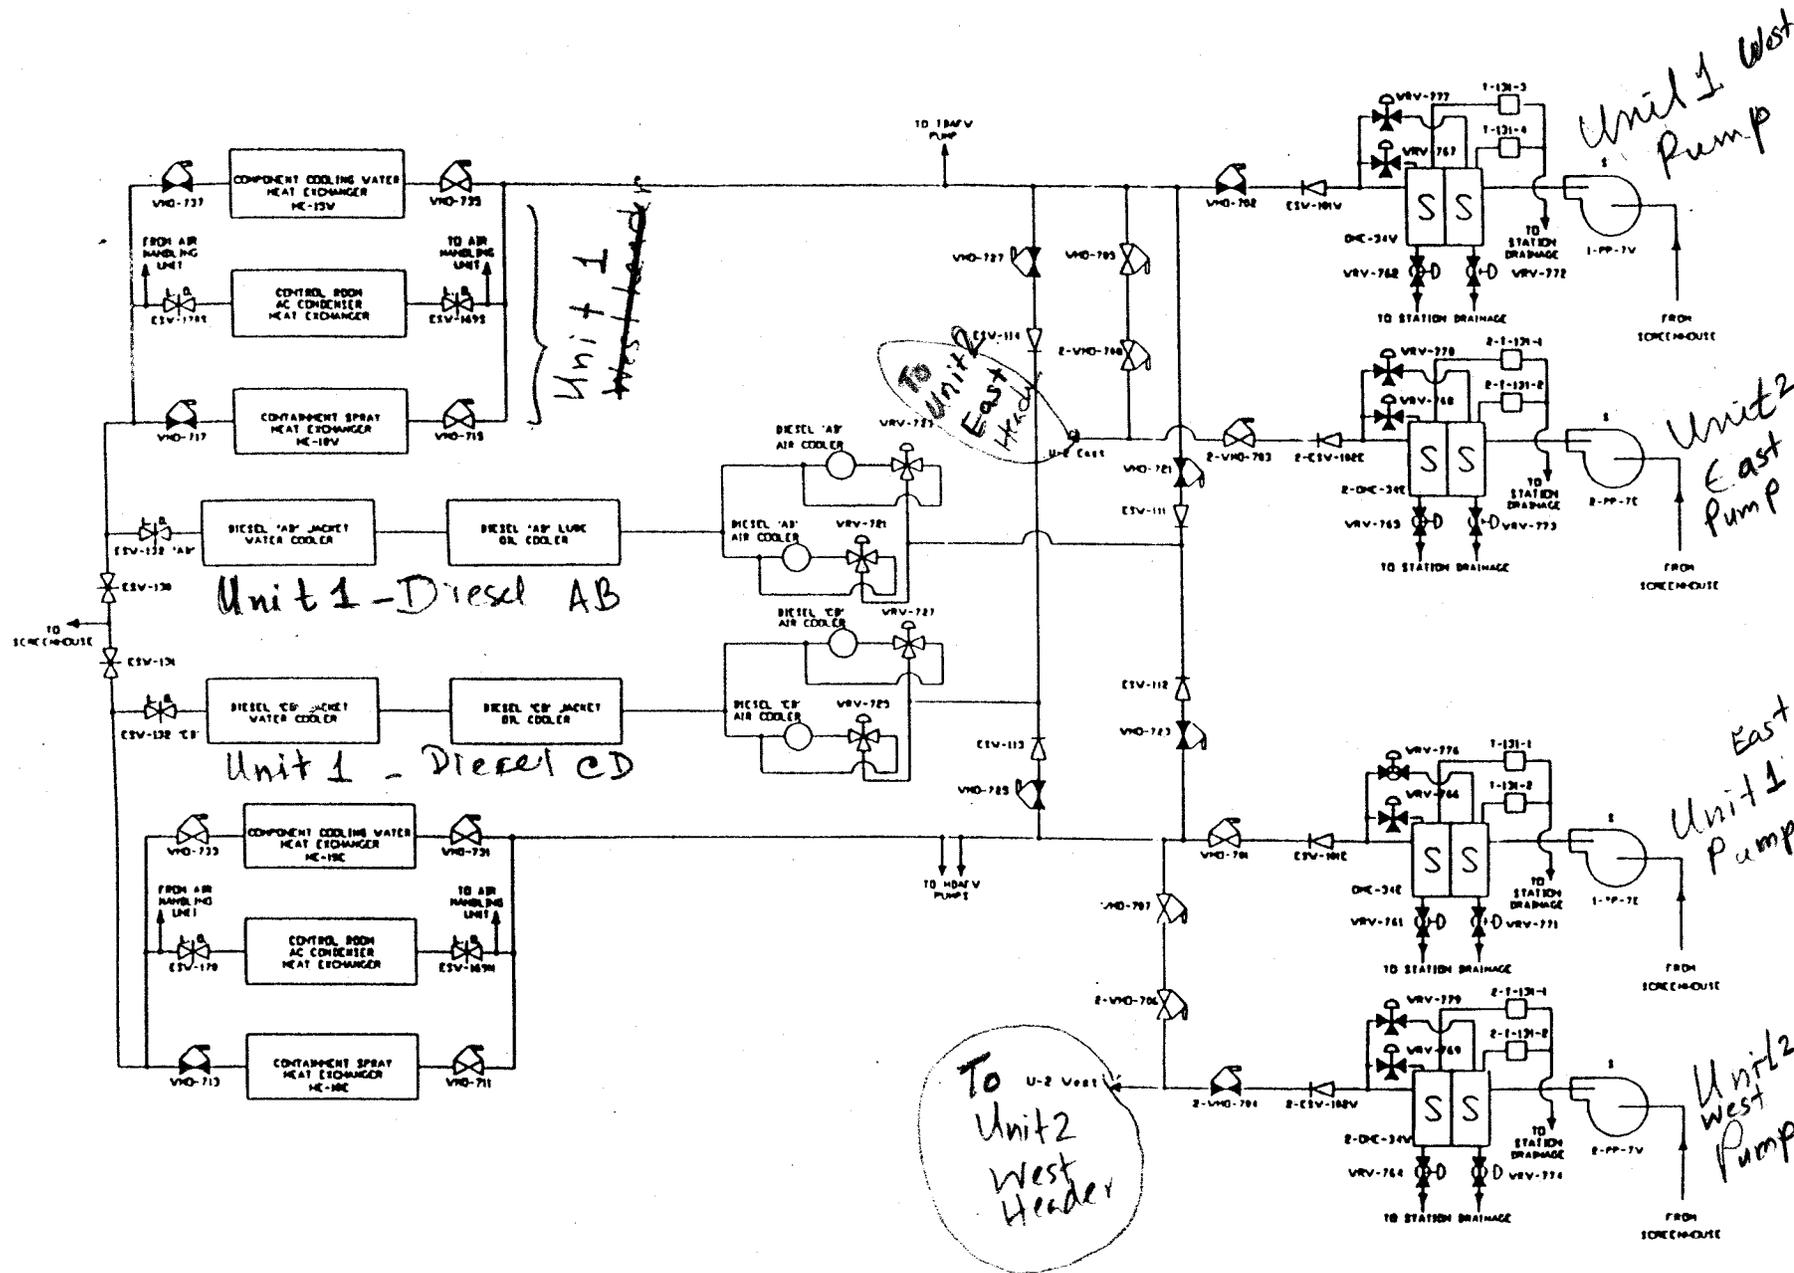
Figure 1 (Issue No. 61): ESW System Simplified Flow Diagram

- The ESW system is shared by both units. The system has many redundancies and capabilities to share ESW pumps between the two units as shown in figure 1. The two Cook units are equipped with four ESW pumps. Only two of the pumps are needed to support normal operation or accident loads of both units. The heat exchangers for the two diesel generator sets on each unit are served by both ESW headers of that unit. As a result of this configuration, any of the four ESW pumps can be aligned to cool a given EDG.
