NP-33-00-004-00

LER 2000-004
Davis-Besse Nuclear Power Station, Unit No. 1
Date of Occurrence - April 22, 2000

TITLE (4)
Personnel Error During Bus Transfer Testing Results In Loss of Offsite Power

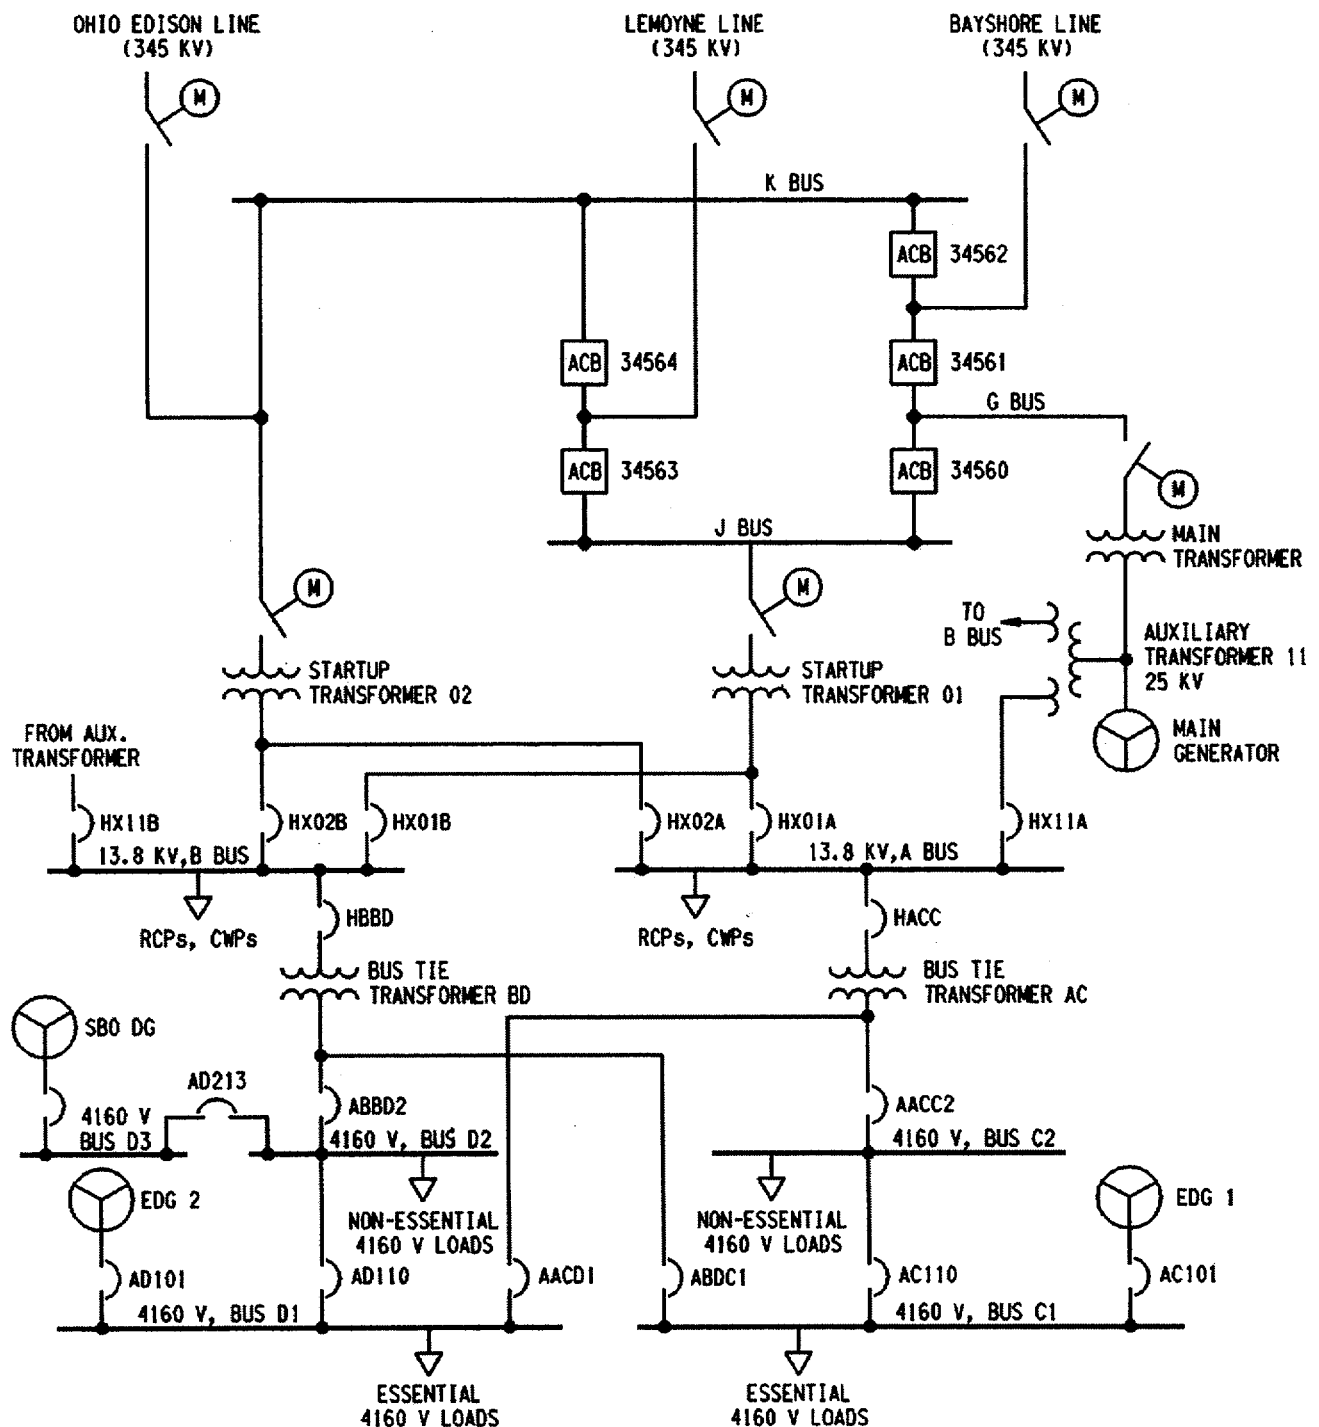
FIGURE 1-DAVIS-BESSE ELECTRICAL DISTRIBUTION SYSTEM

Davis-Besse Nuclear Power Station (DBNPS) Technical Specification Surveillance Requirement 4.8.1.1.1.b states that each qualified circuit between the offsite transmission network and the onsite Class 1E A.C. electrical power distribution system be demonstrated operable at least once each refueling interval during shutdown by manually and automatically transferring unit power supply to each of the offsite circuits. On April 22, 2000, during the twelfth refueling outage with the reactor defueled, Surveillance Test DB-SC-03022, Off-Site AC Sources Bus Transfer Test, was initiated to fulfill this Surveillance Requirement. All station loads were being powered from the 345 kV Bayshore line [FK] through Startup Transformer 01 [EA-XFMR] and 13.8 kV bus A [EA-BU] in accordance with this test to allow testing to be conducted on 13.8 kV bus B. Refer to Figure 1 for a diagram of the DBNPS electrical system.

With switchyard breaker 34563 [FK-BRKR] open, an automatic (fast dead) transfer of Bus B from Startup Transformer 02 to Startup Transformer 01 was performed by simulating a fault on Startup Transformer 02. Breaker HX02B [EA-BRKR] tripped isolating Bus B from Startup Transformer 02, and breaker HX01B closed to power Bus B from Startup Transformer 01. Switchyard breakers 34562 and 34564 and Ohio Edison breakers B-88 and B-115 at the Beaver Substation opened to isolate Startup Transformer 02 from the 345kV distribution system. All associated equipment performed as expected. Annunciator alarm 1-1-G, Startup Transformer 02 Lockout, was also illuminated as expected in the control room.

The actuation of the main generator protection relay 74-B/GX(XK) at 2340 hours on April 22, 2000, caused a lockout of the main generator [EL-TG] and main transformer [EL-XFMR], opening switchyard breakers 34560 and 34561. This interrupted the circuit between the Bayshore line and Startup Transformer 01, resulting in a loss of offsite power. Both emergency diesel generators [EK-DG] started and loaded onto their respective essential buses. The loss of offsite power resulted in a loss of flow in the spent fuel pool cooling system [DA] since the spent fuel pool cooling system is not powered from an essential electrical bus (the reactor core was off-loaded to the spent fuel pool at the time). Station and instrument air alarms were also received due to the loss of electrical power to the air compressors.
