Millstone Nuclear Power Station, Unit No. 3
Relief Request from ASME Code Section XI Requirements

RELIEF REQUEST FROM ASME SECTION XI REQUIREMENTS
Service Water Piping Leak Reported in CR M3-00-1210 on 5/6/00

Service Water Pipe Wall Leak Evaluation at FW-112 & FW-49
(Ref. line 3-SWP-003-210-03)

M3-EV-00-0019

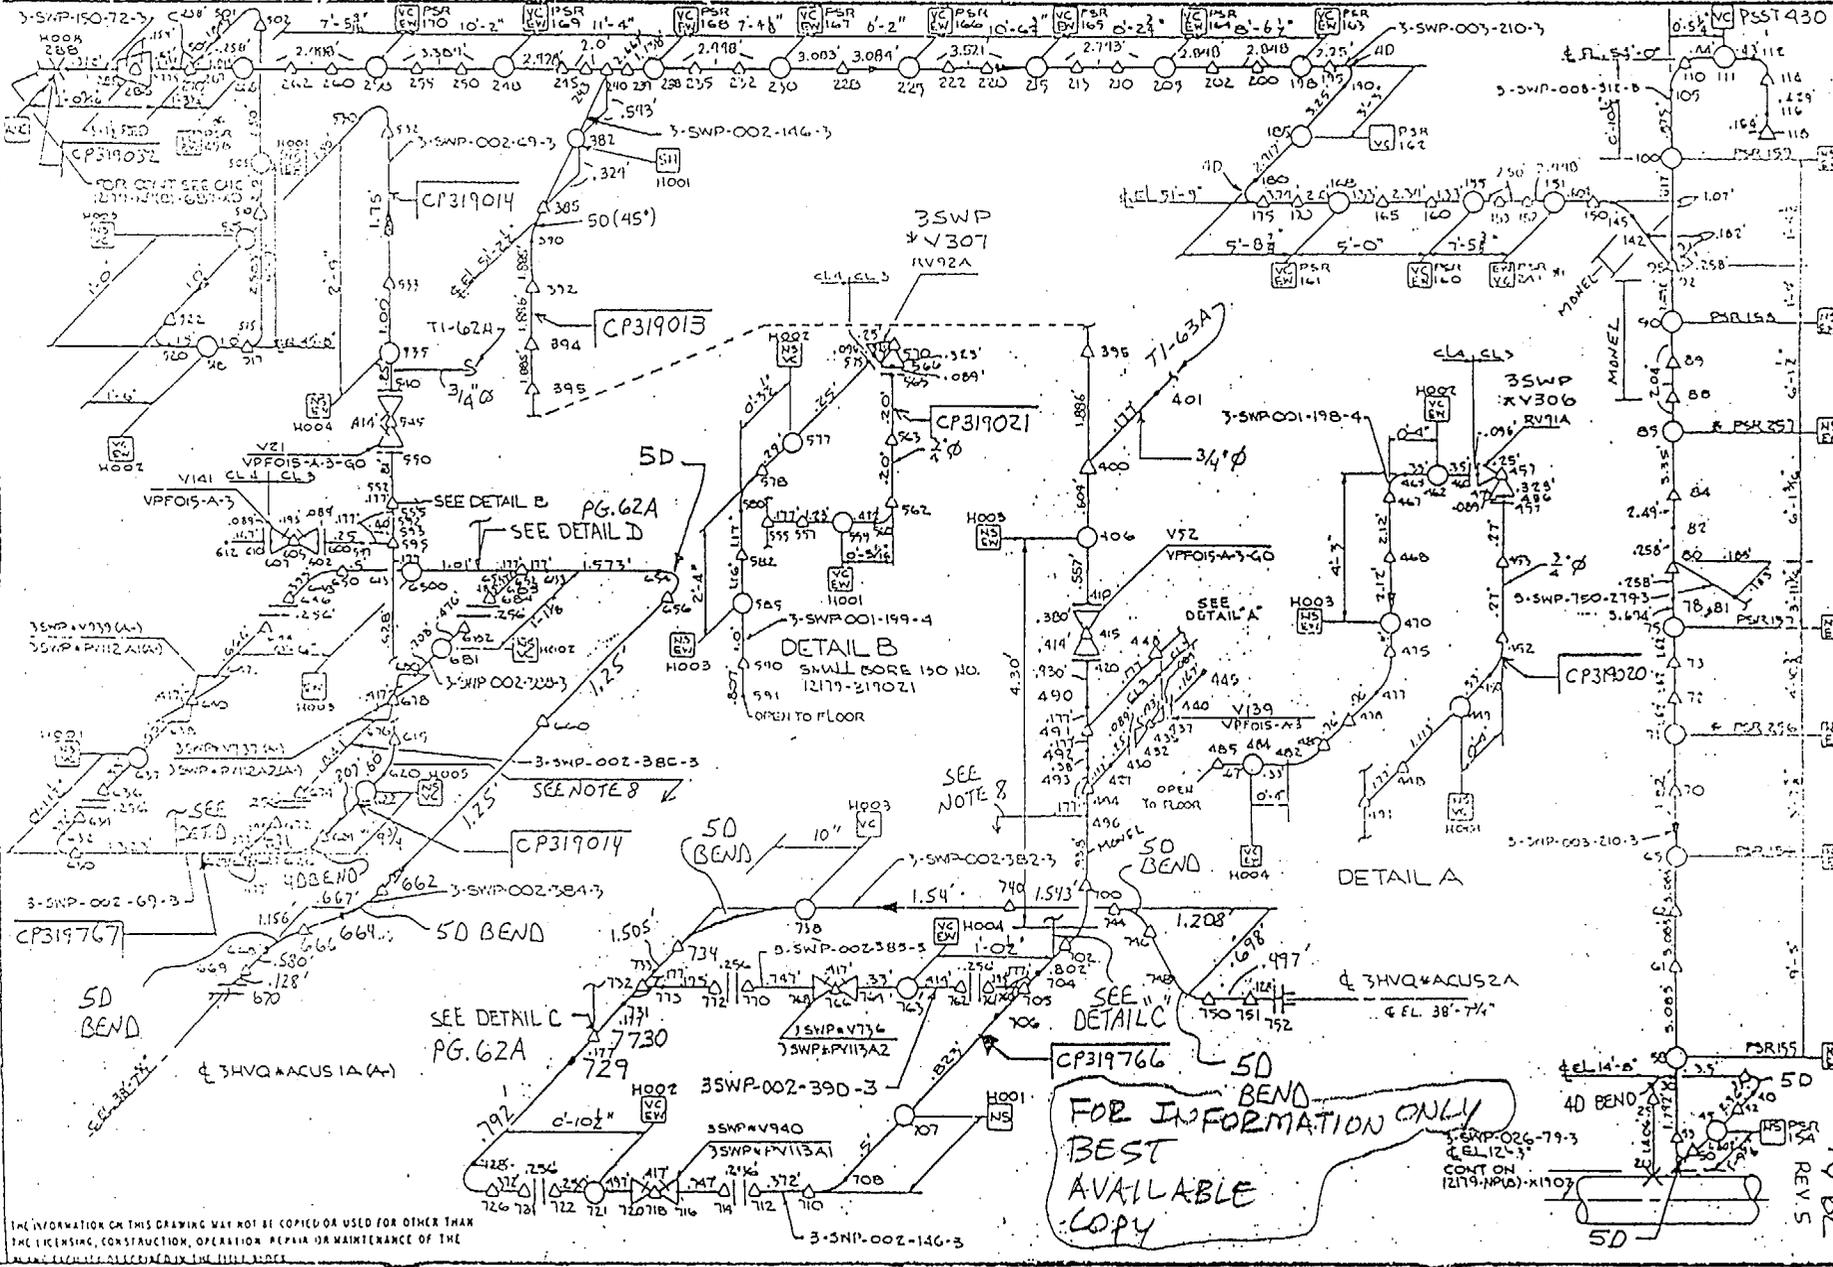
Doc. No.: 12179-NP(F)-X1913 REV 5 OA CATT

A through-wall pinhole leak located on the downstream side of a reducer on line 3SWP-003-210-3, which is the cooling water return line from the Safety Injection pump cooler (3CCI*E1A). The leak is in a 2" long straight section of piping (piece 56) located between a reducer (FW112) and a tee fitting (FW49) as shown on isometric drawing number CI-SWP-210.

Flaw Description/Size: (i.e., flaw size, adjacent wall thickness, single/multiple flaw, total area examined, etc.): The flaw area is highly localized and is limited to the piping section in an area of approximately 1.25 in². The through wall portion of the flaw is approximately 0.0313" in diameter. The pipe wall thickness in the flaw area surrounding the pin hole varies from 0.054" to 0.090" and the wall thickness surrounding the flawed area varies from 0.210" to 0.222".

Flaw Location: On a 2" long section of straight piping located between a reducer (FW 112) and tee fitting (FW 49). This piping is the "A" train cooling water return piping for the Safety Injection pump heat exchanger (3CCI*E1A) and the ESF Building Ventilation units (3HVQ*ACU1A and 3HVQ*ACU2A)

Installation of a temporary patch of rubber lining material secured in place with a pipe clamp
