Re: Indian Point Unit No. 2
Docket No. 50-247

Subject: Response to the Staff's Questions Regarding the Root Cause Evaluation for
Steam Generator Tube Rupture Event of February 15, 2000 (TAC No.
MA8219)

Response to Root Cause Evaluation Issues Nos. 4, and 15

Consolidated Edison Company of New York, Inc.
Indian Point Unit No. 2
Docket No. 50-247
June 2000

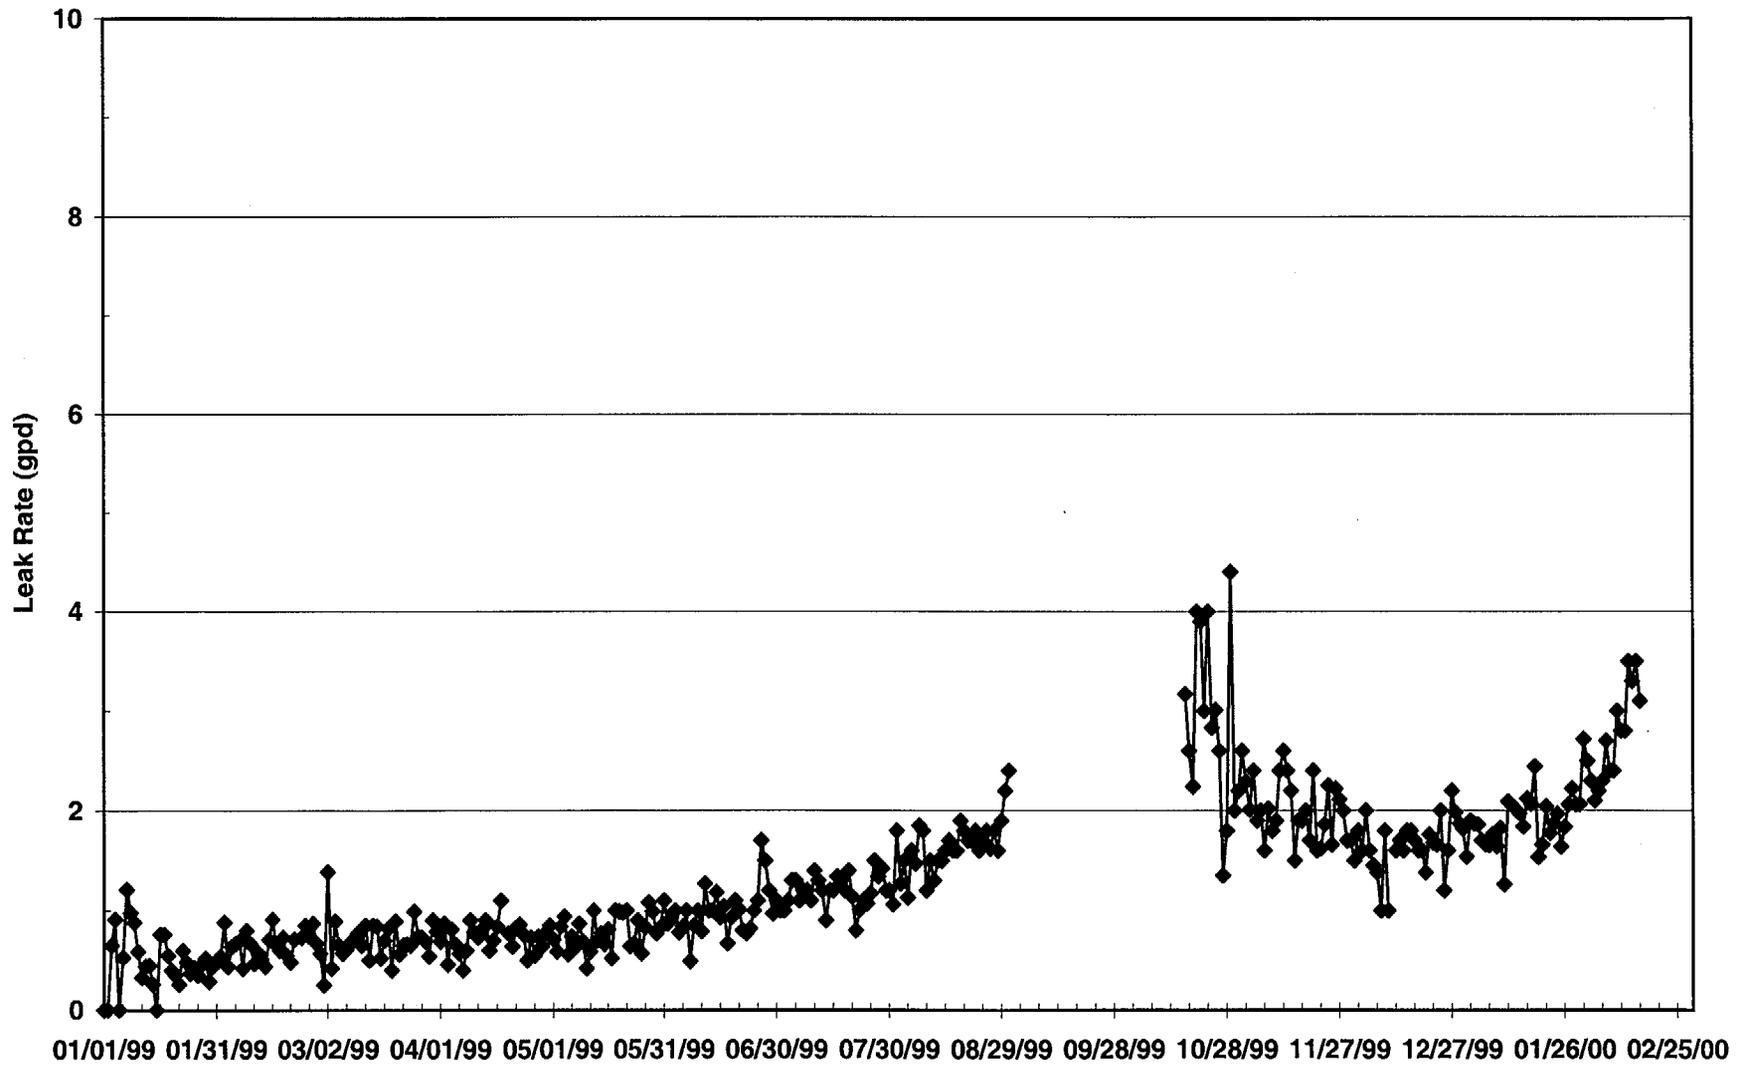
Primary to Secondary Leak

A graph illustrating the primary to secondary leakage rates, as derived by the air ejector radiation monitor readings from January 1, 1999 until just before the event, is attached.

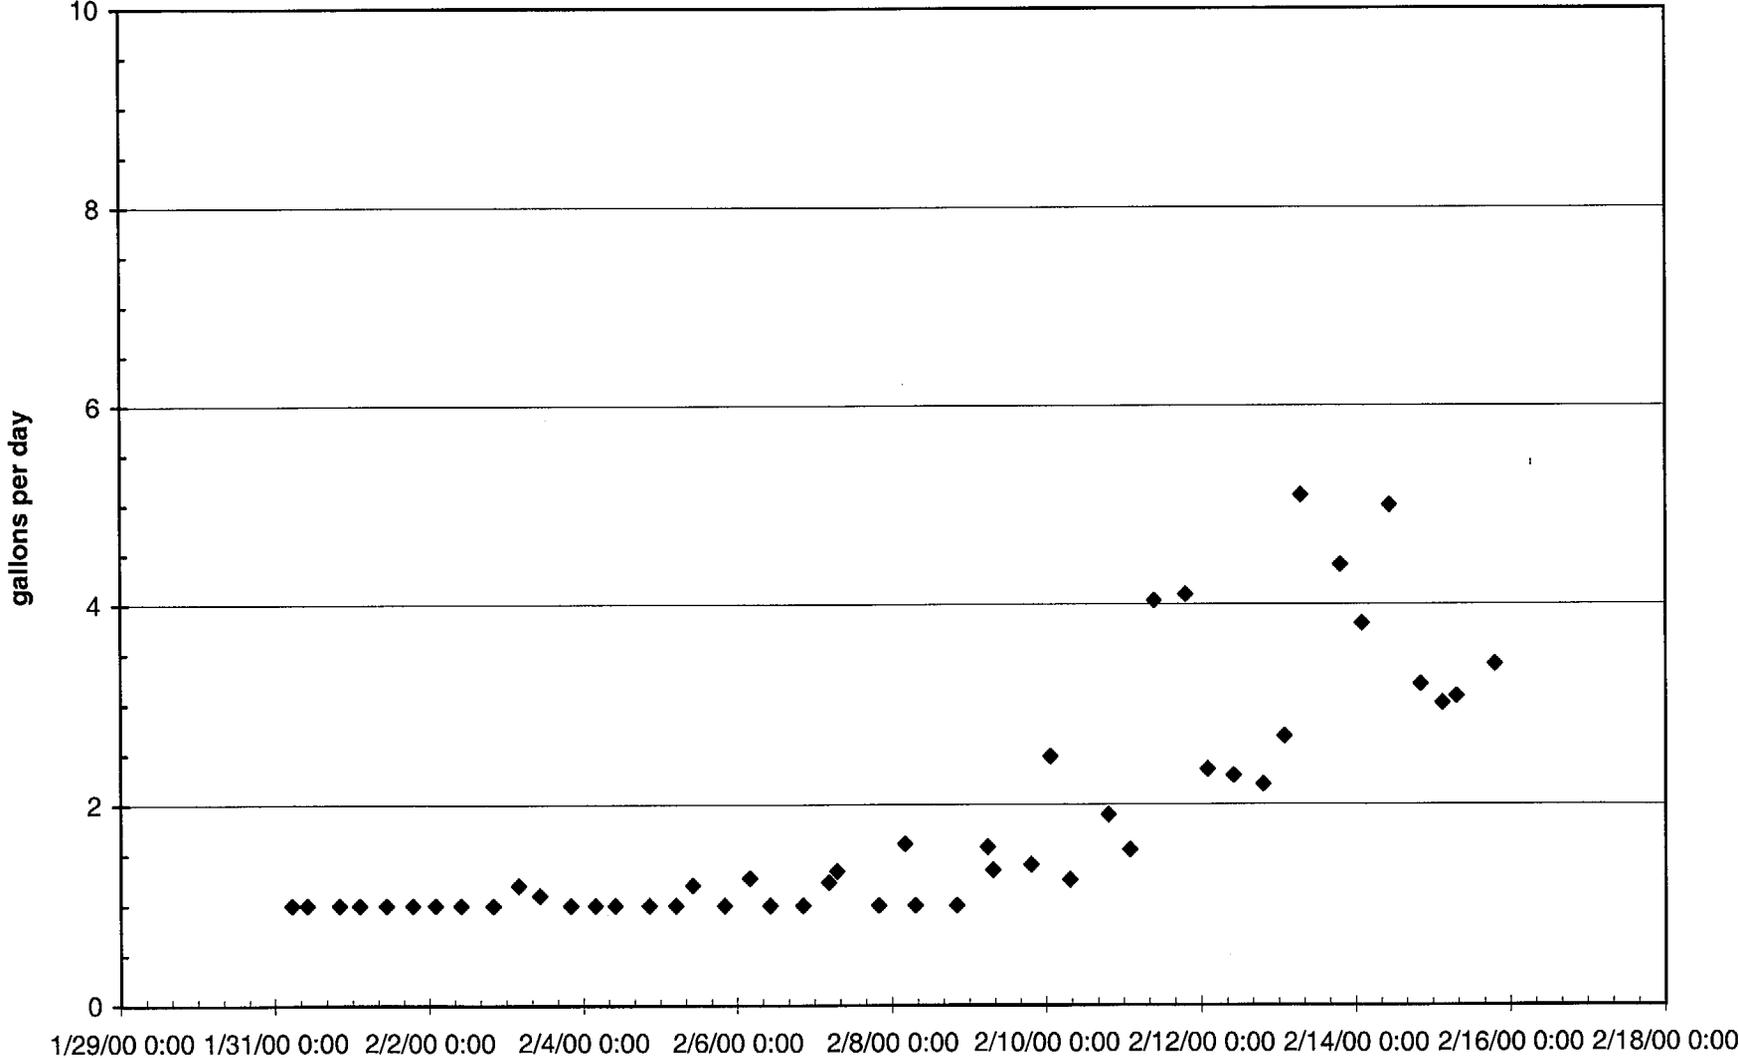
24 Steam Generator Leak Rate - N-16

On February 15, 2000 at approximately 1915 hours, the N-16 monitor was indicating 3.4 gpd. The steam generator tube rupture event had initiated at approximately 1929 hours. A graph illustrating 24 steam generator primary to secondary leakage, as indicated by the N-16 monitor, is attached.

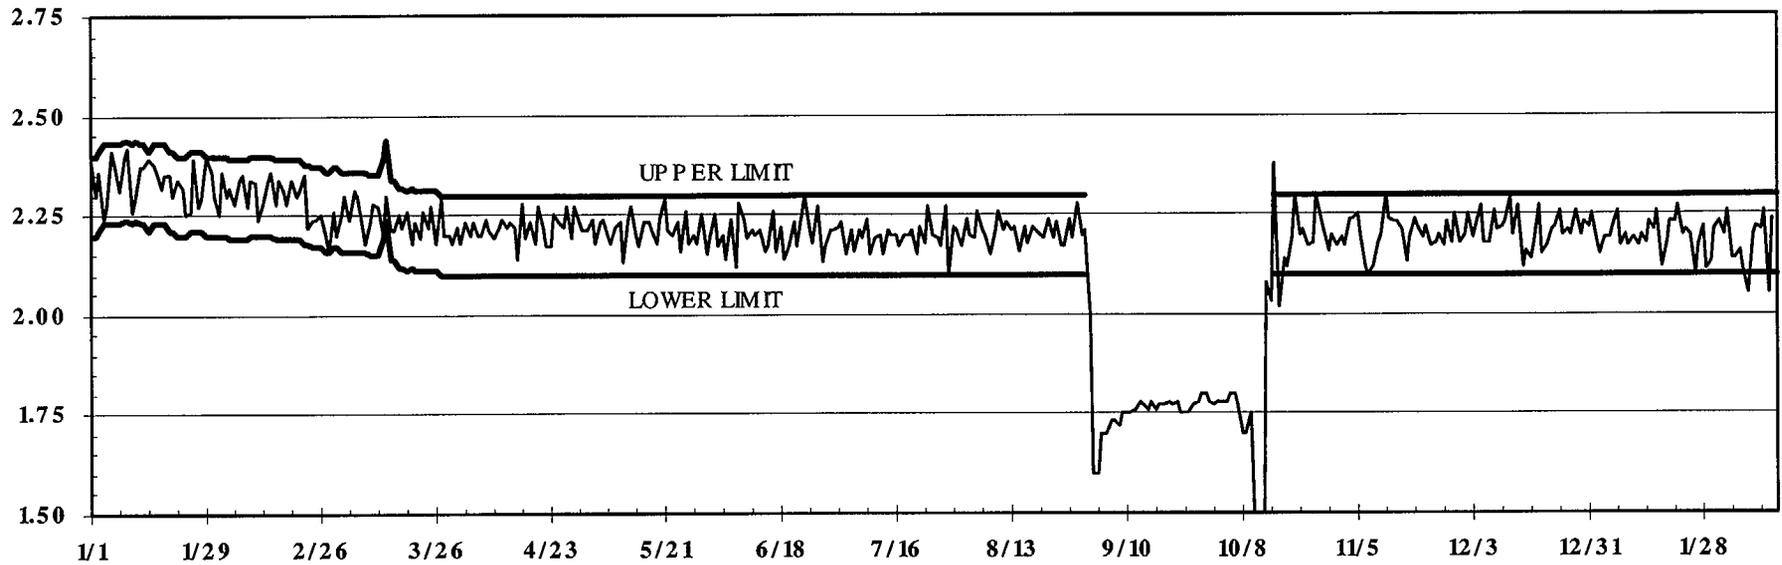
REACTOR COOLANT LITHIUM

Based upon a review of the primary water chemistry history during the past operating cycle, Con Edison believes that water chemistry did not contribute to the occurrence of primary water stress corrosion cracking (PWSCC), which is the identified root cause for the tube leak. The primary system chemistry parameters reviewed for the operating cycle were boron/lithium concentration and hydrogen concentration. Boron/lithium concentration, which controls the pH, was maintained with procedural limits. Hydrogen concentration was also maintained within an approved band of 25- 50 cc/kg.

Attached graphs illustrate both of the above mentioned chemistry parameters to have been maintained within acceptable limits during the previous operating cycle.
