Subject: Response to the Staff's Requests for Additional Information (RAI) Regarding the Steam Generator Tube Examinations conducted during Spring of 2000 Outage, and the Root Cause Evaluation of the Steam Generator Tube Rupture Event of February 15, 2000 (TAC No. MA8219)

**Response to Questions Regarding Steam Generator Tube Examinations
Performed During Spring 2000 Outage**

**Consolidated Edison Company of New York, Inc.
Indian Point Unit No. 2
Docket No. 50-247
June 2000**

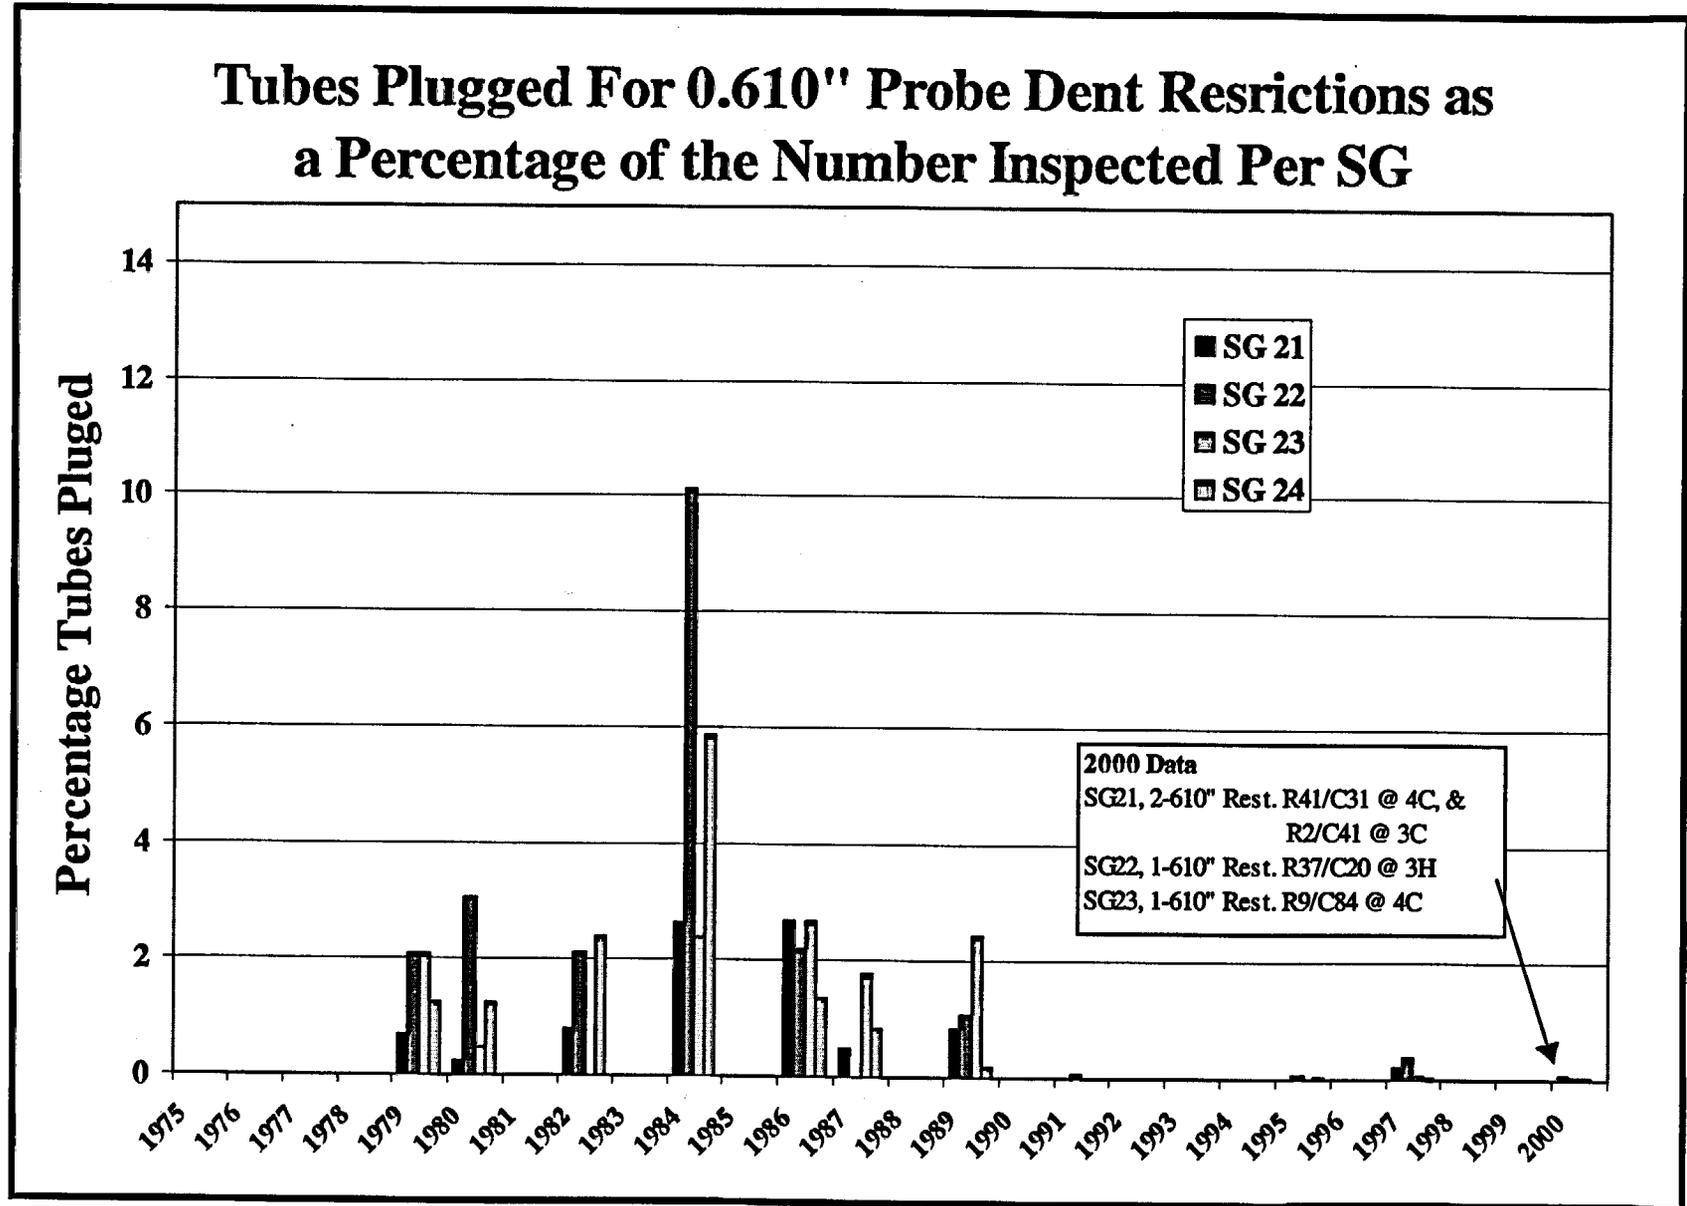
Figure 1

The number of tubes plugged for 610 mil probe dent restrictions as a percentage of the total number of tubes inspected each outage since 1979 is shown in Figure 1. This Figure showed that the percentage of tubes plugged for restriction to the 610 mil probe peaked in 1984 and has declined since that time.

In 1995, the full length examination program consisted of 71%, 50%, 70% and 100% of the tubes in SG21, SG22, SG23, and SG24, respectively. The sampling at that time did not include a large number of lower row U-bends. The purpose of the full length inspection scope was to determine a baseline condition for AVB wear. The AVB sampling concentrated on tubes in rows 16 and higher. Almost all of the 1997 restrictions were in the low row U-bends. This would account for the difference in the higher number of 610 probe restrictions found in the 1997 versus the 1995 inspections.

During the 2000 inspection a total of only four tubes showed restriction to the 610 mil bobbin probe. None of these tubes were located at the u-bend or sixth TSP. Rather two were located in SG 21 at the third and fourth TSP, one in SG 22 at the third TSP, and one in SG 23 at the fourth TSP.

Therefore the data does indeed indicate that the increase in the number of tubes identified as being restricted to the 610 mil probe in 1997 was due to an inspection transient for three reason:

- 1) The 1995 inspection focused on AVB ware in rows 16 and higher. Almost all of the 1997 restrictions were in low row U-bend areas.
- 2) The number of tube restrictions decreased from 1997 to 2000, and
- 3) The inspection scope and probes used in 1997 and 2000 were the same.
