UNITED STATES
NUCLEAR REGULATORY COMMISSION
WASHINGTON, D.C. 20555-0001

SUBJECT: FINAL SNL LETTER REPORT, "CIRCUIT FAILURE MODE AND
LIKELIHOOD ANALYSIS"

Circuit Analysis - Failure Mode And Likelihood Analysis

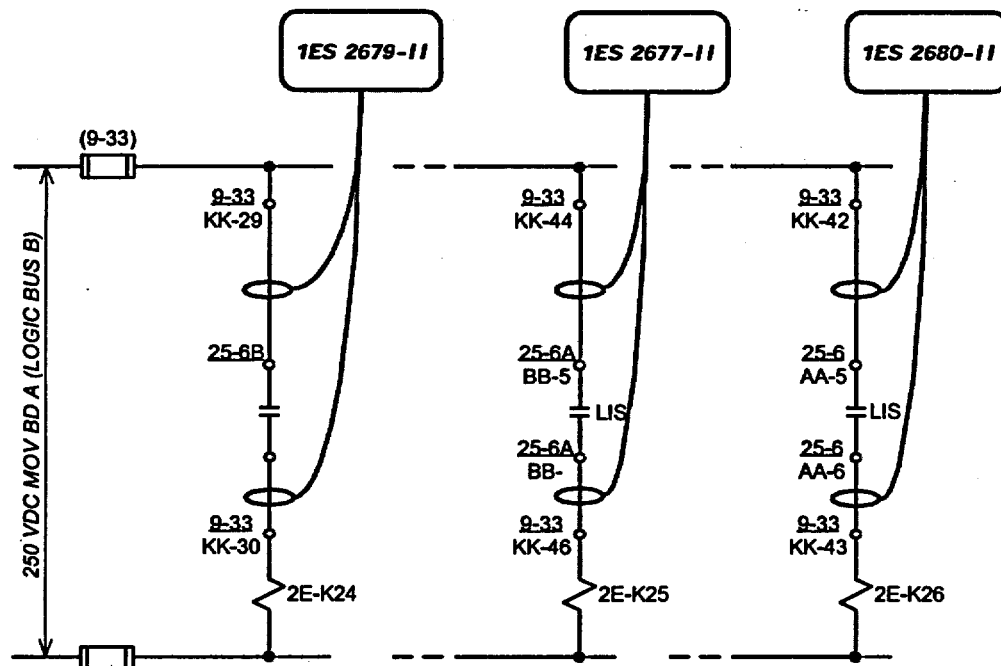
Figure C-1 Partial schematic of ABS relay logic circuit.

These particular relays are intended to initiate alarms for a low water level condition in the reactor. Sheet 2 of 730E929 is referenced in the tables of contact functions on sheet 1 but was not included in the package of electric system drawings. Figure C-1 shows a schematic of the relevant relay branches in the ABS relay logic circuit. Unfortunately, the relay IDs given on the two drawings do not match. It is possible, however, to postulate that internal conductor-to-conductor shorts within an ABS relay logic circuit cable could cause the annunciator alarm.

In addition, information gathered regarding these cables (see Figure C-1) indicates that they all were routed through the zone of fire influence as shown in Table C-4, thus giving credence to the possibility that one (or more) conductor shorts may have occurred to initiate the alarm. It is important to realize that Checkpoint 131 is in the reactor building and is the closest checkpoint to the cable penetration from the cable spreading room where the fire initiated.

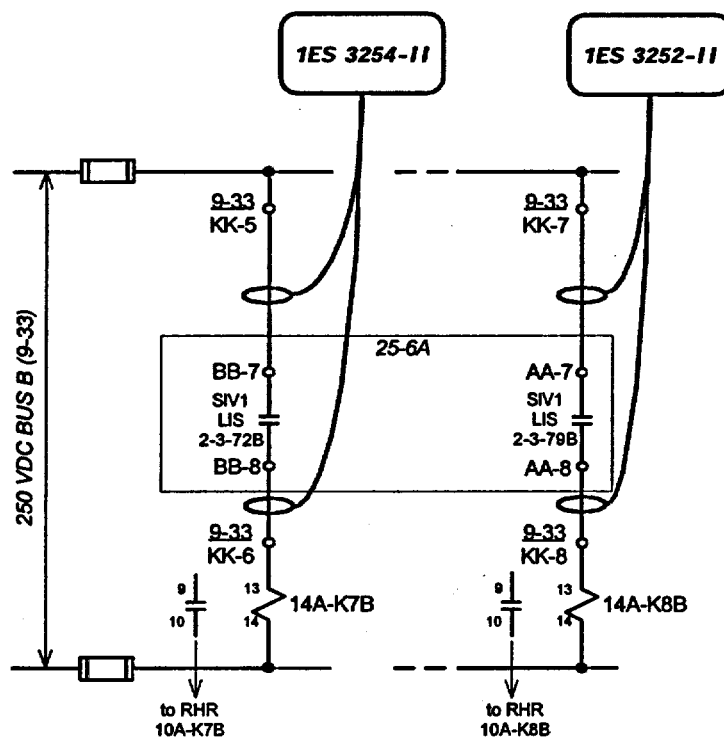
Figure C-2. Partial schematic of Core Spray relay logic circuit.

cables affecting two of these circuit annunciator relays were identified as being fire damaged. Figure C-2 shows the relevant portions of the alarm logic relay circuit for the core spray system. Table C-7 indicates the type and cable trays these cables were located in at three of the fire influence zone checkpoints. As a result of this information, it appears that a conductor-to-conductor shorting event—simulating a low level condition signal from the level switch contacts—is a very definite possibility.

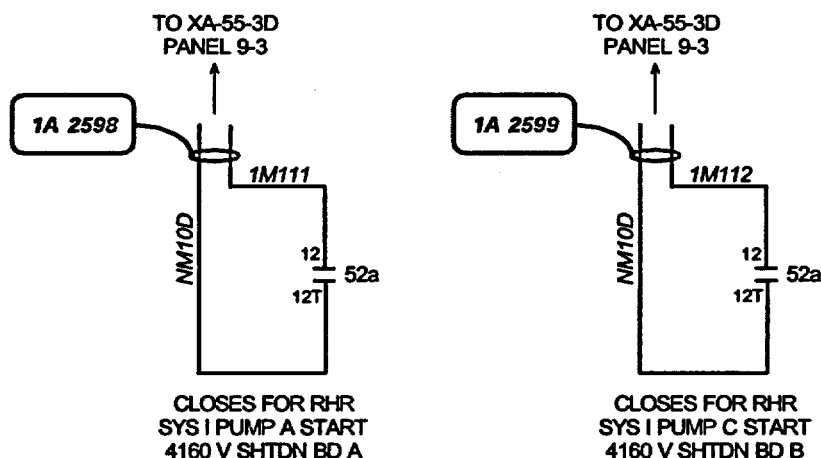
Figure C-3. Partial schematic of annunciator circuit for the RHR Pump Start alarms.

Information gathered regarding the cable routings indicates different cable identifiers for these circuits (e.g., 2A 2598 vs. 1A 2598). This discrepancy may simply be an error made during the markup of drawing 45N620-2. (Also, assuming the “2A” identifier indicates a system II component, the fact, as will be discussed later, that the drawing package includes markups of the control circuits for RHR pumps 2A and 2C makes this assumption appear to be consistent with the bulk of the available information.) Cables 2A 2598 and 2A 2599 were both routed through the zone of fire influence as shown in Table C-9.

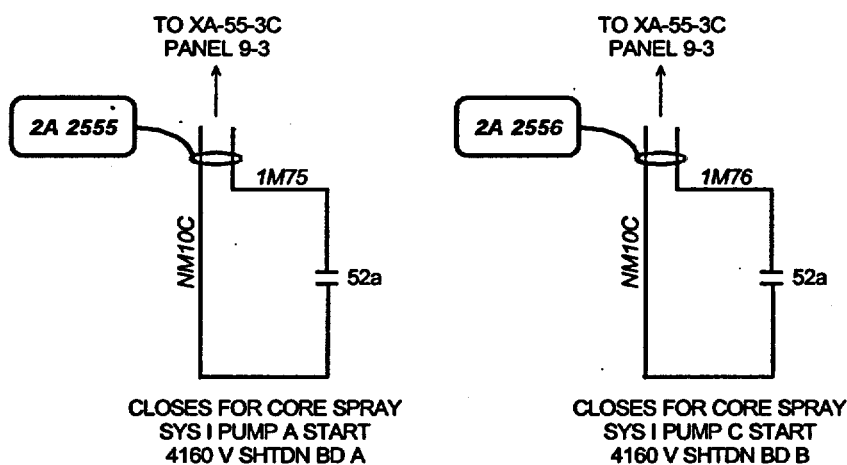
Figure C-4. Partial schematic of annunciator circuit for the Core Spray Pump Start alarms.

Figure C-4 shows a partial schematic of the Core Spray Pump Start alarm circuit. Unlike the case for the RHR pump alarm circuit markups, the CS pump alarm circuit markups indicate cables 2A 2555 and 2A 2556 as the cables of concern (i.e., no discrepancies).

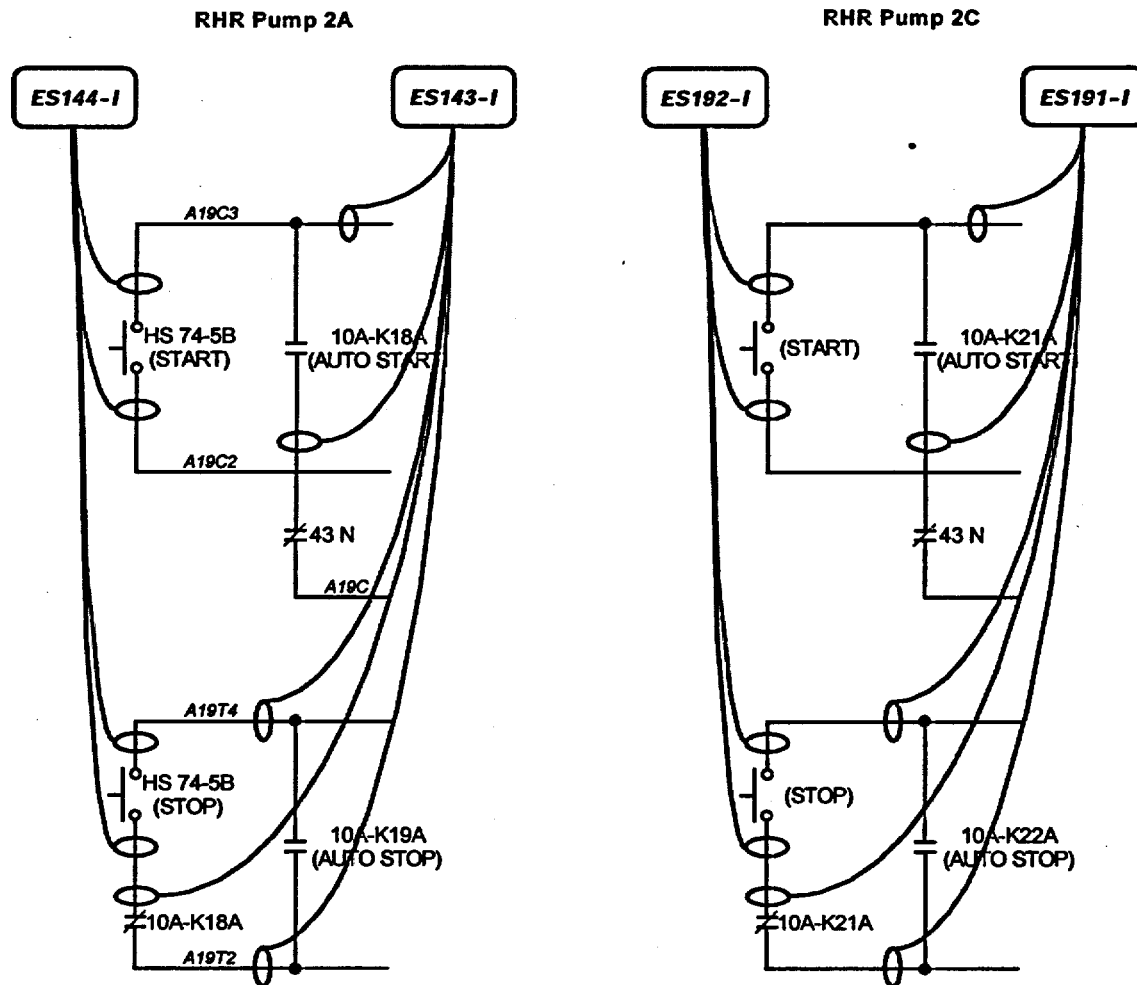
Figure C-5. Partial schematic of the relay and hand switch branches for the RHR pump

It is important to note that shorting of the two conductors going to the hand switch (START) contacts in cable ES144-I (ES190-I) or shorting of the two conductors leading to the auto-start relay in cable ES143-I (ES191-I) would have been able to initiate the pump's operation. Conductor shorting in these cables for the stop (or "trip") circuits is problematical. Shorts that bypass either the hand switch (STOP) contacts or the auto-stop relay contacts should have resulted in tripping the

power breaker for the pump motor(s). However, the events log indicates that the operator could not stop the pumps after their spurious restart at 12:44. This might be explained in one of two ways: 1) conductors leading to or from the STOP hand switch contacts may have failed in an open circuit manner (a very convenient explanation) or 2) the trip coil was a time-delay type wherein continuous shorting of the start/auto-start contact conductors could have overridden the influence of the trip coil. There is no information available to determine if one or either of these possibilities is correct.

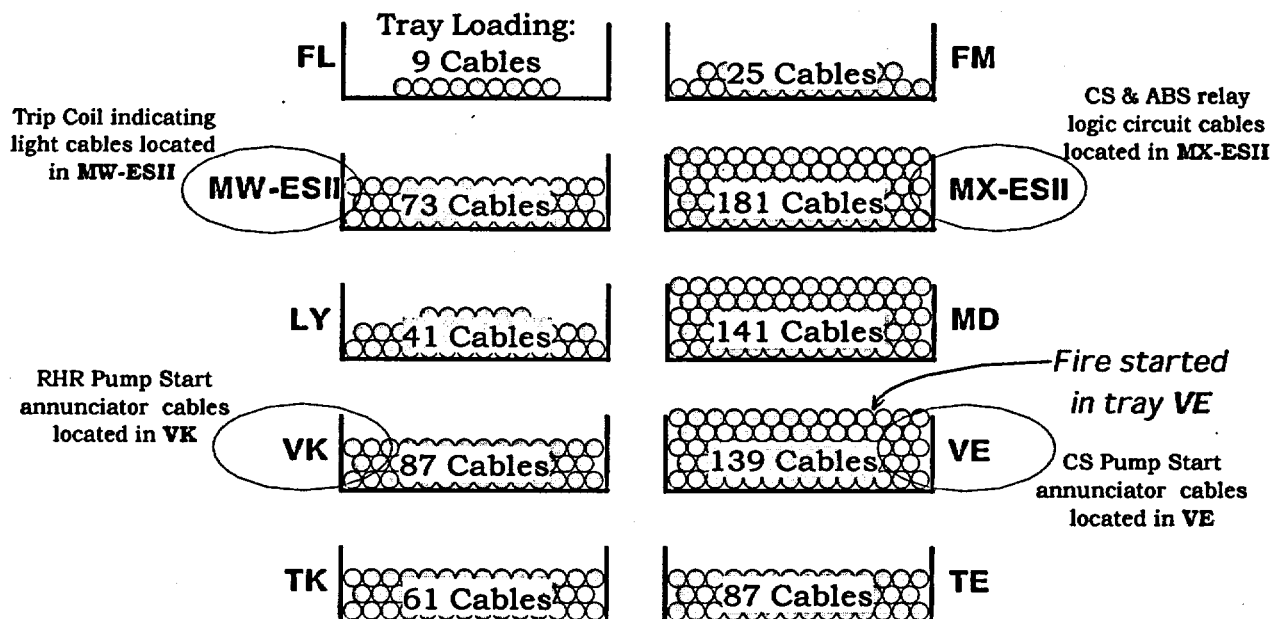
Figure C-9. Cable tray locations and contents. (Ref: Exhibit C1, pp. 30-32 of 69, *Physical Damage to Electric Cables and Raceways Involved in the Browns Ferry Nuclear Plant Fire on March 22, 1975*, contained in Regulatory Investigation Report Office of Inspection and Enforcement Region II.)

pump start alarm circuits are contained in tray VE, where the fire started, and the RHR pump start alarm circuits are contained in tray VK just next to VE. The auto-blowdown and core spray logic circuitry is located two trays above VE (in MX-ESII), and with the fuel loading of trays MX-ESII, MD, and VE it is conceivable that the fire would spread to MX-ESII very rapidly. Finally, the trip coil indicating light circuits are all contained within tray MW-ESII, further away from the ignition point than the other three trays, hence, the effects should have been noted later in the event (as indeed they were).
