DOCUMENT NO.: 00003-23-0084-F16-005 REV.: 0 Page: i* of 30*
DOCUMENT TITLE: Duke Power Cure Time Fire Test Analysis
PROJECT NAME: Cure Time Fire Test
PROJECT NO.: 00003.23.0084
CLIENT: Duke Power QA CONDITION: 3

**Duke Power Company
Corporate Fire Protection**

**Duke Power Cure Time
Fire Test Analysis**

**Technical Document:
00003-23-0084-F16-005
Revision 0**

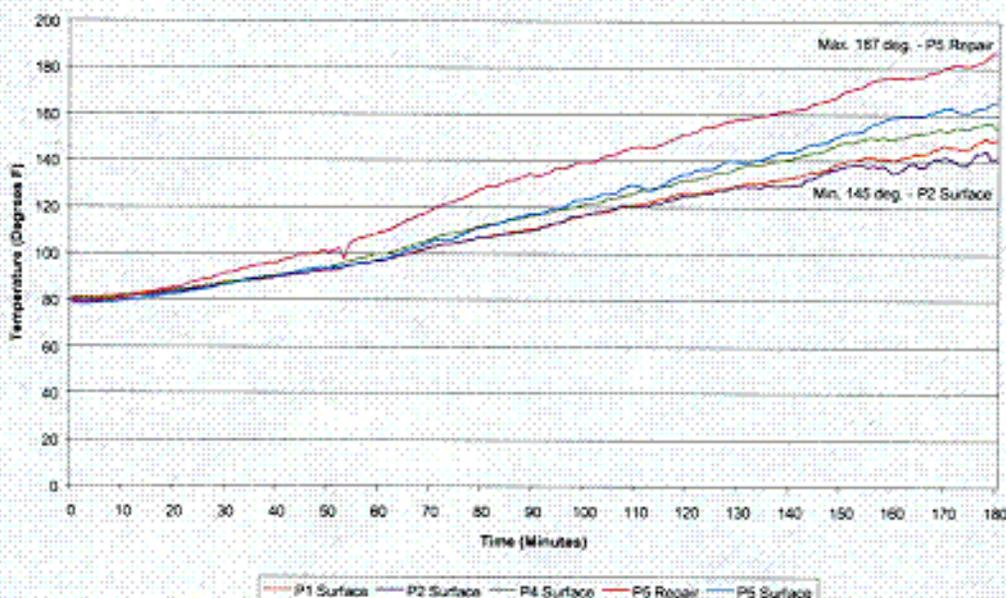
Figure 4.1-1
Seal Surface Temperatures (Pens. 1, 2, 4 and 5)

This graph clearly shows that the temperature on the unexposed seal surface of each of the seal assemblies increased gradually throughout the test. The fact that the temperature recorded for the repair area of Penetration 5 was slightly higher than the other seal surface temperatures (187°F as compared to the range of 145°F-166°F) is attributed to the thermocouple's proximity to the pipe. The seal surface thermocouples for Penetrations 1, 2, 4 and 5 were placed at the midpoint between the pipe and edge of the sleeve. This placement resulted in the thermocouples being located about 2-1/2" away from the pipe. The thermocouple over the surface of the repair area was placed near the center of the repair. Since the repair was approximately 3" in diameter and extended out from the pipe, the repair area thermocouple was located about 1-1/2" from the pipe. This determination is further supported by a comparison of this thermocouple (187°F) to the temperature recorded at the interface of the pipe for Penetration 5 which was monitored on the seal surface 1" away from the pipe (194°F for TC#16).

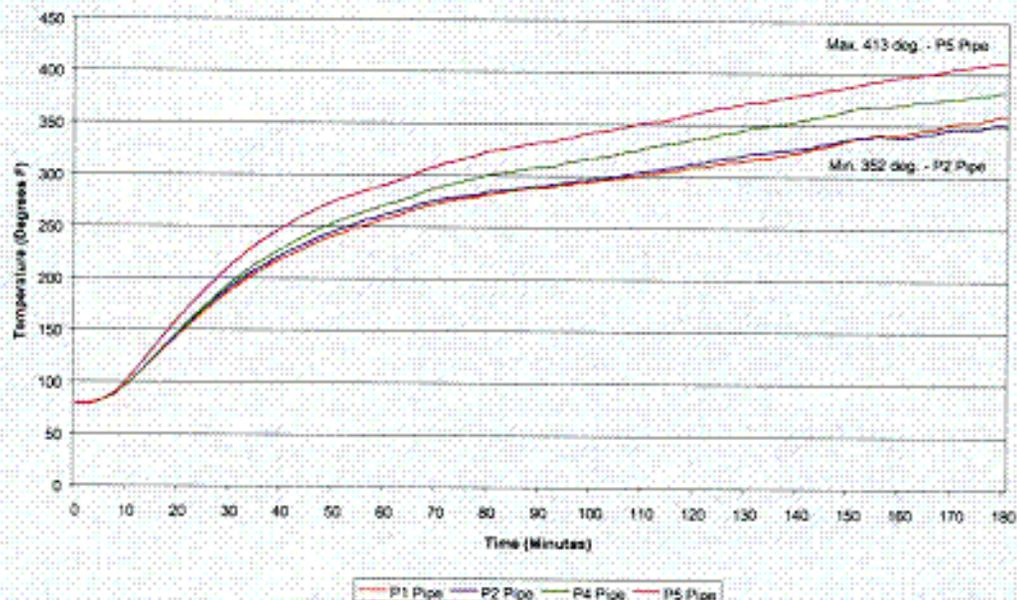
Figure 4.1-2
Pipe Temperatures (Pans. 1, 2, 4 and 5)

A comparison of penetrating item temperatures (monitored on the pipe at a point 1" above the seal surface) for these penetrations yielded similar results. Throughout the 3-hour test, temperatures monitored on the penetrating pipe for each of these penetrations gradually increased and were in the same general range (see Figure 4.1-2).

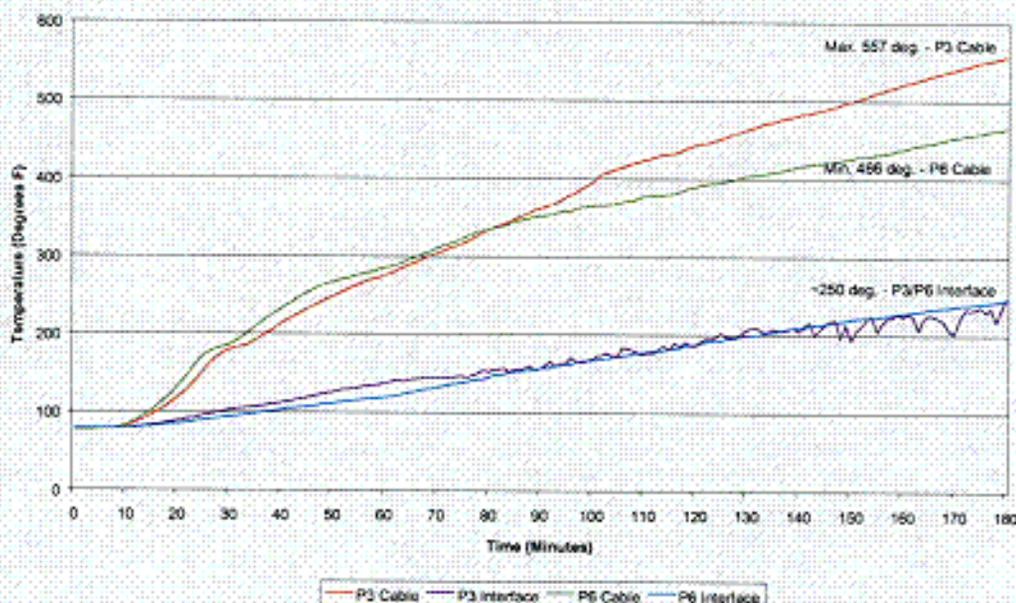
Figure 4.2-2
Cable & Interface Temperatures (Pens. 3 and 6)

A comparison of penetrating item temperatures (monitored on the largest diameter cable at a point 1" above the seal surface) and interface temperatures (monitored on the seal surface at a point 1" away from the penetrating item) were also consistent for these penetrations as indicated in Figure 4.2-2 below.

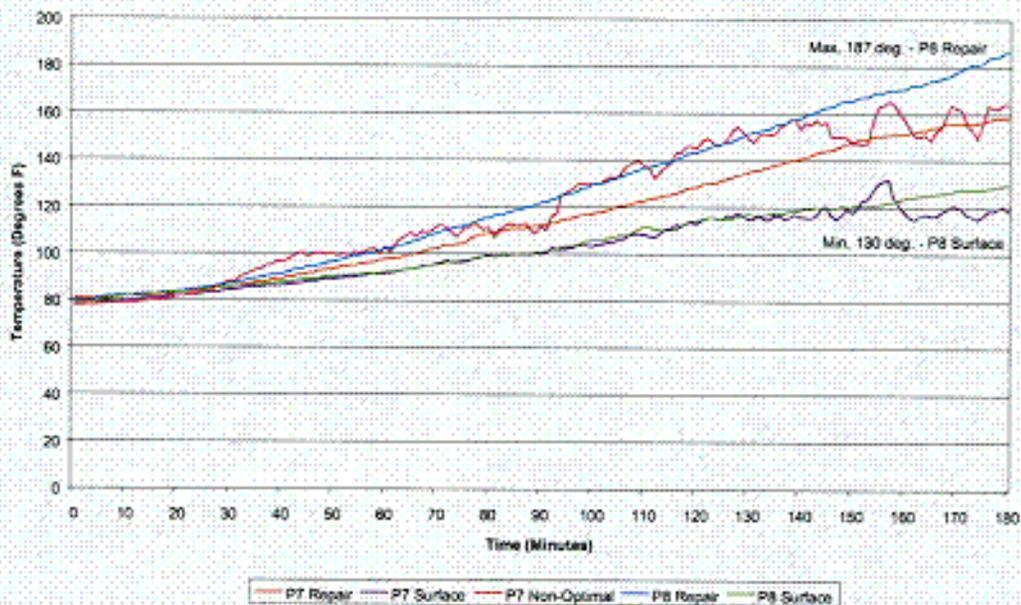
Figure 4.3-1
 Seal Surface Temperatures (Pens. 7 and 8)

This graph clearly shows that the temperature on the unexposed seal surface of both of the seal assemblies increased gradually throughout the test and remained well below the acceptance limits. Additionally, a review of these thermocouple readings confirms that non-optimal cell structure silicone foam performs thermally in a manner similar to silicone foam that exhibits optimal cell structure.

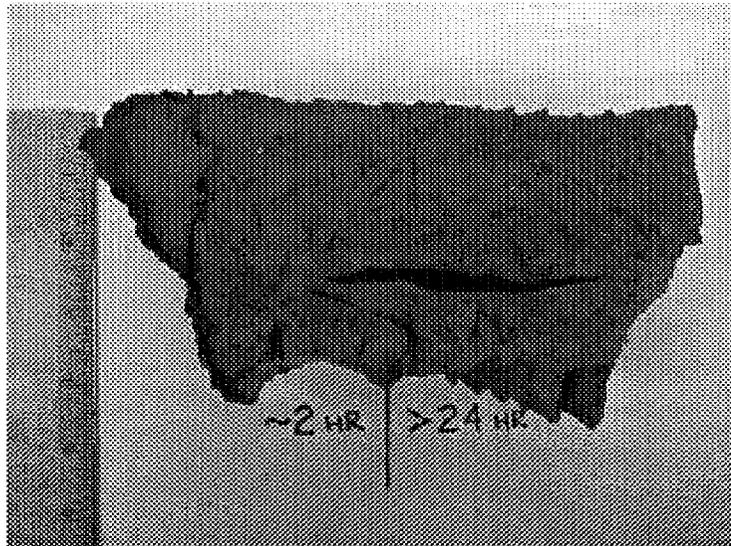
Additionally, there appeared to be no difference in the char depth between the silicone foam that was allowed to cure for more than 24-hours and the reduced cure time foam (~ 2-hour cure for Penetration 7 and < 30-minute cure time for Penetration 8). The photograph below depicts a section of the material removed from Penetration 7. A similar char depth was observed in the corresponding area of Penetration 8.

**Penetration 7 Section View
(~ 2-Hour Cure/ > 24-Hour Cure)**

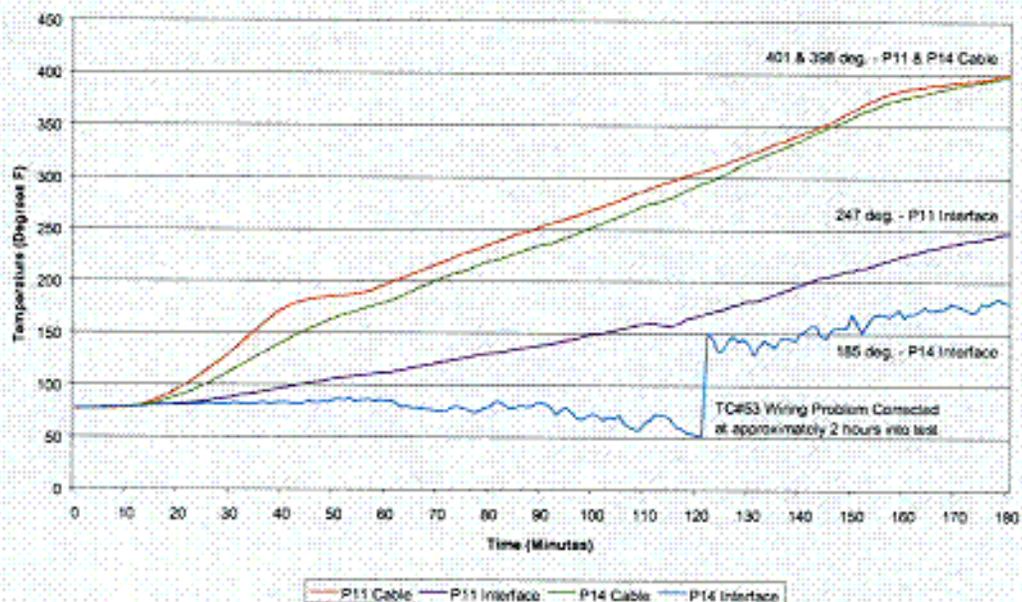
Figure 4.6-2
Cable & Interface Temperatures (Pens. 11 and 14)

A comparison of penetrating item temperatures (monitored on the largest diameter cable at a point 1" above the seal surface) and interface temperatures (monitored on the seal surface at a point 1" away from the largest penetrating cable) were also consistent for these penetrations as indicated in Figure 4.6-2 below.

It should be noted that the thermocouple leads for TC #53 were inadvertently crossed. Omega Point Laboratory personnel identified this condition at approximately 2 hours into the fire endurance test. Upon correcting the wiring error, TC #53 began to record accurate data. Based on relatively low endpoint temperature for this thermocouple, and considering the temperature profile of the corresponding thermocouple for Penetration 11, there is no reason to believe that temperatures near the acceptance limits were approached at any time during this test at this location. Therefore, this error has no adverse impact on the validity of the test results.
