DOCUMENT TITLE: Duke Power Cure Time Fire Test Analysis

PROJECT NAME: Cure Time Fire Test

CLIENT: Duke Power QA CONDITION: 3

**Technical Document:  
00003-23-0084-F16-005  
Revision 0**

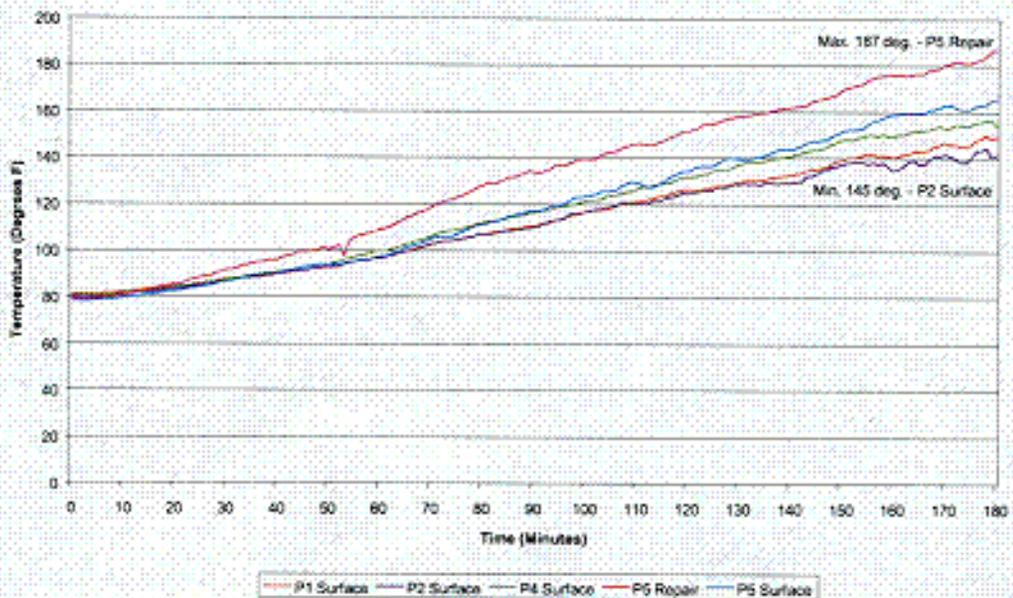
Figure 4.1-1  
Seal Surface Temperatures (Pens. 1, 2, 4 and 5)

This graph clearly shows that the temperature on the unexposed seal surface of each of the seal assemblies increased gradually throughout the test. The fact that the temperature recorded for the repair area of Penetration 5 was slightly higher than the other seal surface temperatures (187°F as compared to the range of 145°F-166°F) is attributed to the thermocouple's proximity to the pipe. The seal surface thermocouples for Penetrations 1, 2, 4 and 5 were placed at the midpoint between the pipe and edge of the sleeve. This placement resulted in the thermocouples being located about 2-1/2" away from the pipe. The thermocouple over the surface of the repair area was placed near the center of the repair. Since the repair was approximately 3" in diameter and extended out from the pipe, the repair area thermocouple was located about 1-1/2" from the pipe. This determination is further supported by a comparison of this thermocouple (187°F) to the temperature recorded at the interface of the pipe for Penetration 5 which was monitored on the seal surface 1" away from the pipe (194°F for TC#16).

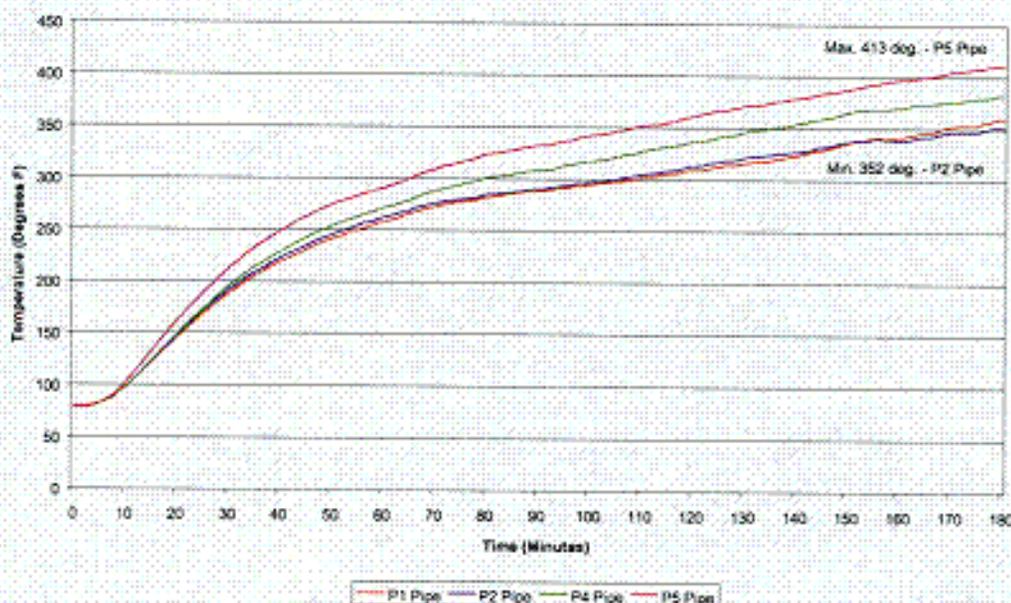
Figure 4.1-2  
Pipe Temperatures (Pans. 1, 2, 4 and 5)

A comparison of penetrating item temperatures (monitored on the pipe at a point 1" above the seal surface) for these penetrations yielded similar results. Throughout the 3-hour test, temperatures monitored on the penetrating pipe for each of these penetrations gradually increased and were in the same general range (see Figure 4.1-2).

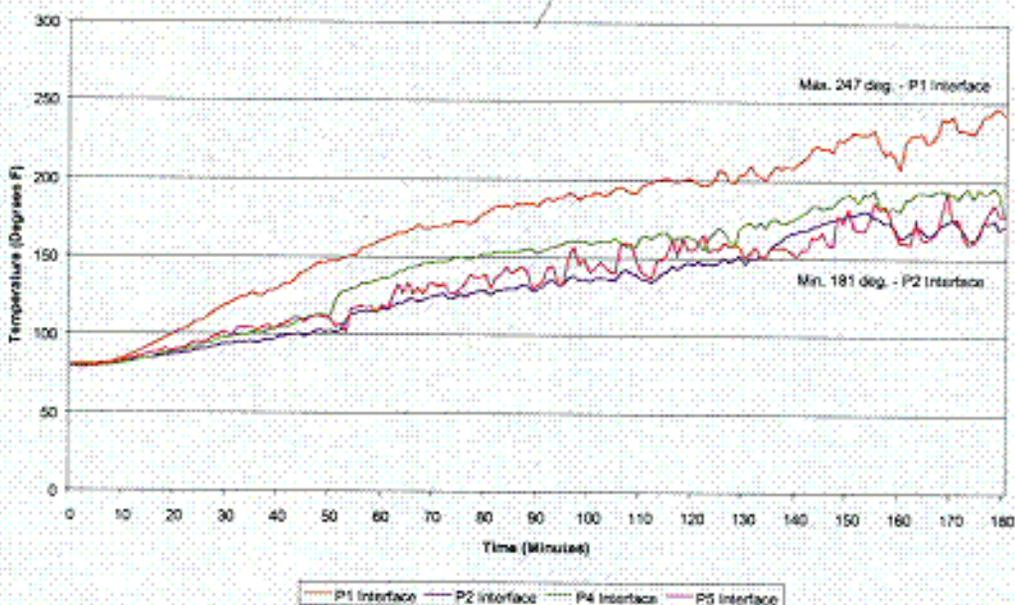
Figure 4.1-3  
Interface Temperatures (Pens. 1, 2, 4 and 5)

Interface temperatures (monitored on the seal surface at a point 1" away from the penetrating item) were also consistent for these penetrations as indicated in Figure 4.1-3 below.

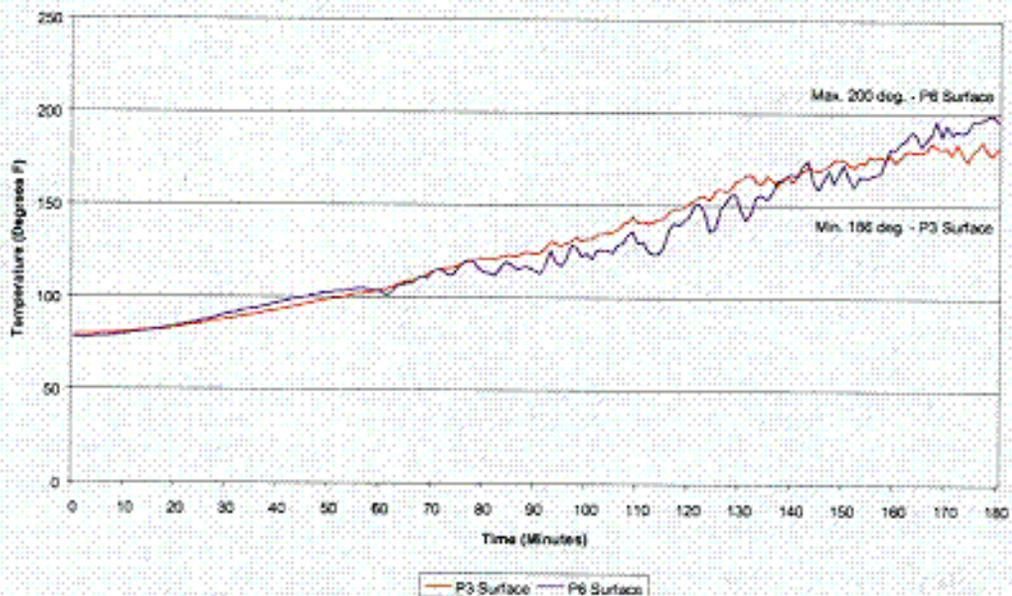
Figure 4.2-1  
Seal Surface Temperatures (Pens. 3 and 6)

This graph clearly shows that the temperature on the unexposed seal surface of both of the seal assemblies increased gradually throughout the test and remained well below the acceptance limits.

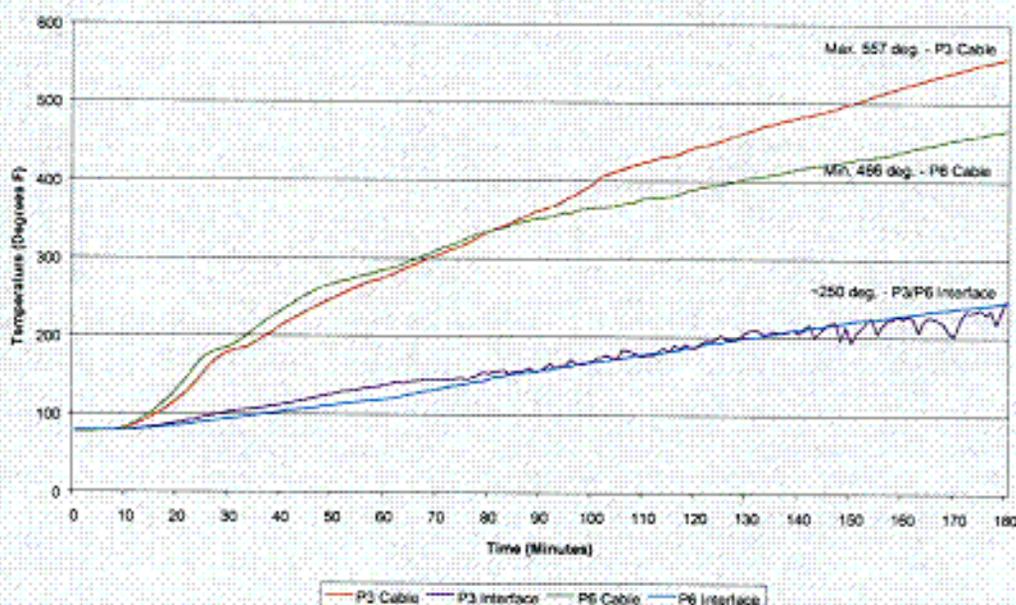
Figure 4.2-2  
Cable & Interface Temperatures (Pens. 3 and 6)

A comparison of penetrating item temperatures (monitored on the largest diameter cable at a point 1" above the seal surface) and interface temperatures (monitored on the seal surface at a point 1" away from the penetrating item) were also consistent for these penetrations as indicated in Figure 4.2-2 below.

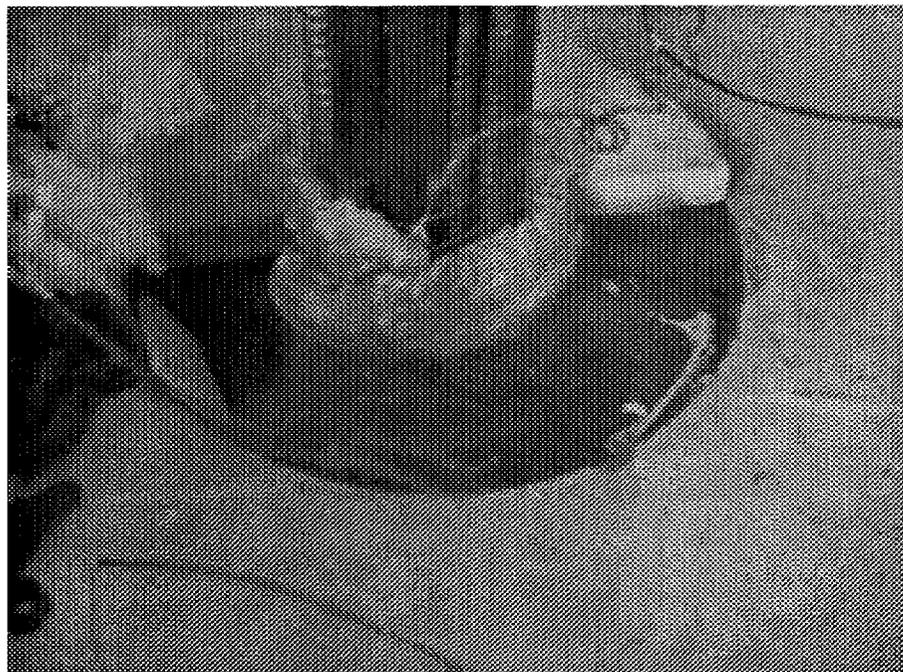
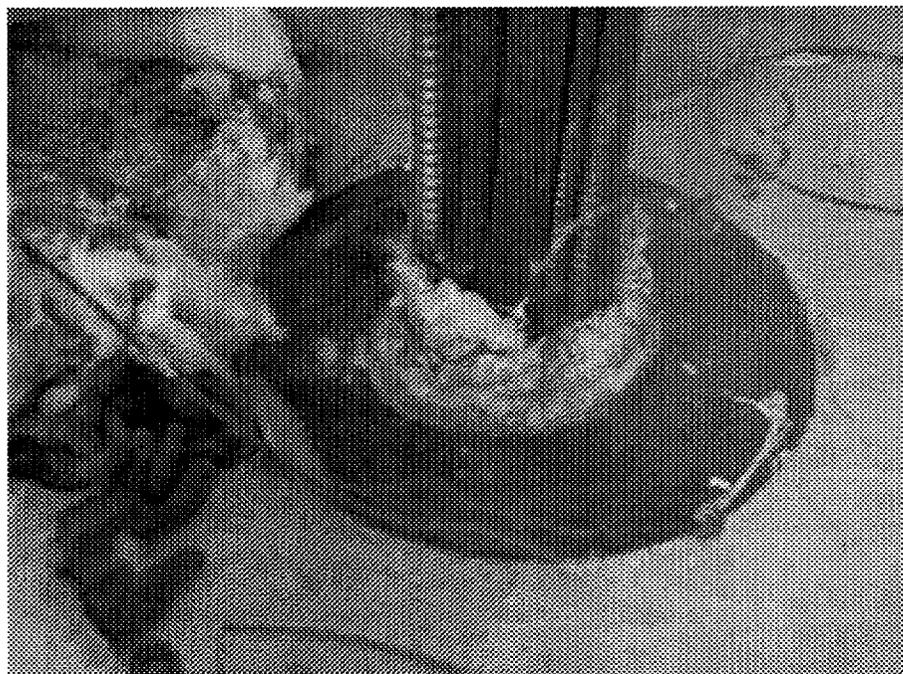
Generally, a post-test examination is performed a few hours after the hose-stream test, once the test specimen has cooled slightly. The time-critical sequence associated with conducting this test necessitated that the fire endurance and hose-stream portions of the test be concluded in late afternoon. Because of this, the post-test examination was scheduled for the next morning. However, immediately following the hose-stream test, it was observed that Penetration 3 was emitting a significant amount of smoke. Because Penetration 3 was only a 6" thick silicone foam seal and a cable bundle was the only penetrating item through this seal, it was believed that if this specimen was allowed to smolder overnight, an accurate post-test examination might not be possible. With this in mind, the top side dam was removed from Penetration 3. With the dam removed it was visually confirmed by personnel from Duke Power, DE&S and Promatec Technologies that a thin layer of resilient foam did indeed remain intact beneath the damming board (see digital photos below taken at 4:34pm on 3/2/00).

**Penetration 3 With Partial Top Side Dam Removed**

**Penetration 3 With All Top Side Damming Removed**

Approximately 30 minutes later flaming occurred inside Penetration 3. Omega Point Laboratory personnel extinguished the fire by means of a dry chemical extinguisher. Upon returning to the lab the next morning, it was observed that no material was remaining inside Penetration 3.

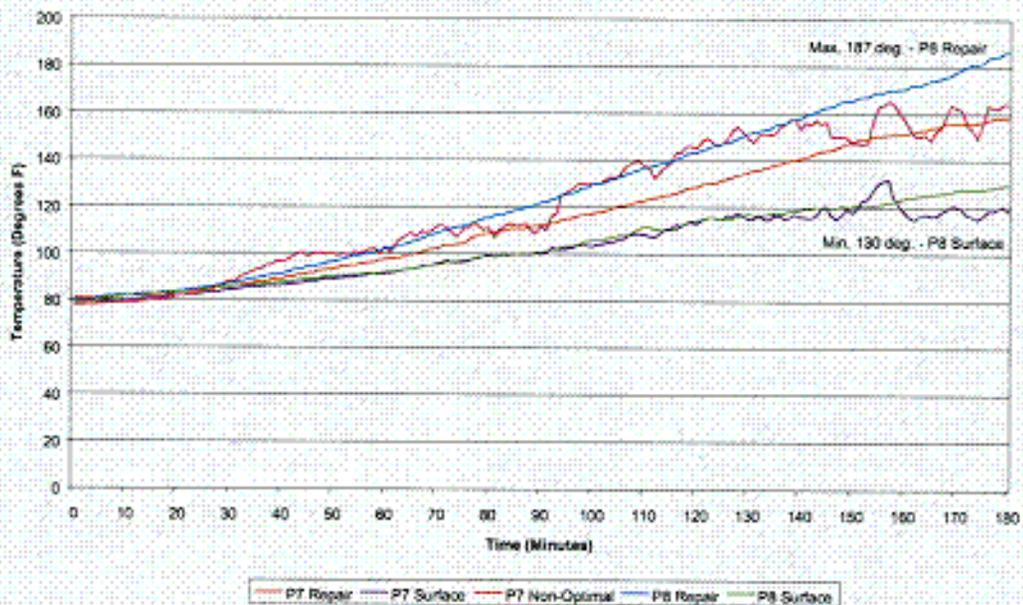
Figure 4.3-1  
 Seal Surface Temperatures (Pens. 7 and 8)

This graph clearly shows that the temperature on the unexposed seal surface of both of the seal assemblies increased gradually throughout the test and remained well below the acceptance limits. Additionally, a review of these thermocouple readings confirms that non-optimal cell structure silicone foam performs thermally in a manner similar to silicone foam that exhibits optimal cell structure.

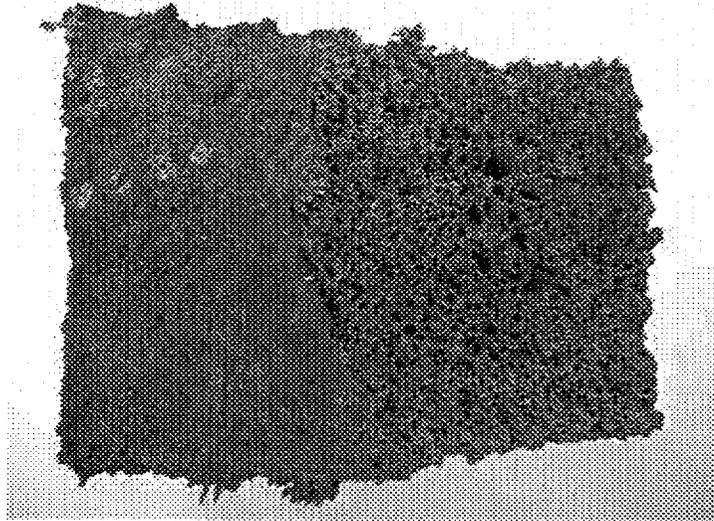
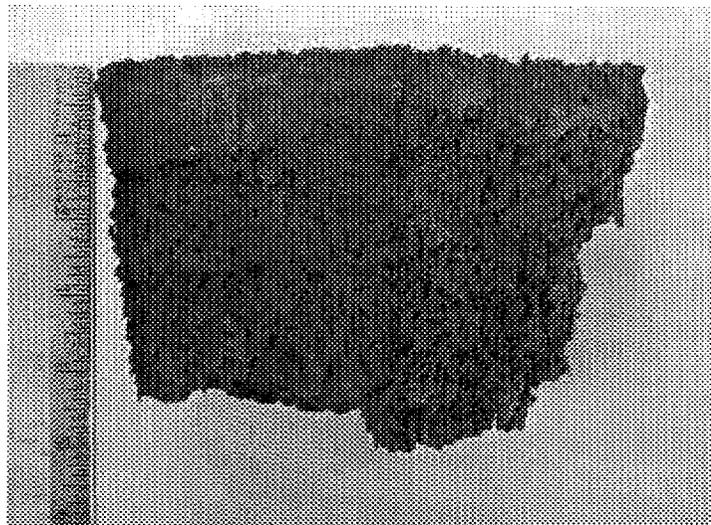
Post-test examination of these penetrations revealed that each of these seals displayed similar characteristics. In both cases both top and bottom side damming boards were intact with 4"-5" of resilient foam remaining. Consistent throughout both of these seals was the fact that slightly more foam was charred along the cable interface than the blockout interface. The non-optimal cell structure foam contained in Penetration 7 appeared to char at the same rate as the silicone foam exhibiting optimal cell structure (see photographs below).

**Penetration 7 - Plan View  
(Optimal / Non-Optimal Interface)**

**Penetration 7 - Section View  
(Optimal / Non-Optimal Char Depth)**

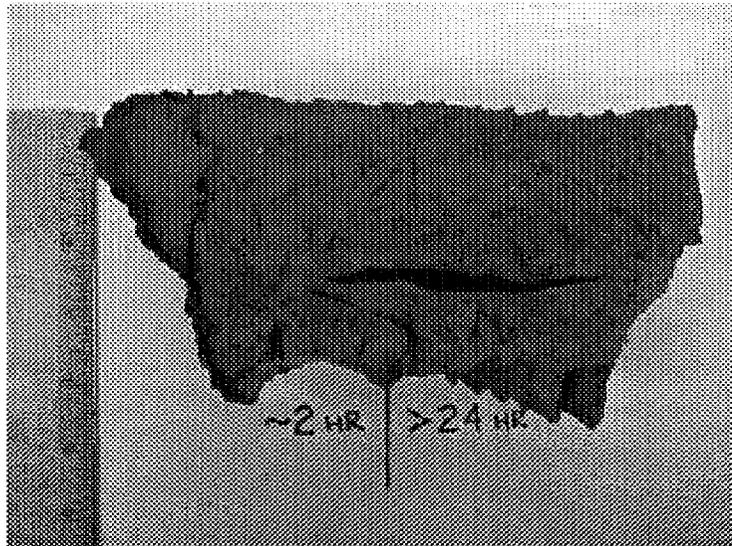
Additionally, there appeared to be no difference in the char depth between the silicone foam that was allowed to cure for more than 24-hours and the reduced cure time foam (~ 2-hour cure for Penetration 7 and < 30-minute cure time for Penetration 8). The photograph below depicts a section of the material removed from Penetration 7. A similar char depth was observed in the corresponding area of Penetration 8.

**Penetration 7 Section View  
(~ 2-Hour Cure/ > 24-Hour Cure)**

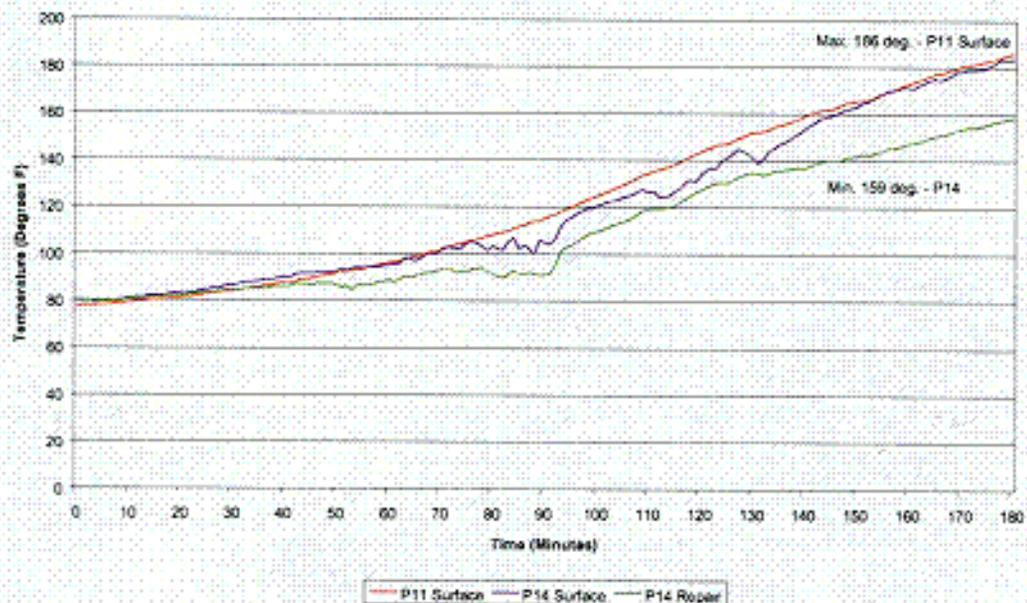
Figure 4.6-1  
Seal Surface Temperatures (Pens. 11 and 13)

This graph clearly shows that the temperature on the unexposed seal surface of both of the seal assemblies increased gradually throughout the test and remained well below the acceptance limits. Additionally, the repair area of Penetration 14 (< 30-minute cure time) performed slightly better than the surrounding baseline seals, as evident by the lower endpoint temperature (159°F at 3-hours into the test).

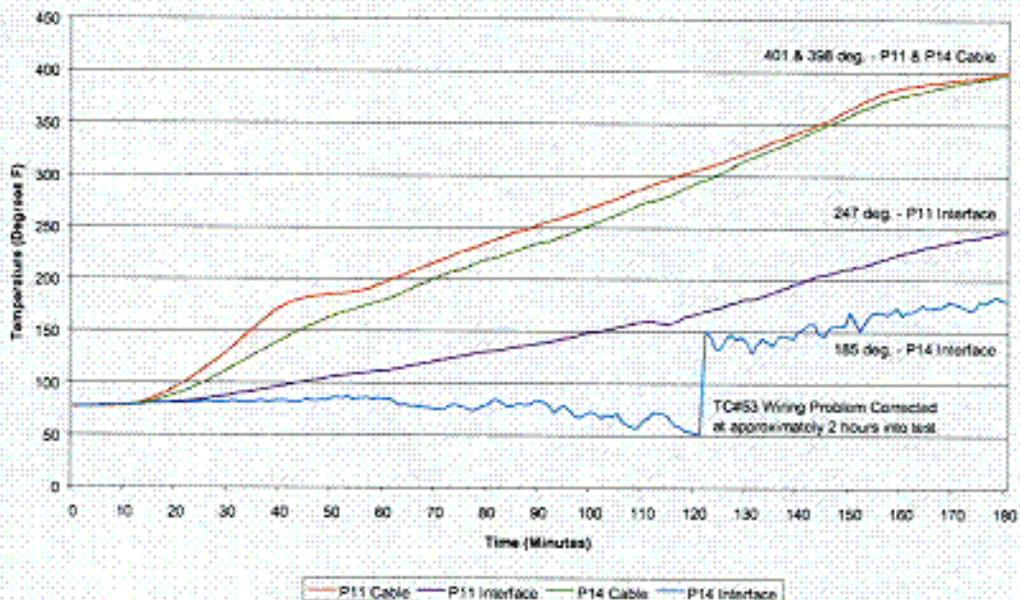
Figure 4.6-2  
Cable & Interface Temperatures (Pens. 11 and 14)

A comparison of penetrating item temperatures (monitored on the largest diameter cable at a point 1" above the seal surface) and interface temperatures (monitored on the seal surface at a point 1" away from the largest penetrating cable) were also consistent for these penetrations as indicated in Figure 4.6-2 below.

It should be noted that the thermocouple leads for TC #53 were inadvertently crossed. Omega Point Laboratory personnel identified this condition at approximately 2 hours into the fire endurance test. Upon correcting the wiring error, TC #53 began to record accurate data. Based on relatively low endpoint temperature for this thermocouple, and considering the temperature profile of the corresponding thermocouple for Penetration 11, there is no reason to believe that temperatures near the acceptance limits were approached at any time during this test at this location. Therefore, this error has no adverse impact on the validity of the test results.

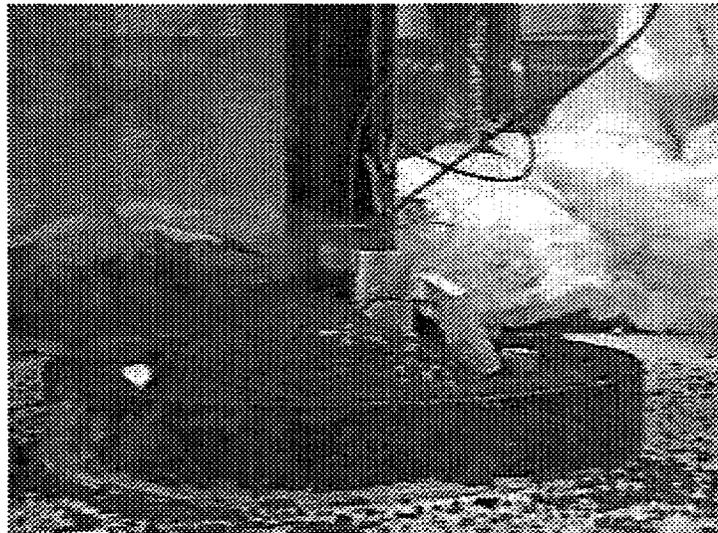
Approximately 2-hours into the fire endurance test, it became obvious that Penetration 9 was going to fail due to passage of flame. The unexposed side of the seal had formed an inverted cone extending several inches above the original seal surface on the pipe (see photograph below).

**Penetration 9  
(Unexposed Side At ~2 Hours)**

At 2-hours and 17-minutes the temperature monitored on the pipe exceeded the 680°F acceptance limit. Cracks had developed on the surface of the seal material, and an orange glow could be seen illuminating from the cracks. A few minutes later (approximately 2-hours and 20-minutes into the test), intermittent flaming occurred along the cracks in the seal surface. Penetration 9 was declared a failure. Fire resistant ceramic blanket material was placed over Penetration 9 to allow the fire test to continue.

There were essentially two failure modes associated with Penetrations 9 and 12. First, the penetrating pipes exceeded the limiting endpoint temperature of 680°F at 2:13 (hr:min) for Penetration 12 and 2:17 (hr:min) for Penetration 9. The second failure mode associated with Penetrations 9 and 12 was the flaming which occurred on the unexposed side of the penetrations (~2:20 for Penetration 9 and ~2:30 for Penetration 12). The failure of these penetrations is attributed to two conditions; 1) the presence of seal material inside a sleeve extension immersed in the furnace, and 2) the fact that the fire test was conducted at positive pressure.

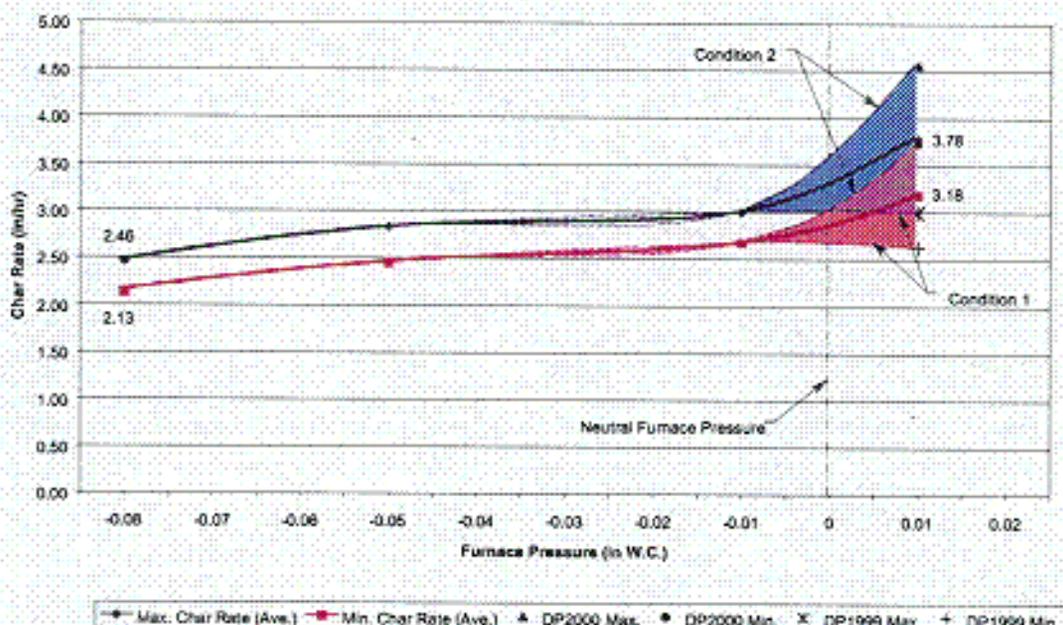
Figure 5.3-4  
Char Rate vs. Furnace Pressure

Figure 5.3-4 depicts the relationship between silicone foam char rate and furnace pressure using minimum and maximum char rate profiles developed by normalizing the data from Table 5.3-3.

From Figure 5.3-4 it is apparent that the rate at which silicone foam chars increases as furnace pressure increases. Because a majority of test data available within the industry was conducted in negative furnace pressure environments, the graph is clearly defined to the left of the neutral furnace pressure plane. However, only the Duke Power fire tests from 1999 and 2000 provide data points from tests exposed to positive furnace pressure environments, and each of these tests contained an anomaly. Therefore, the graph to the right of the neutral furnace pressure plane requires further explanation.

The Figure 5.3-4 lines associated with *Condition 1* represent the minimum and maximum char rate profiles if the data from the March 1999 Duke Power test is used. Char rate profiles following Condition 1 lines are known to be lower than actual char rates based on the fact that the 1999 Duke Power test was terminated at 2 hours and forty minutes. Actual char rates would be higher based on the intensity of an E-119 exposure during the final twenty minutes of a three-hour fire endurance test. Additionally, Penetration 6 from this test consisted of a 4" silicone foam build-out that overlapped the sleeve by a minimum of 4" in all directions on the exposed side of the test slab. This condition resulted in the steel sleeve being shielded from the furnace environment for a considerable portion of the fire endurance test, thereby slowing the silicone foam char rate. This condition was unlike any other configuration from the tests used to collect comparison data.

The Figure 5.3-4 lines associated with **Condition 2** represent the minimum and maximum char rate profiles if the data from the March 2000 Duke Power Test is used. Char rate profiles following Condition 2 are known to be higher than actual char rates based on the fact that a 2" portion of the seal was contained inside a 2" length of the steel sleeve that protruded into the furnace. This condition resulted in the initial 2" of the seal being subjected to the extreme furnace environment from essentially 5 sides as opposed to a seal within the plane of the test slab that is exposed to the furnace environment from 1 side only. Thereby accelerating the rate at which the initial 2" of the seal was consumed. Similar to Condition 1, this condition was unlike any other configuration from the test data used for comparison.

Ultimately, the portion of the Figure 5.3-4 graph to the right of the neutral furnace pressure plane was based on the mid-point between Condition 1 and Condition 2 data. Arbitrarily selecting the mid-point of each data set to complete the Figure 5.3-4 graphs only serves to show that char rates continue to increase as furnace pressure increases (at least through +.01" W.C.). The actual char rate profile would fall within the shaded areas of the graph. In fact, silicone foam char rates may actually increase dramatically when tested in a positive furnace pressure environment due to the positive furnace pressure continually fanning the char layer of the seal. The fanning phenomenon has been credited in recent testing of wooden fire doors as a probable factor in the failure of door assemblies tested at positive furnace pressure.
