June 30, 2000

SUBJECT: ASCO General Controls NH Series  
Hydramotor® Actuators

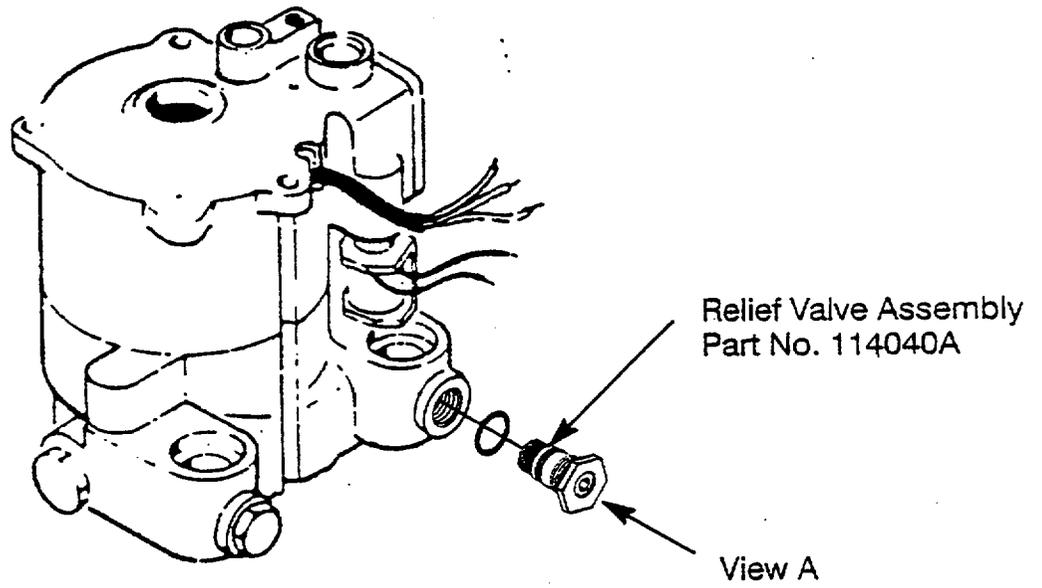
**View of NH90 Pump Assembly illustrating location of Relief Valve Assembly, 114040A**

Analysis of the returned units confirmed that the actuator was not maintaining the piston in the retracted position although the pump was running. Further analysis revealed that the adjustment screw in the relief valve assembly had backed out slightly, preventing the build-up of sufficient hydraulic pressure to overcome the piston spring force. Inspection of the relief valve revealed that the adjustment screw had not been staked. This staking operation is intended to prevent movement of the adjustment screw (see attached drawing). Although not documented on the relief valve assembly drawing, assemblers had been instructed to perform this operation on every relief valve. We have determined that this procedure was followed regularly by assembly personnel except for one assembler. All unstaked relief valves from on hand and distributor stock have been traced to this assembler. All records are being reviewed to identify product built by the assembler, so that customers can be notified. ASCO Engineering and QA have immediately initiated changes to assembly procedures to insure that all critical steps including the staking operation are documented and verified.

Location of stake in vicinity  
of threaded area between  
adjustment screw and re-  
lief valve body.

Our investigation of this problem is continuing. ASCO plans to send a similar notification to affected customers delineating the potential problem with these relief valves by July 7<sup>th</sup>. This notification will list all potentially affected product. Within two weeks of this interim notice, ASCO will provide individual purchasers with information (customer PO, quantity, product number, etc.) so that affected product can be identified. The notification will also include options to inspect for and correct the relief valve problem or offer assistance as necessary.
