LA-13638

# A Review of Criticality Accidents

2000 Revision

**Issued: May 2000**

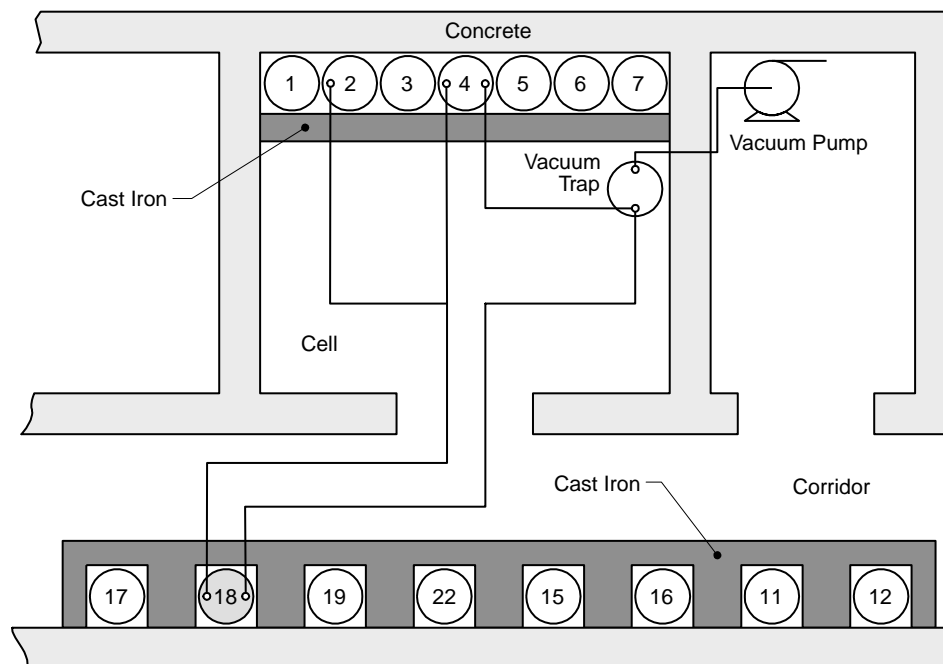
Figure 6. Layout of vessels and equipment in the staging area.

The staging area contained 15 identical short right circular cylindrical stainless steel vessels, each with a unique identification number. The vessels were 400 mm in diameter and 320 mm high with the cylindrical axis oriented vertically. The staging area was not equipped with radiation monitoring instruments. Criticality control was implemented by a 500 gram plutonium mass limit per vessel. Criticality

On Sunday, 15 March 1953, the written instructions alerted shift personnel that two transfers of plutonium solution were scheduled to arrive at the vessels in the concrete cell. Table 1 shows the contents of the seven vessels as recorded in the operational log before the accident. It should be noted that in violation of procedures, vessels 2 and 4 were in use, and the 500 gram mass limit was being ignored. A plan was prepared to receive the first transfer of plutonium solution. The plan specified that the contents of vessels 2 and 4 were to be transferred to vessel 18, which was located in the second array. The operational log showed vessel 18 was empty. Based on the values in Table 1 and the assumption that vessel 18 was empty, this transfer would result in vessel 18 having the solution volume and plutonium mass given in Table 2.

As part of the investigation, both experiments and calculations were performed to estimate the conditions for criticality in vessel 18. The results determined that 30 ℓ of solution containing 825 g of plutonium (27.5 g/ℓ) would be required for criticality. These values agree closely with the best estimate of the contents of vessel 18 at the time of the accident, 31 ℓ of solution with  $848 \pm 45$  g of plutonium (27.4 g/ℓ). One contributing cause of the accident was the unrecorded transfer of 5 ℓ of solution from vessel 1 to vessel 18.

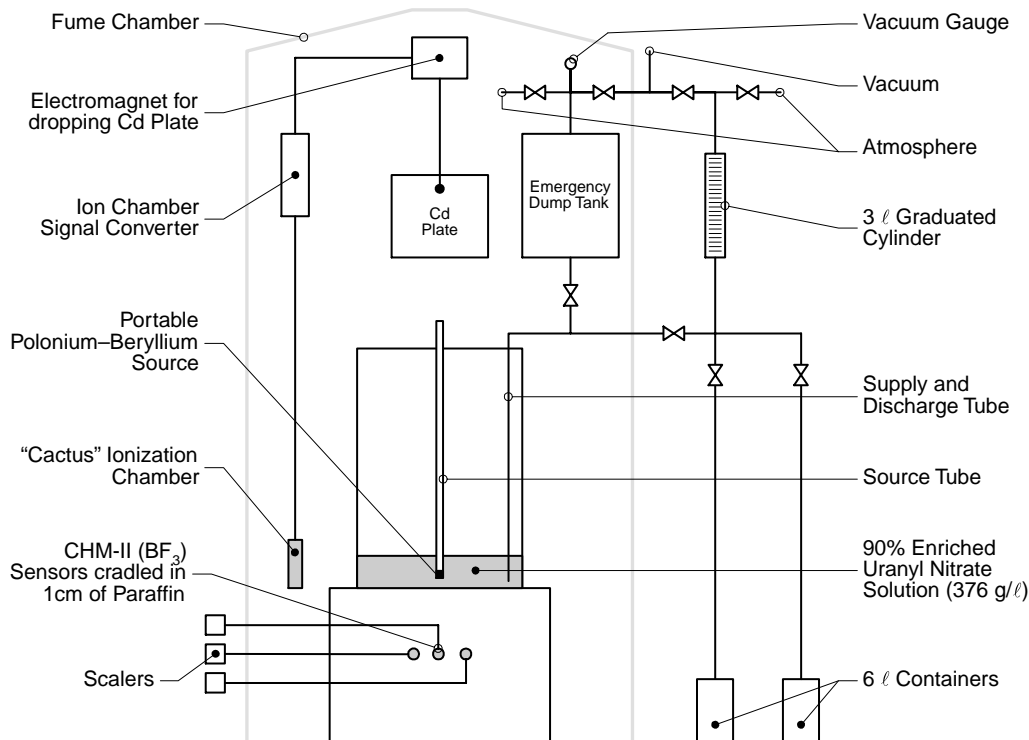
Figure 8. Layout of the experimental equipment.

The experiment vessel was bolted to a stand and sat atop an 8 mm thick steel support plate approximately

They immediately noticed a flash (due to Cherenkov radiation), and simultaneously, fissile solution was violently ejected, reaching the ceiling about 5 m above. The three experimenters dropped the vessel and, along with a fourth experimenter who was located about 2.5 m away from the excursion, went immediately to the change room, showered, and were transported to the hospital. The combination of additional reflection from the three experimenters and the change in the geometry of the solution volume was sufficient to cause the system to exceed prompt critical. The small neutron background, estimated at only 100 neutrons per second, apparently also contributed to delayed initiation and thus to increased excursion energetics.

- Violation of the procedure that stipulated the complete draining of the experiment solution into 6 liter bottles.
- Unbolting and removing the experiment vessel when it contained solution. This was not specifically permitted in the operating procedure.

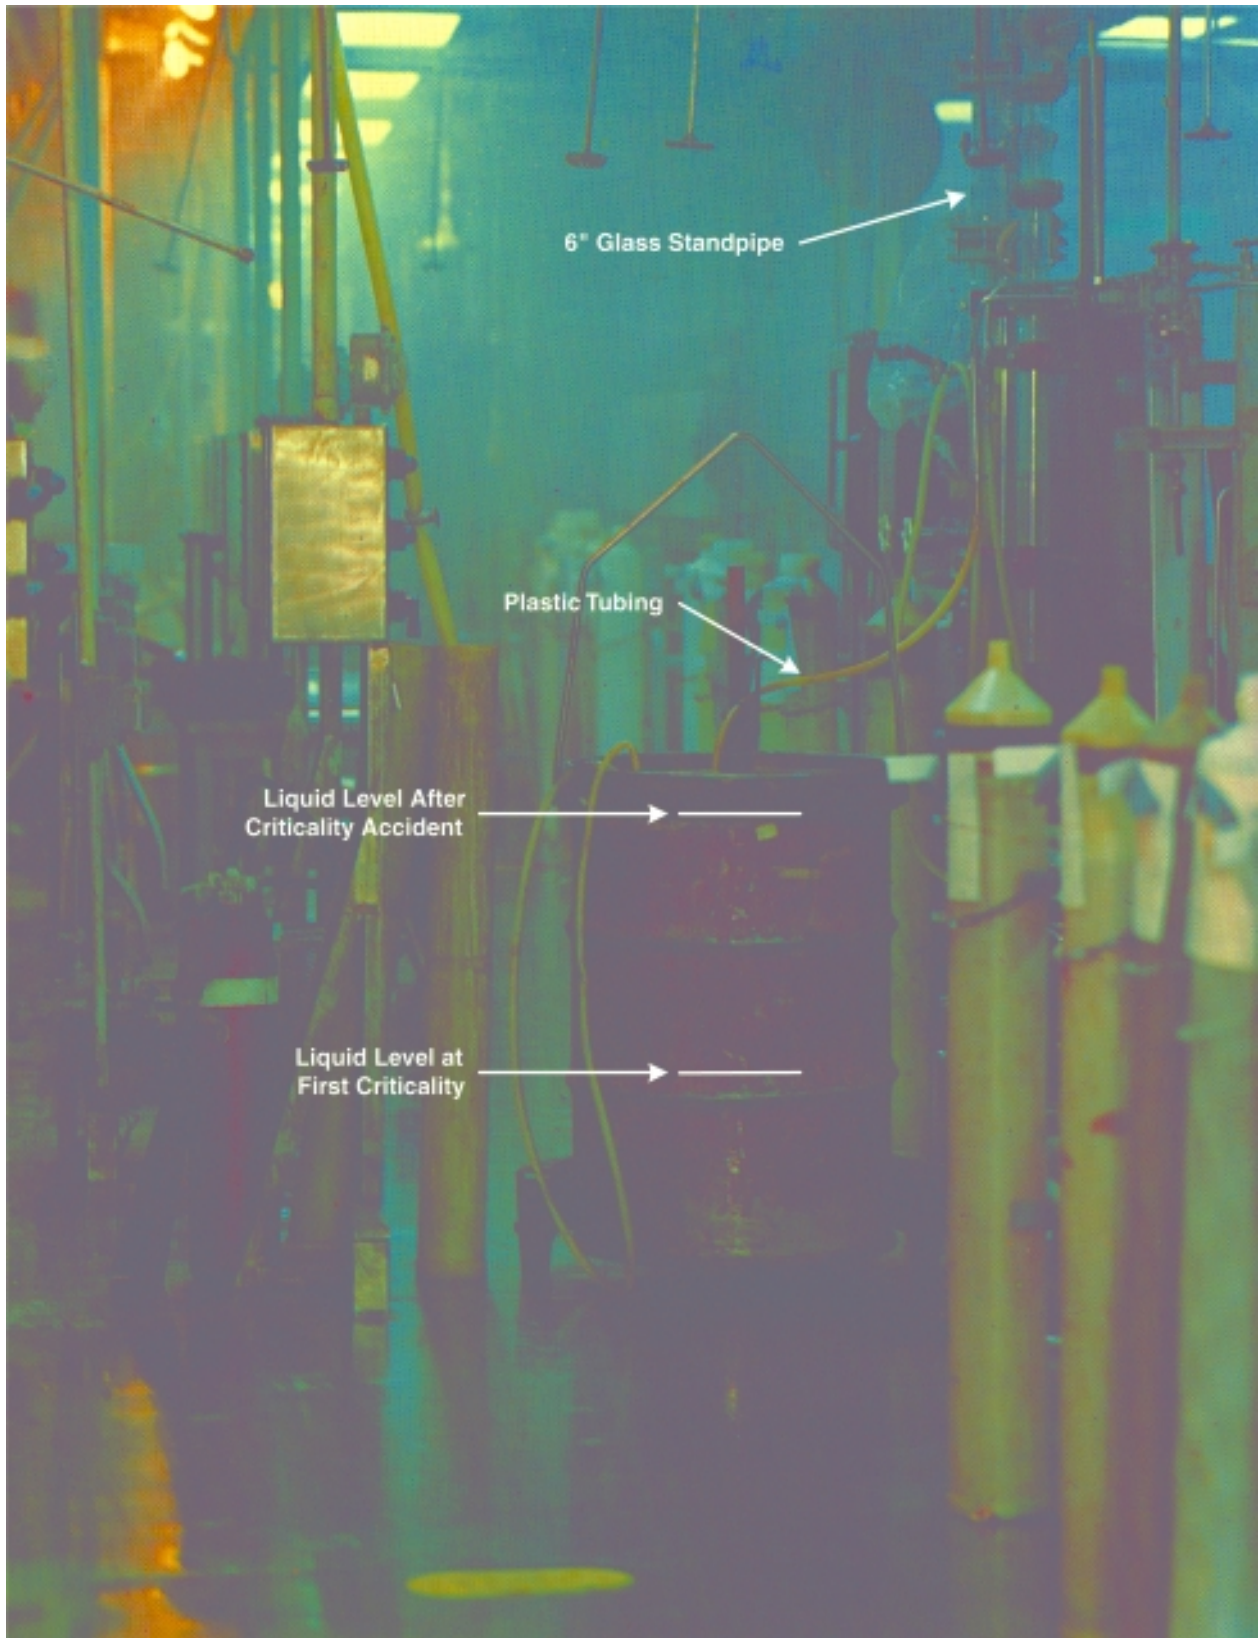
Figure 10. Drum in which the 1958 Y-12 process criticality accident occurred.

At ~01:00 during the shift preceding the accident (23:00 Sunday, 15 June, to 07:00 Monday, 16 June), the C-1 Wing supervisor noted that uranyl nitrate solution was present in a 6 inch (152 mm) diameter glass standpipe that was part of the pH adjustment station (Figure 9). He instructed an operator to drain the standpipe. At 05:00, the supervisor again noted uranyl nitrate in the standpipe and questioned the operator as to whether it had been drained earlier. The operator confirmed that it had been, and upon further

Unknown to anyone at the time, uranyl nitrate had been leaking from the B-1 Wing through valve V-1 from the early hours of the previous shift until about 13:30, when one of the operators checked it (and by applying pressure completely closed the valve), as instructed by the supervisor. Before this, the uranyl nitrate had been collecting in vessel FSTK 1-2, because valve V-3 had also been open.

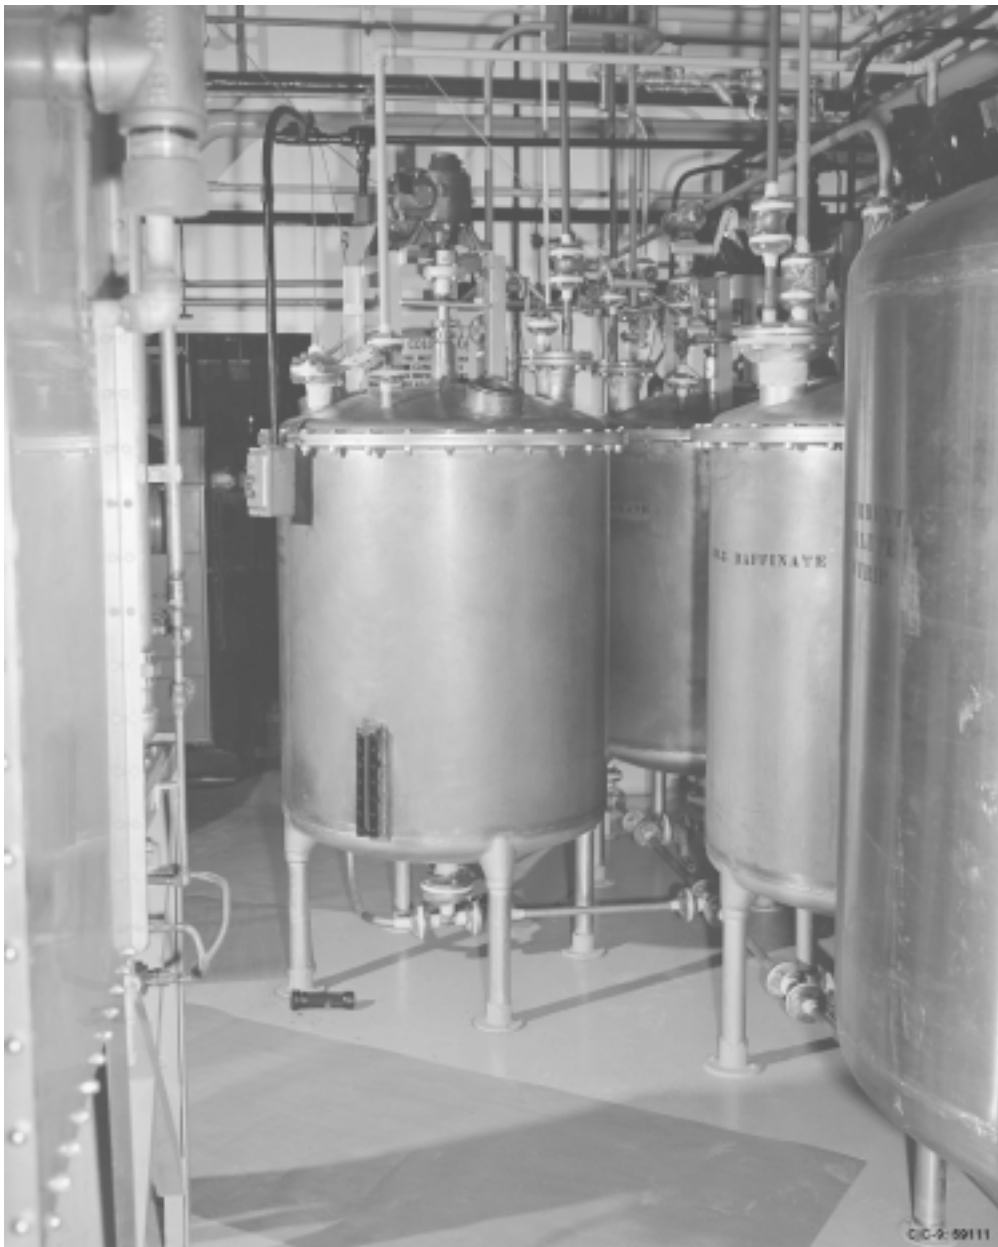
Figure 12. Vessel in which the 1958 Los Alamos process criticality accident occurred.

The accident resulted in the death, 36 hours later, of the operator who was looking into a sight glass when the motor was turned on. The dose to his upper torso was estimated to have been  $12,000 \pm 50\%$  rem. Two other persons apparently suffered no ill effects after receiving radiation doses of 134 and 53 rem. No equipment was contaminated or damaged even though the shock associated with off-axis bubble generation displaced the tank about 10 mm at its supports.

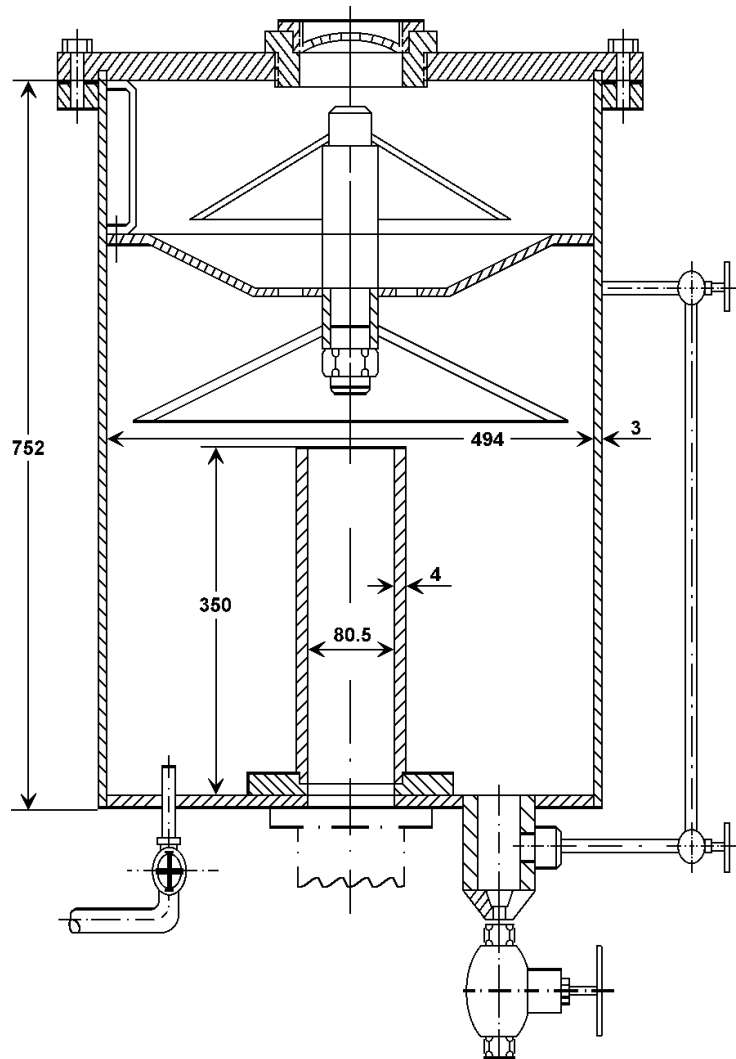
Figure 16. Oil reservoir (Dimensions are in mm).

When the pump was turned on at 07:30, the oil in the pump's cavities was forced out into the central pipe of the oil reservoir. This sudden injection of oil containing uranium led to the second and much larger excursion. The shutdown of this excursion was due to a combination of temperature rise and radiolytic gas generation, which caused ejection of the oil from this central pipe back into the pump's cavities and the gas purification equipment. As with the first excursion, the

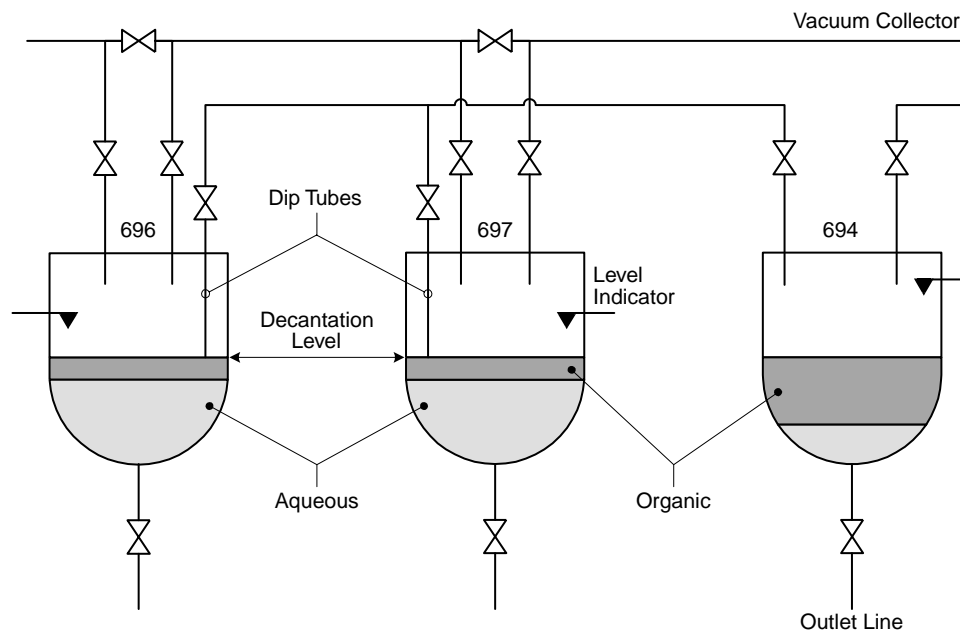
Figure 19. Schematic of vessels showing organic and aqueous solutions (not intended to imply the exact conditions at the time of the accident).

During typical operations, sufficient quantities of aqueous solutions would accumulate in vessels 696 and 697, causing the automatic decanting to occur up to four times per day. The elevation difference between the level indicator and the dip tube was slight, thus causing only 1 or 2 ℓ to be transferred at a time.

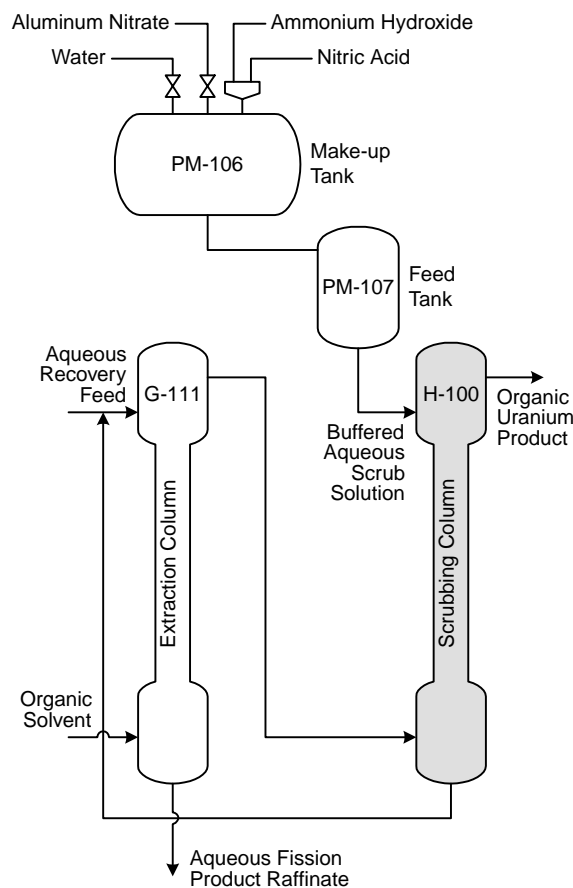
for the scrubbing column, H-100, had been leaking for about a month prior to the accident. Over time, this leak caused a dilution of the feed solution from 0.75 M to 0.08 M. The 13,400 ℓ make-up tank was equipped with a density alarm that would have indicated the discrepancy, but the alarm was inoperable. A density alarm was scheduled to be installed on the 3,000 ℓ process feed tank (PM-107) that was filled, as necessary, from the make-up tank, but this had not been done. The make-up tank was instrumented with a strip-chart recorder showing the solution level in the tank. However, the leak into the tank was so slow that the change in level would have not have been discernible unless several days worth of the chart was analyzed. To complicate matters, the chart recorder had run out of paper on 29 September and it was not replaced until after the accident. Furthermore, procedures that required the taking of samples from the feed tank, PM-107, to confirm the density, were not being followed.

Figure 27. First cycle extraction line equipment. The accident occurred in the lower disengagement section of the H-100 column.

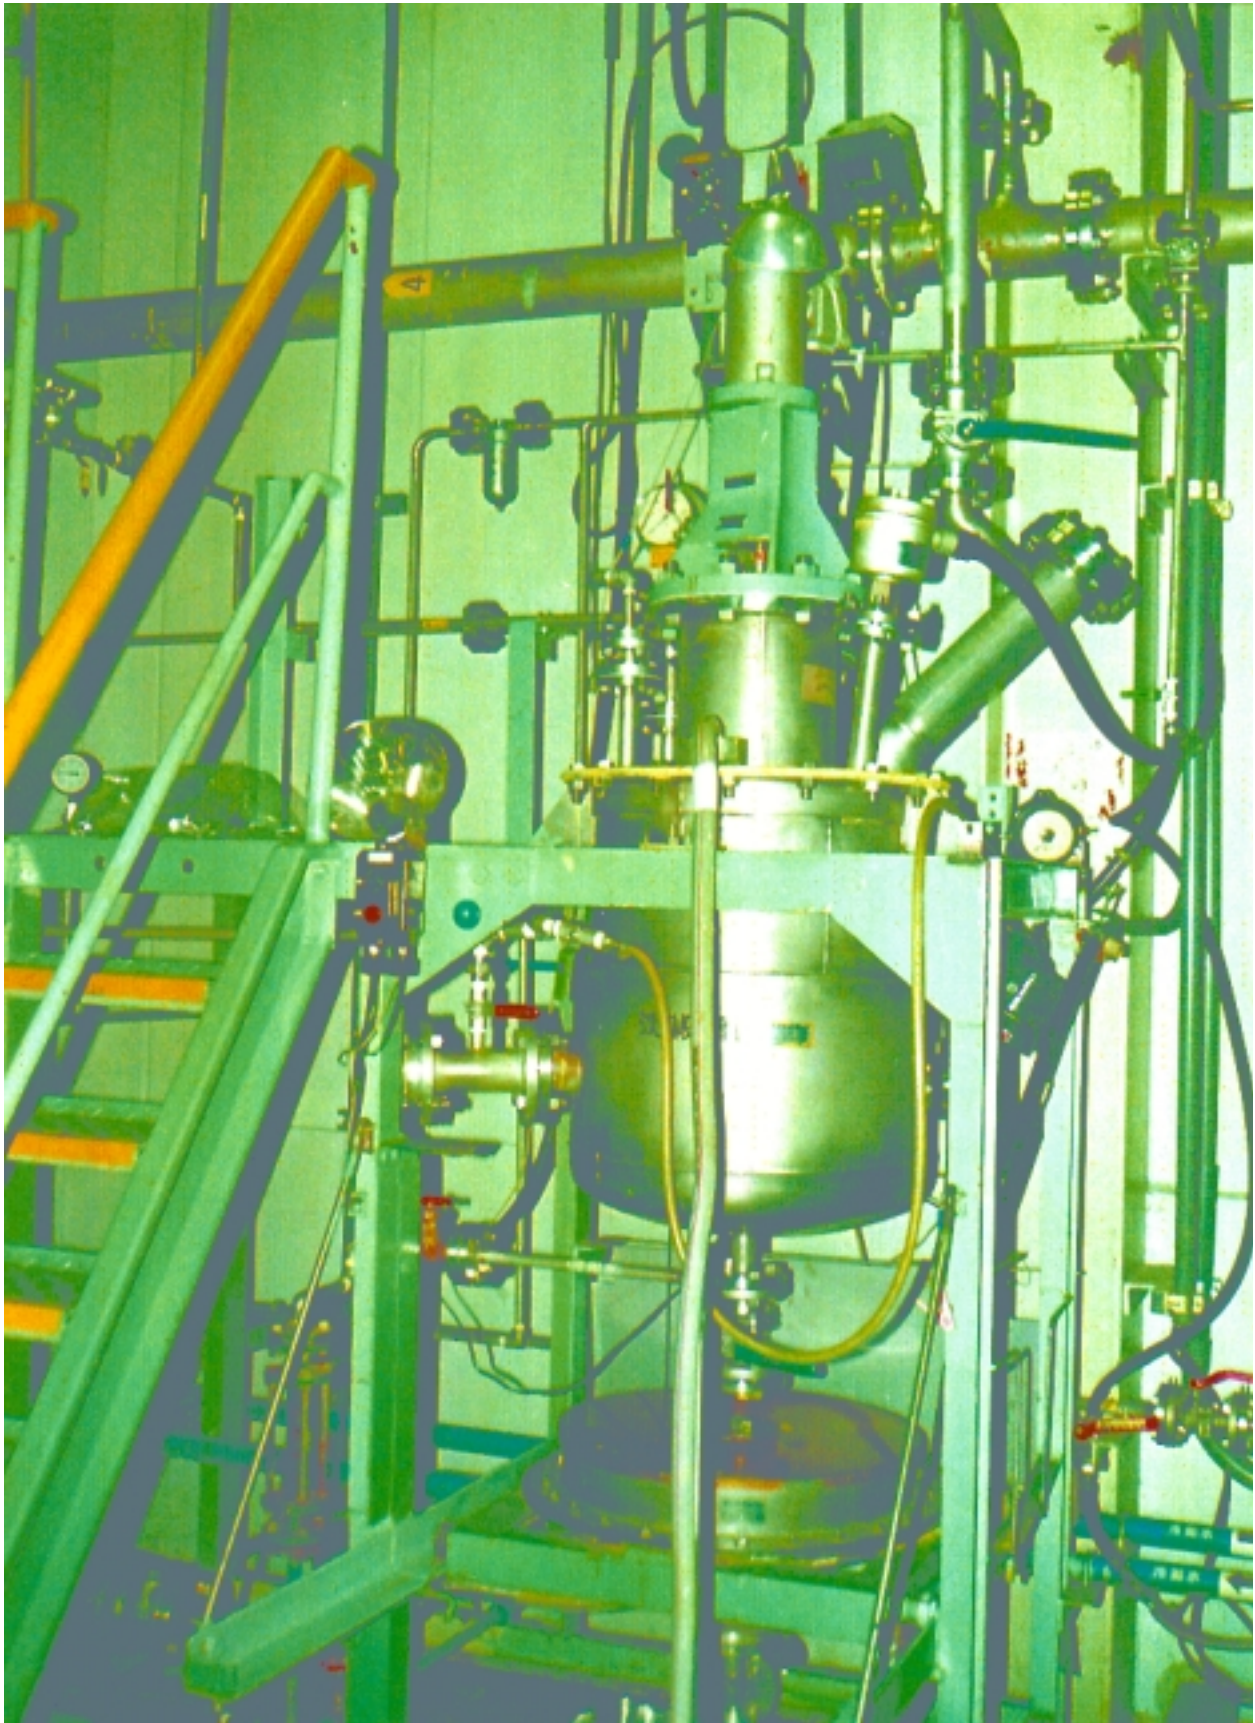
Figure 35. The precipitation vessel in which the process criticality accident occurred.

About 4.5 hours after the start of the accident, radiation readings taken at the site boundary nearest to a residential house and a commercial establishment showed combined neutron and gamma ray dose rates of about 5 mSv/hour. At this time the Mayor of Tokaimura recommended that residents living within a 350 m radius of the JCO plant evacuate to more remote locations. After 12 hours, local, Ibaraki-ken, govern-

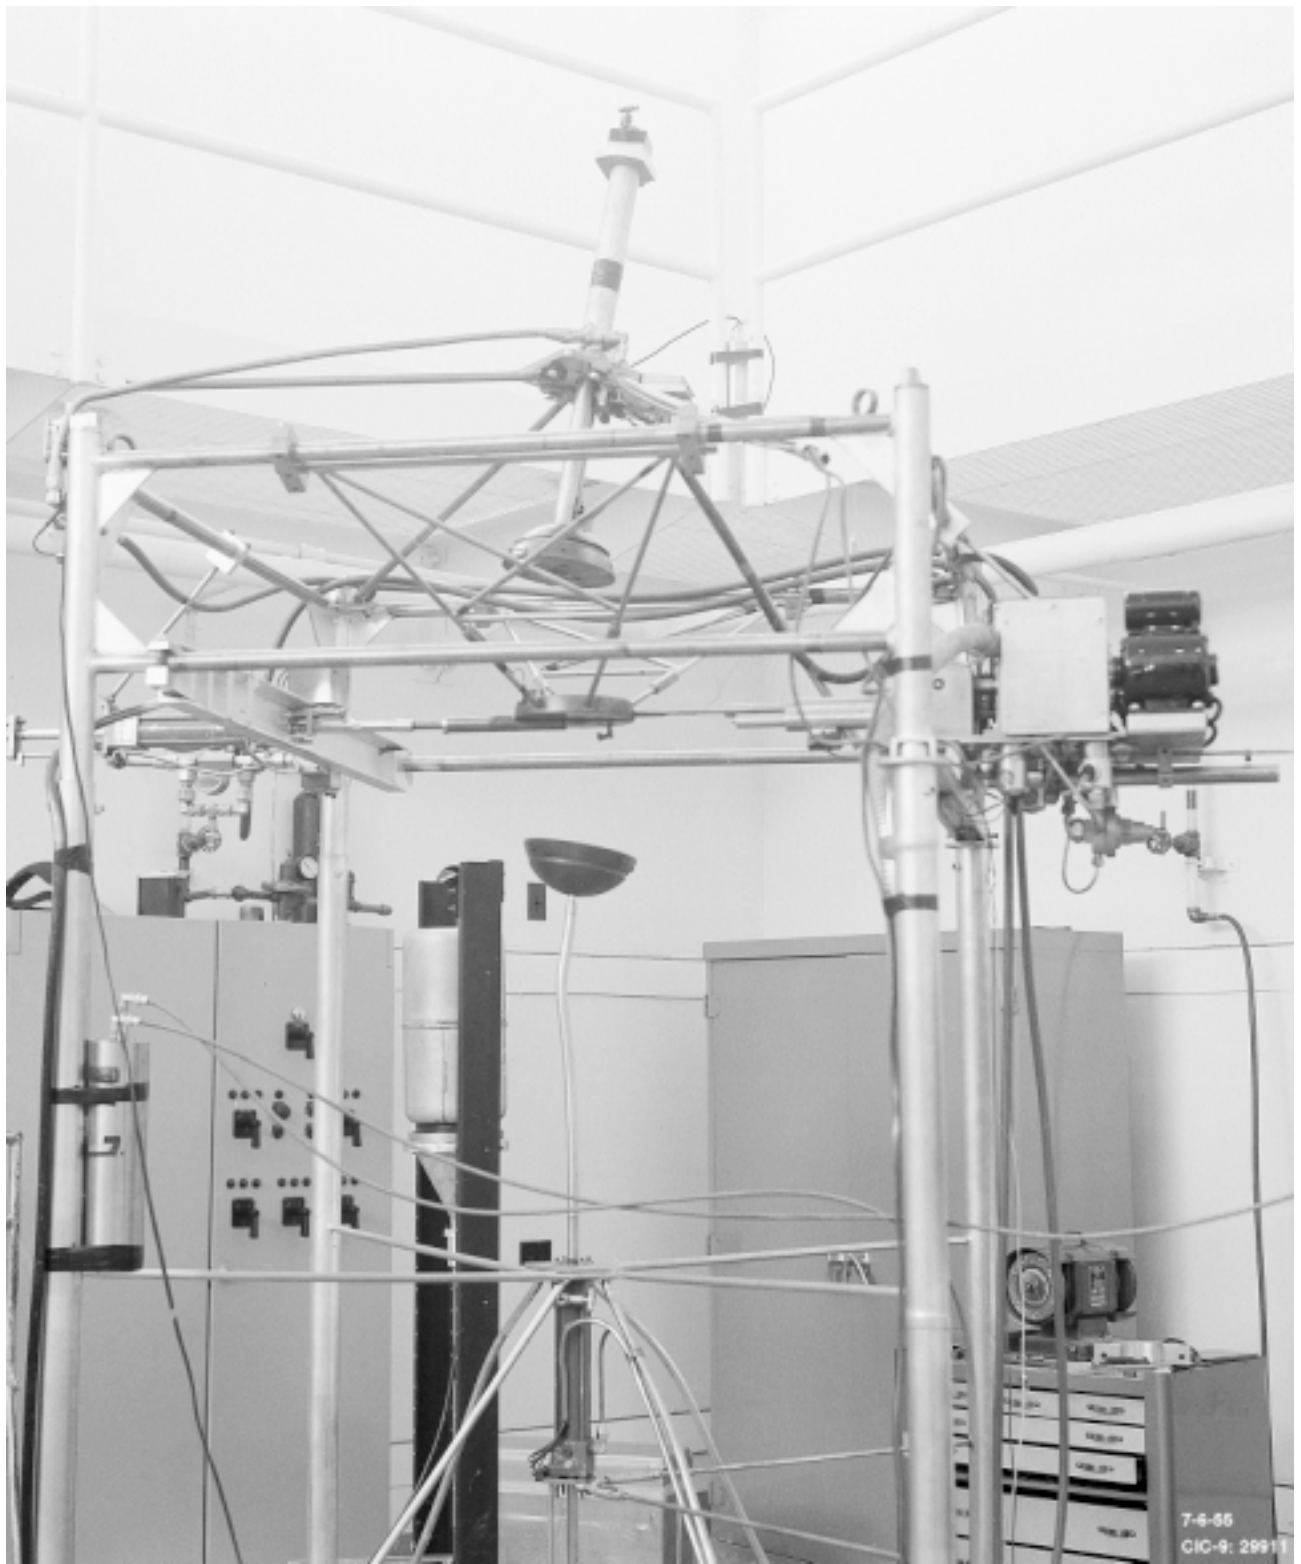
Figure 49. Lady Godiva after the excursion of 3 February 1954.

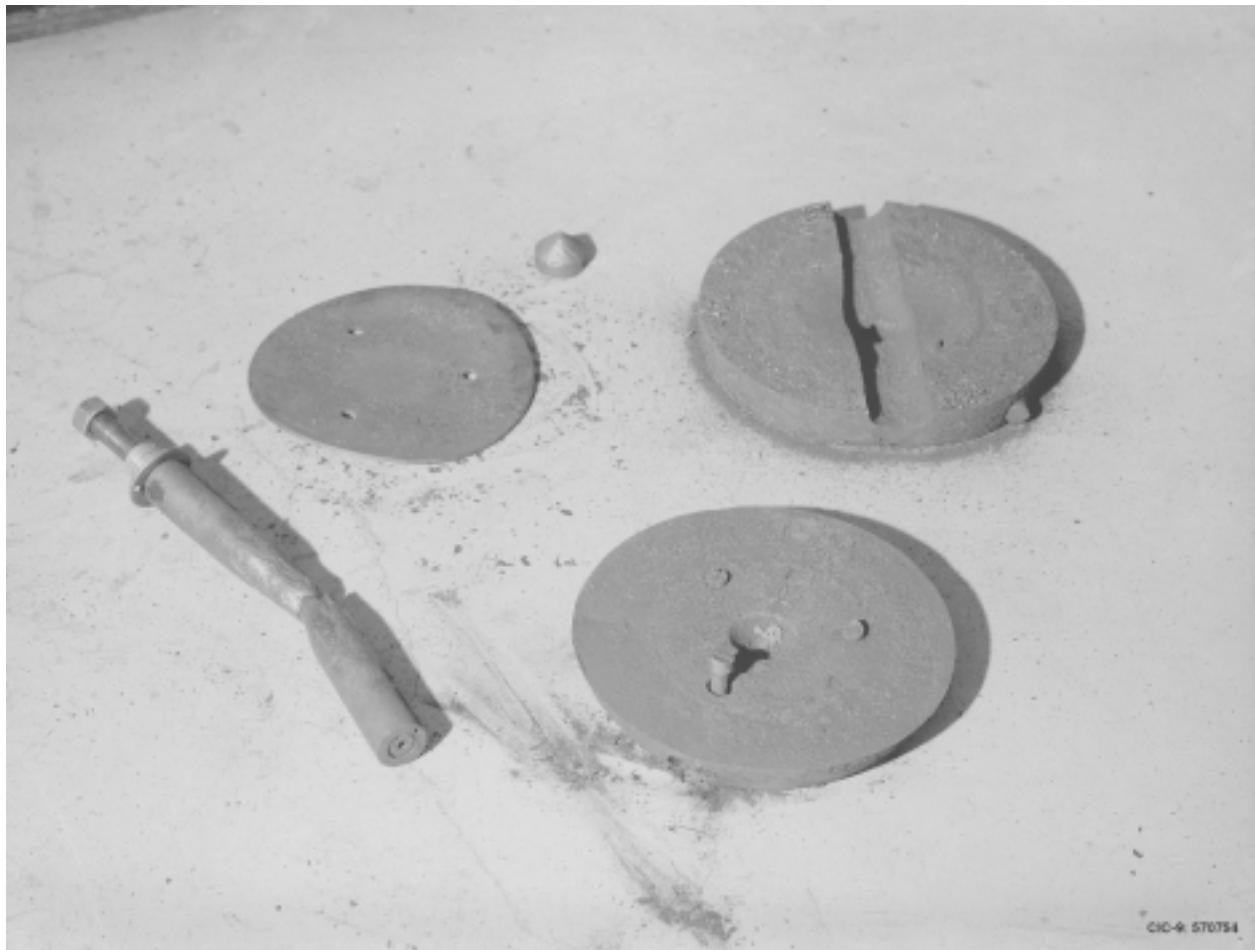
Figure 50. Burst rod and several sections of Lady Godiva showing oxidation and warpage that accompanied the second accident, 12 February 1957.

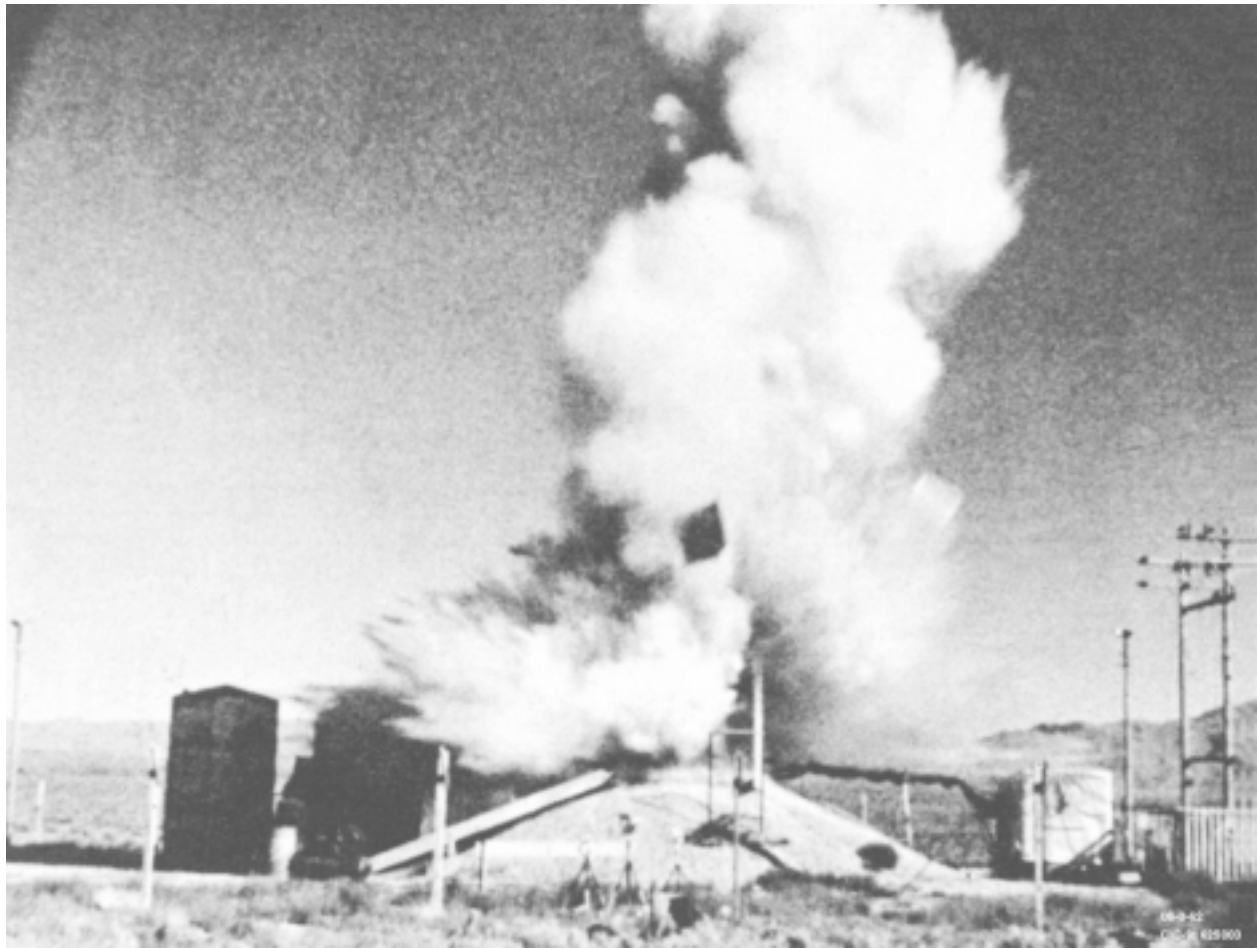
Figure 59. The destructive excursion in BORAX, 22 July 1954.
