Subject: Arkansas Nuclear One - Unit 2
Docket No. 50-368
License No. NPF-6
2P00 Steam Generator Tube Inspection

2P00 STEAM GENERATOR TUBE INSPECTION

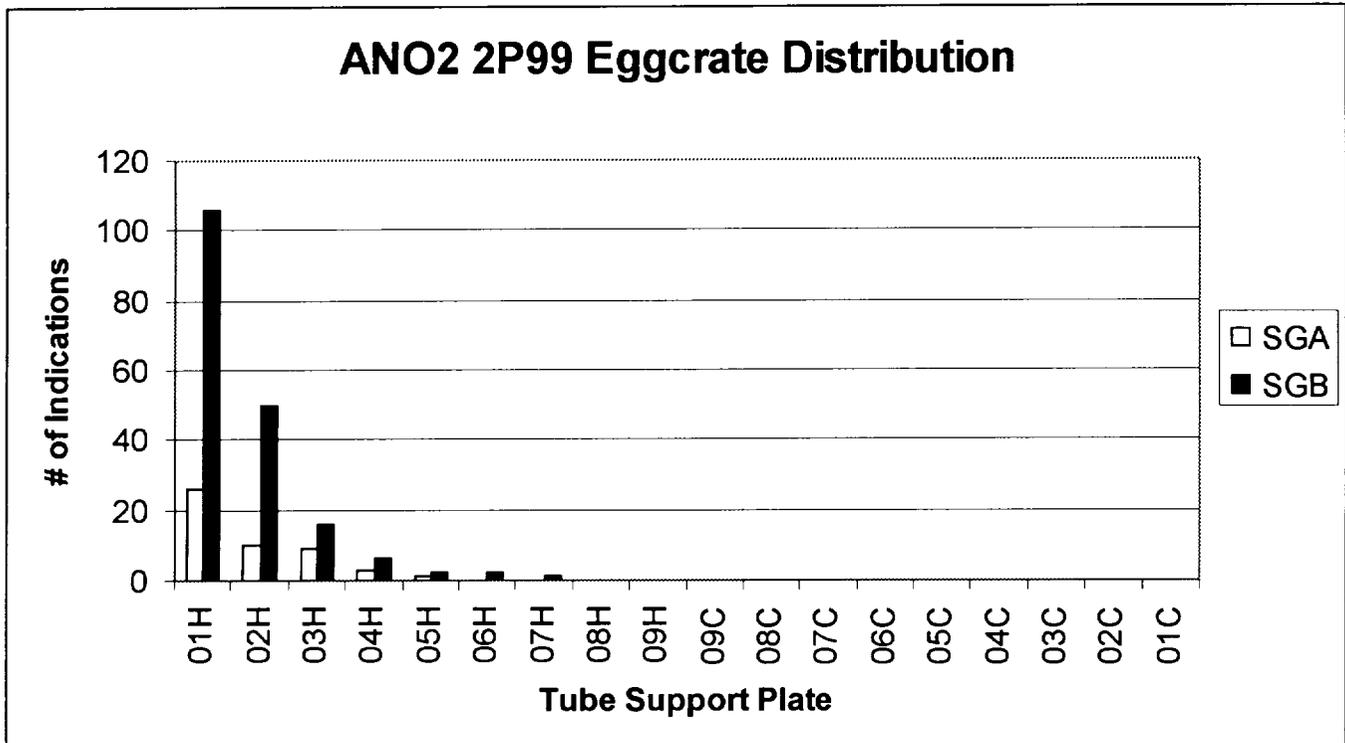
Figure 1

A review was performed to identify the locations of the indications detected in the previous inspection (2P99). As shown in Figure 1, the majority of the indications at the TSPs have been found in the lower sections of the hot leg side of the SG. This is due to the higher temperature effect on the flaw initiation and growth rate. The 2P99 inspection results are consistent with those of previous inspections. Because the lower hot leg tube sections have had the majority of axial indications, as well as the largest indications, these areas are of primary interest for the mid-cycle inspection.

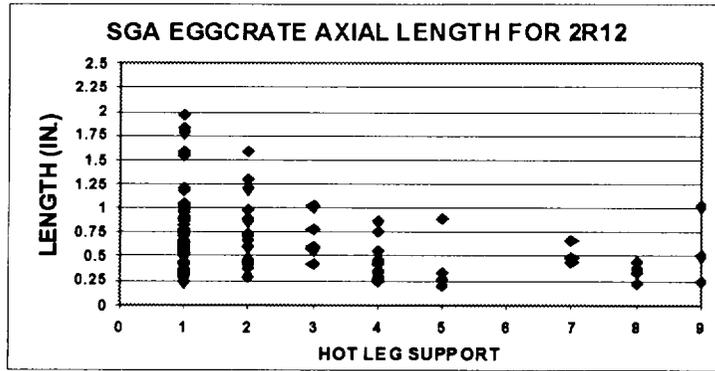
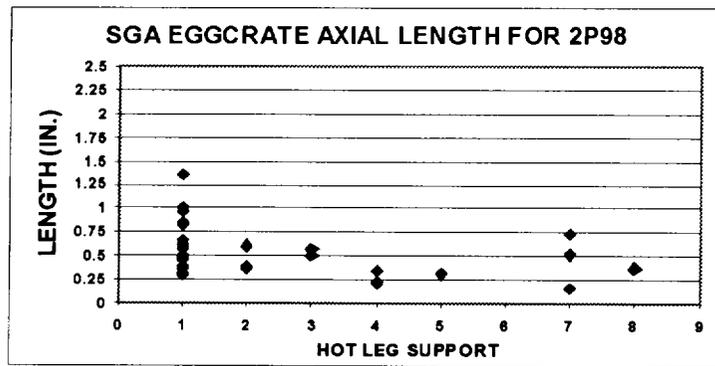
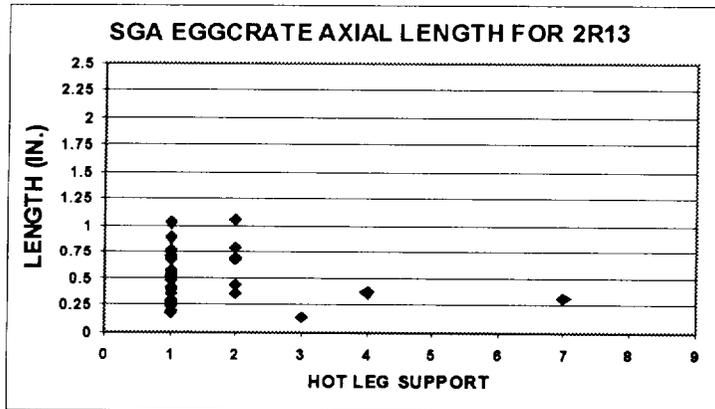
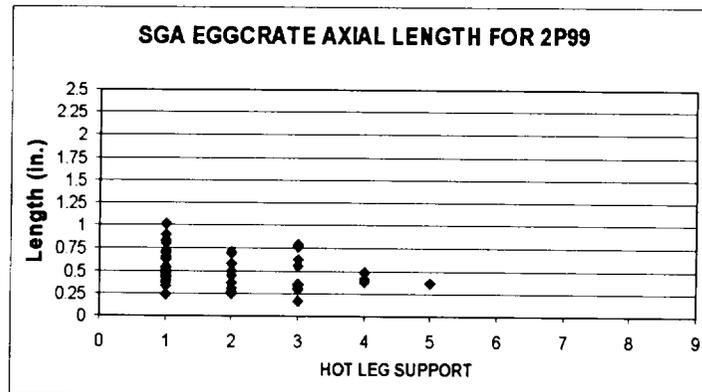
FIGURE 2: "A" SG COMPARISON

Figures 2 and 3 depict the relative lengths of the axial indications at the hot leg support plates by SG. The values are plotted as length in inches for each support plate. The outages are in chronological order from top to bottom. As shown, the number of indications decrease with higher elevation. The lengths of the flaws generally decrease as distance from the tubesheet increases. This condition is consistent with the decreasing

operating temperatures higher in the tube bundle. The largest flaws each inspection have consistently been observed at the 01Hot and 02Hot support plate. It is also noted that during the first outage trended (2R12), the number of indications and lengths appear to be much higher than the other outages. This occurred because 2R12 was the first outage that a larger diameter bobbin coil was used in conjunction with a change in philosophy related to repair on detection. Prior to 2R12, axial flaws in the eggcrates were sized by bobbin and left in service if determined to be less than 40 percent through wall (TW). Several indications identified for repair during 2R12 had been in service for several outages. All indications identified during 2R12 were repaired by mechanical plugging regardless of depth.
