H. B. ROBINSON STEAM ELECTRIC PLANT, UNIT NO. 2
DOCKET NO. 50-261/LICENSE NO. DPR-23

LICENSEE EVENT REPORT NO. 2000-001-00
MANUAL REACTOR TRIP DUE TO TURBINE
ELECTRO-HYDRAULIC CONTROL TUBING FAILURE

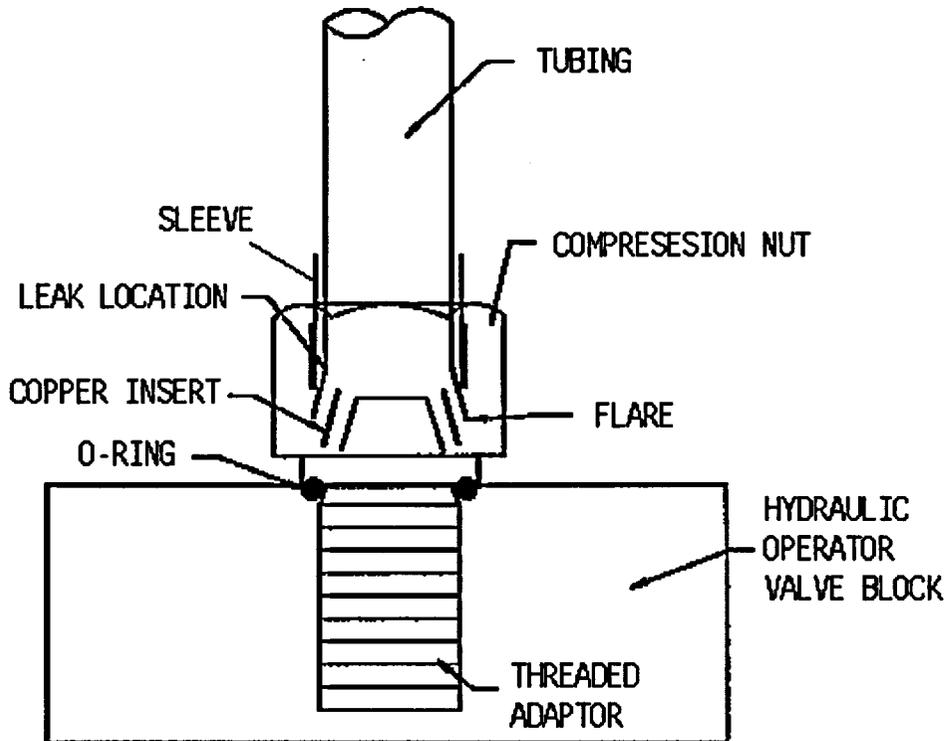
FIGURE 1: PARKER-HANNIFIN
TRIPLE-LOK 37° FLARED TUBE FITTING
WITH COPPER INSERT

Investigation of the leak revealed a circumferentially oriented crack in the EH fluid tubing [TBG] (extending approximately 2/3 of the tubing circumference) at the EH system supply line connection to the hydraulic actuator for the Moisture Separator Reheater 2A Reheat Intercept Valve [V]. The failed section of tubing [TBG] was repaired prior to restart of the unit. Figure 1 shows a diagram of the tubing connection and the approximate location of the tubing leak. An investigation to determine the cause of the tubing failure was initiated on June 21, 2000. Metallurgical examination of the failure was conducted to assist the investigation. The investigation and metallurgical examination discovered evidence of both corrosion and vibration and that a material defect in the tubing was present at the failure location. The investigation also discovered that two copper inserts had been inadvertently installed in the fitting where only one is expected. The investigation concluded that the extra copper insert did not significantly contribute to this tubing failure.

This event was caused by a failure of the Main Turbine System [TA] EH System tubing [TBG]. An investigation of the cause of the tubing [TBG] failure concluded that the failure was caused by corrosion fatigue initiated at a defect on the outer diameter surface of the tube. There were no operator errors or procedural deficiencies that contributed to the event.

The investigation also revealed that approximately two weeks prior to the event, this section of tubing was observed to be vibrating more than other sections, when the insulation on this tubing was removed. The additional vibration was attributed to inadequate support for this tubing.

The broken EH system fluid line was repaired and the other two lines on this valve were disconnected and inspected, including a liquid penetrant test. The EH system fluid supply lines for the other three intercept valves were also disconnected and inspected, including a liquid-penetrant test. There were no additional problems found. An engineering walk-down of the EH system was performed. The tubing support for the tubing that failed was modified to reduce vibration.

The vertical orientation of the failed tubing may have allowed precipitation to collect on the lower fitting of the tube, potentially concentrating corrosive materials in that tube fitting. Therefore, the susceptible fittings on vertically oriented EH system tubing will be protected from precipitation by September 11, 2000. This should reduce the potential for corrosion at similar locations in the future.

Improved fittings will be installed on the 14 Main Steam System [SB] and Main Turbine System [TA] valves operated using the EH system. Flexible tubing will be installed in appropriate portions of the EH system, as determined by an engineering evaluation, to reduce the fatigue stresses on EH system tubing. These actions will be completed prior to the end of the next refueling outage (Refueling Outage 20, currently scheduled for the spring of 2001).
