LaSalle County Station, Unit 2
Facility Operating License No. NPF-18
NRC Docket No. 50-374

Subject: Licensee Event Report

TITLE (4) Scram on Low Reactor Water Level Due to Loss of 2A Turbine Driven Reactor Feed Pump Flow

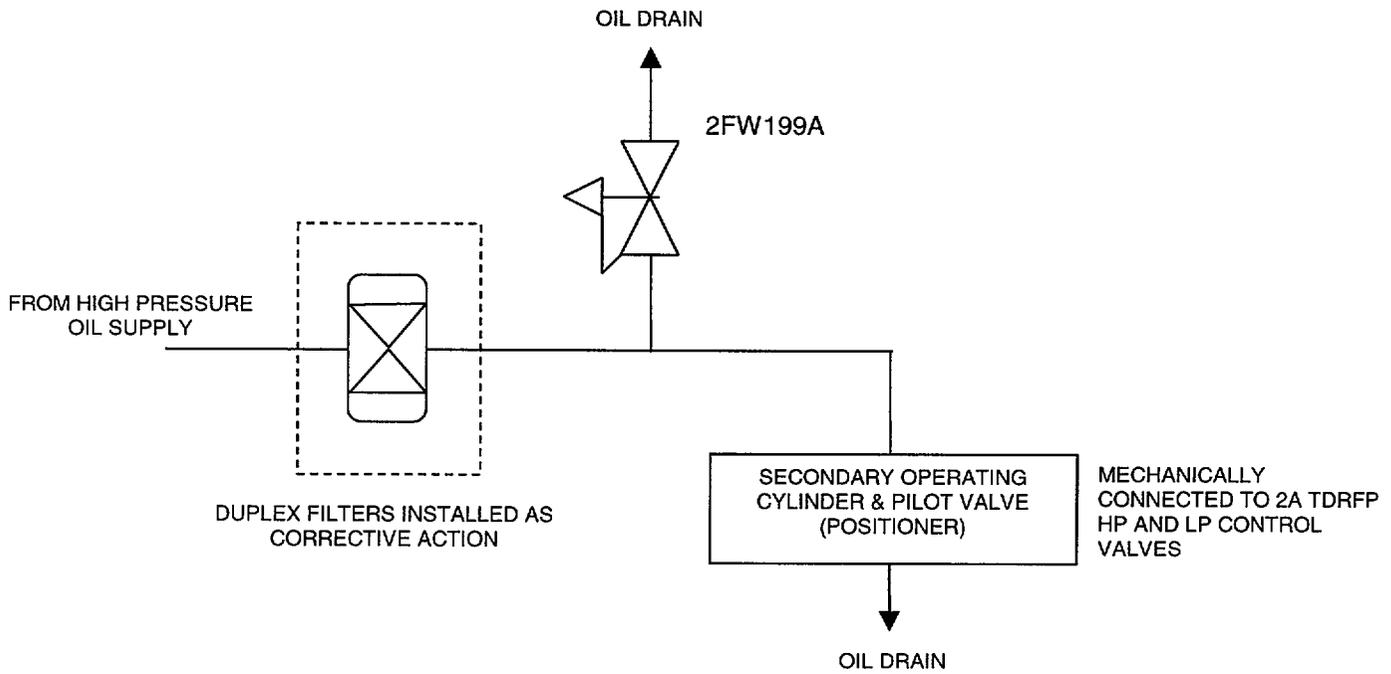
Figure 1

The root cause of the event was the intrusion of wear products into the high pressure control oil pressure regulating relief valve (2FW199A) that were in excess of the valve's tolerances. The wear products became lodged between the valve seat and disk, allowing the high pressure control oil supply to drain. With an inadequate oil supply to the secondary operating cylinder of the 2A TDRFP control valve, the valve closed, resulting in the 2A TDRFP ramping down in speed (see Figure 1).

Wear products of sufficient size were found in the control oil system, although none was found on the seating surface of the 2FW199A valve. It is suspected that the material was flushed out of the valve during the transient.

The corrective action was to install in-line duplex filters on the 2A and 2B TDRFP high pressure control oil system supply lines. Filters for the high pressure control oil had been previously installed on Unit 1, but had not been installed on Unit 2.

In-line duplex filters were installed on the 2A and 2B TDRFP high pressure control oil system supply lines (Complete).
