**UNITED STATES
NUCLEAR REGULATORY COMMISSION
REGION IV
611 RYAN PLAZA DRIVE, SUITE 400
ARLINGTON, TEXAS 76011-8064**

SUBJECT: DIABLO CANYON INSPECTION REPORT NO. 50-275/00-09; 50-323/00-09

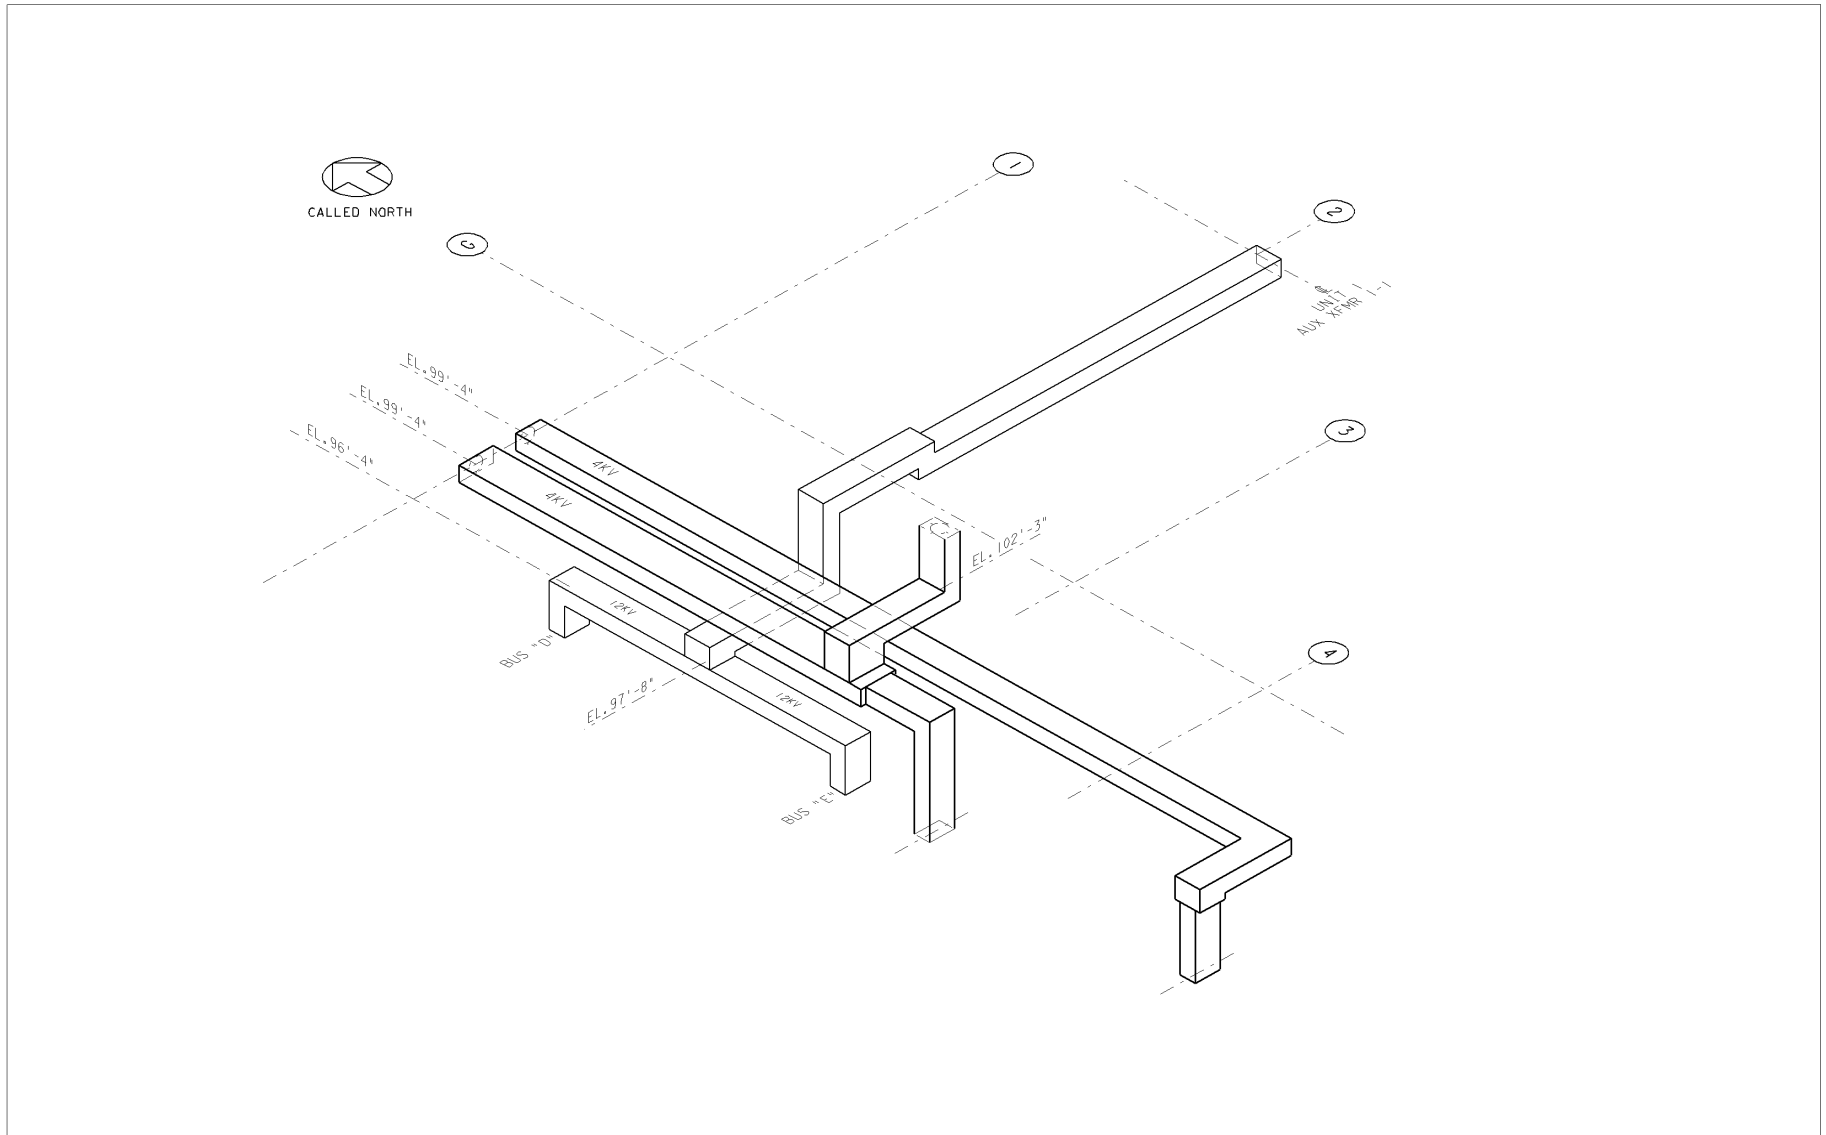
Attachment 8 - Switchgear Room Bus Duct Proximity

The licensee evaluated the extent of nonvital bus duct proximity to each other in each nonvital switchgear room. The licensee determined that for each nonvital 4 kV switchgear the bus ducts for auxiliary power and startup power remained in close proximity for extended stretches. The inspectors noted that a fault on a startup bus duct would be limited and likely result in little damage because of the presence of breakers to interrupt the current flow. However, the inspectors noted that a fault in the 4 kV auxiliary bus duct had no similar breakers to quickly sense and interrupt the fault and would likely affect the adjacent startup bus duct.

The licensee indicated that their approach to prevent a similar exposure of a failure in one nonvital bus duct from affecting an alternate nonvital bus duct would be to ensure preventive maintenance activities were implemented to prevent overheating of the bus duct.
