Re: Turkey Point Units 3 & 4
Docket Nos. 50-250 & 50-251
Reportable Event: 2000-002-00
Date of Event: July 21, 2000
Entry into Technical Specification LCO 3.0.3 While Performing Load
Center Undervoltage Relay Surveillance

LICENSEE EVENT REPORT (LER)

TITLE (4)
Entry into Technical Specification LCO 3.0.3 While Performing Load Center Undervoltage Relay Surveillance

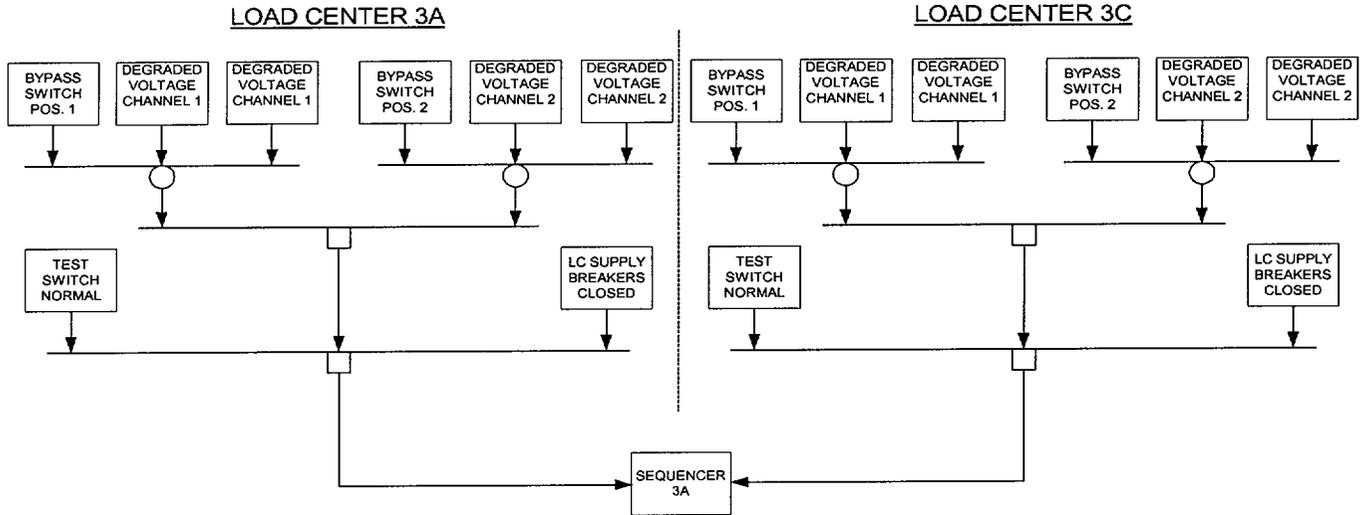
Degraded Voltage - Non-SI Situation

The non-SI scheme has four voltage sensing relays on each load center. Channel 1 utilizes one 327I and one 327T relay; channel 2 does the same. The relays are interconnected in a "one out of two taken twice" channel trip logic such that the logic trips (initiates bus stripping) if degraded voltage is detected by either channel 1 relay (327I or 327T) concurrently with either channel 2 relay (327I or 327T). The 327I relay protects the system from degraded voltage over a long duration while the 327T relay protects the system during a large voltage transient for a short duration.

A five position test switch (with positions labeled 12, 11, Normal, 21 and 22) enables the operator to test either relay on either channel. Placing the test switch in any position other than Normal will block the trip signal from its associated load center.

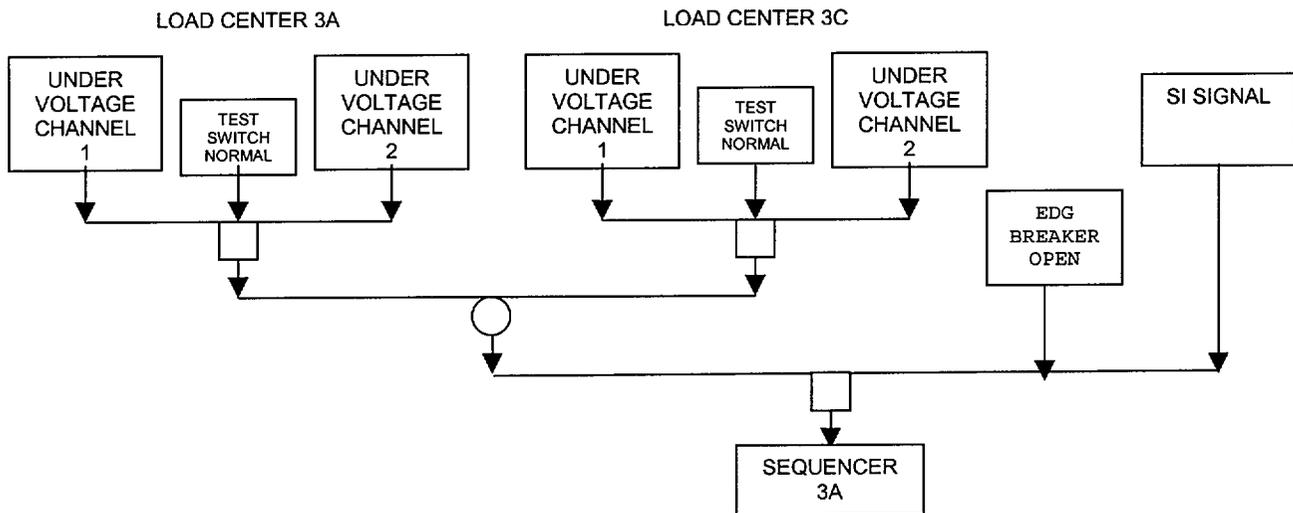
Degraded Voltage Protection; Coincident with SI

The scheme for SI has two voltage sensing relays (327H's) on each load center. If both relays on the load center sense an undervoltage condition (along with an SI signal and the associated EDG's output breaker being open), they will initiate bus stripping on the associated 4.16 kV bus.

A three position, spring return to Normal, test switch enables the operator to test either relay. Placing the test switch in any position other than Normal will bypass the trip circuit of both channels and block the trip signal from its associated load center.
