UNITED STATES
NUCLEAR REGULATORY COMMISSION

SUBJECT: NRC SPECIAL INSPECTION REPORT - INDIAN POINT UNIT 2
STEAM GENERATOR TUBE FAILURE - REPORT NO. 05000247/2000-010

IR 05000247-00-010, March 7 thru July 20, 2000; Consolidated Edison of New York, Inc.; Indian Point Unit 2; Special Team; steam generator tube failure, visual, eddy current inspection, technique qualification, corrective actions.

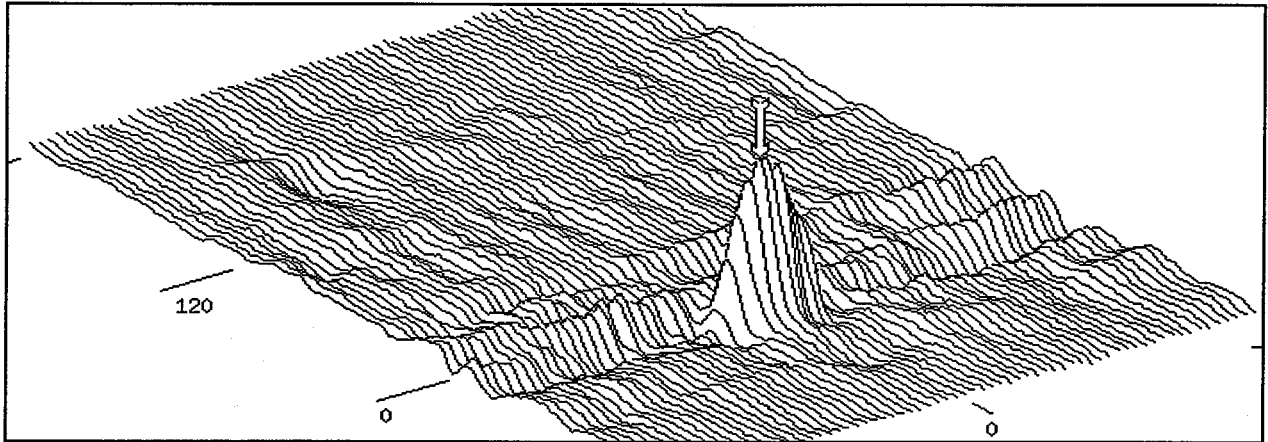
REFERENCED FIGURE 5 - Eddy Current Inspection - Tube R2C67 in SG24

The c-scan plot of the 1997 data from R2C67 is shown in Figure 5. The crack sits beside a noise ridge, in a valley, and is in an easily detectable portion of the tube. The large amplitude of the voltage signal, in relation to the standard calibration notch, would indicate that this is a "mature" crack. No year 2000 data is available since the tube was plugged in 1997.

Figure 5 - Crack in tube 2-67 of steam generator 24, found in 1997.

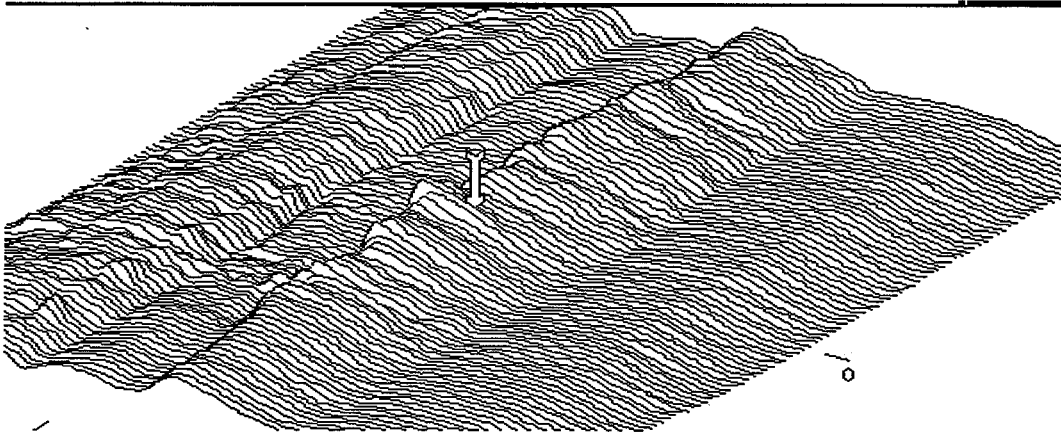
REFERENCED FIGURES 6 thru 8 - Eddy Current Inspection -Tube R2C5 in SG24

1. R2C5 in SG 24 - Figure 6 is a c-scan plot of the vertical component of the ECT voltage signal. The defect signal, indicated by the arrow, sits on a noise ridge that runs the length of the tube. This noise ridge is about 1-volt in amplitude. This ridge makes both the detection and sizing of this defect difficult, because of the very low signal-to-noise ratio. Figures 7 and 8 are the lissajous plots for the flaw area and the noise ridge, respectively. No year 2000 data is available since the tube failed.

Figure 6 R2C5C-scan with 1997 phase setting.

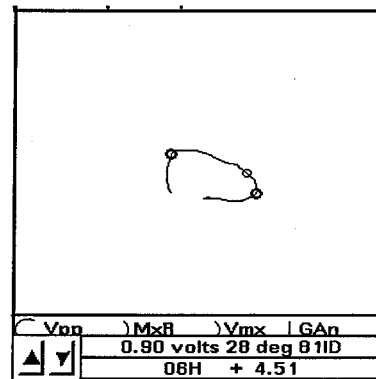
Figure 8 Noise signal that runs the length of the U-bend.

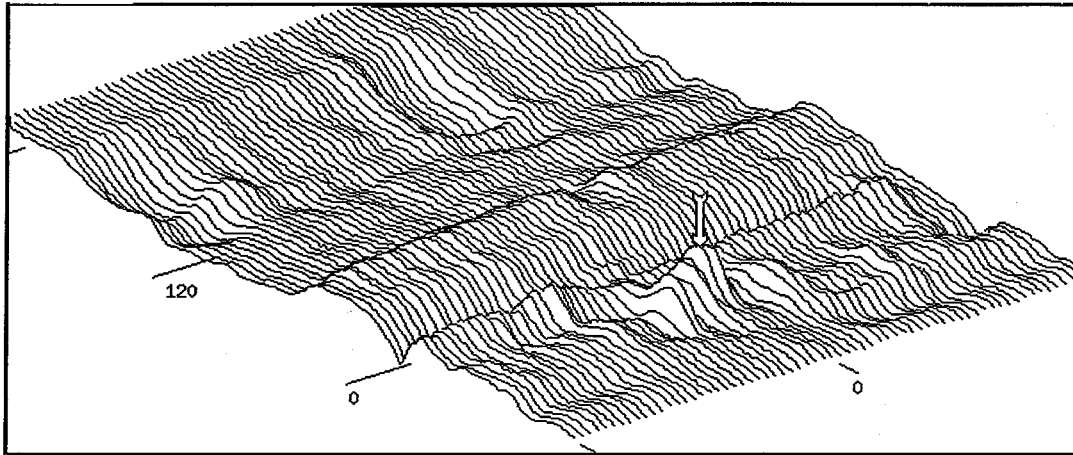
REFERENCED FIGURES - 9 thru 10 - Eddy Current Inspection - Tube R2C69 in SG 24

2. R2C69 in SG 24 - Figure 9 shows the c-scan plot for the 1997 data. There is considerable noise present. For comparison, the c-scan plot for the 2000 data is included as Figure 10. The noise features between the 1997 and 2000 data are similar enough to verify that this is the same defect at the same location. The defect voltage is only about 1 volt, and there is a considerable amount of noise on the tube relative to the defect signal, i.e., low signal-to-noise ratio.

Figure 9 - 1997 mid-range scan

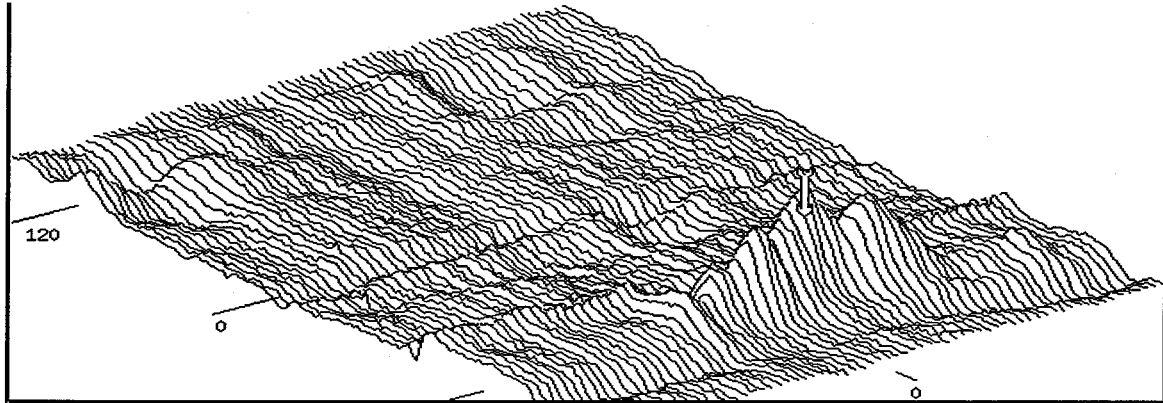
Figure 10 - 2000 mid-range scan

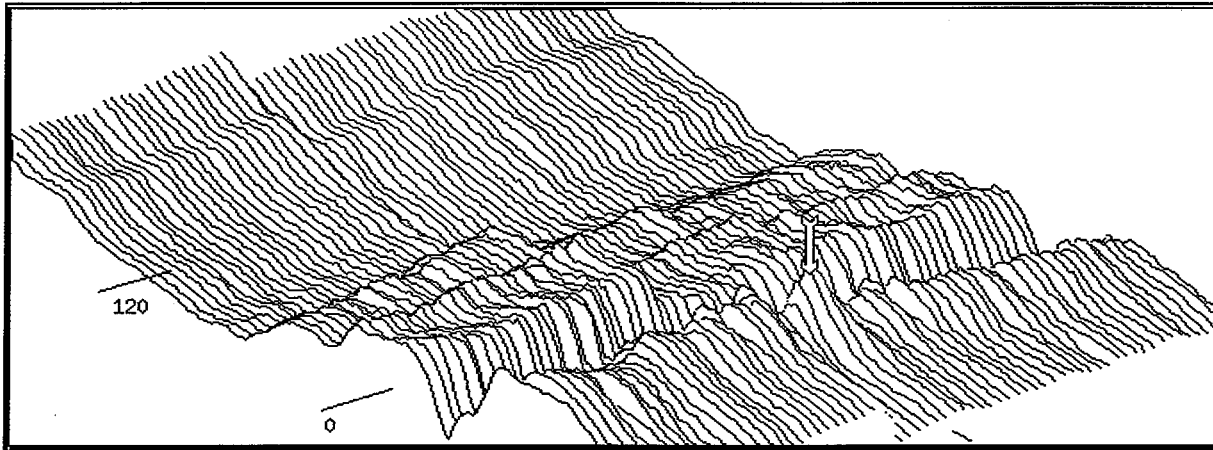
REFERENCED FIGURES 11 thru -12 - Eddy Current Inspection Tube R2C72 in SG 24

3. R2C72 in SG 24 - Figure 11 shows the c-scan plot of the 1997 data. There is considerable noise present. The crack is sitting in a ridge of noise and barely extends above the ridge. For comparison, the c-scan plot for the 2000 data is included as Figure 12. The crack barely extends above a 1-volt amplitude for a short length and exhibits a low signal-to-noise ratio.
4. R2C87 in SG 21 - this tube was identified as having several cracks. Figure 13 shows the c-scan plot of the 1997 data. The most prominent crack is sitting in a relatively clean area of the tube. For comparison, the c-scan plot for the 2000 data is included as Figure 14.

Figure 11 - 1997 scan

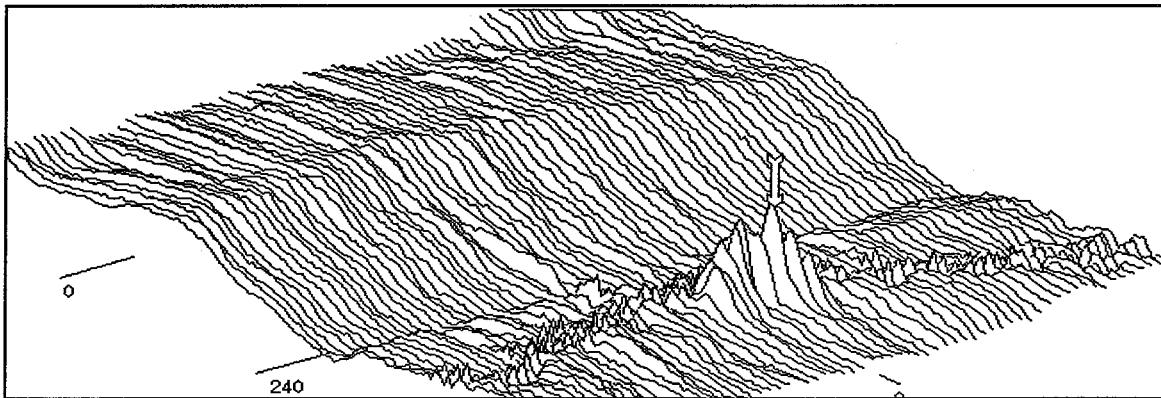
Figure 12 - 2000 scan

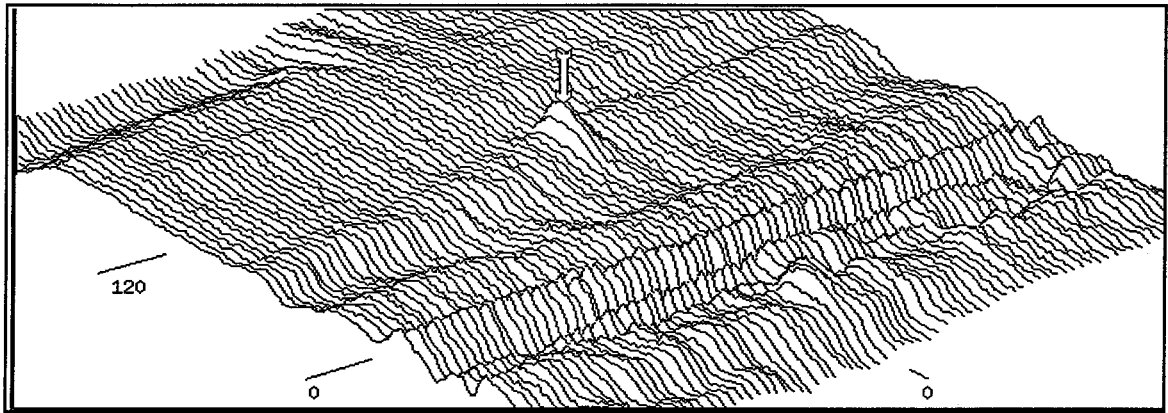
REFERENCED FIGURES 13 thru 14 - Eddy Current Inspection- Tube R2C87 in SG 21

Figure 13 - 1997 scan

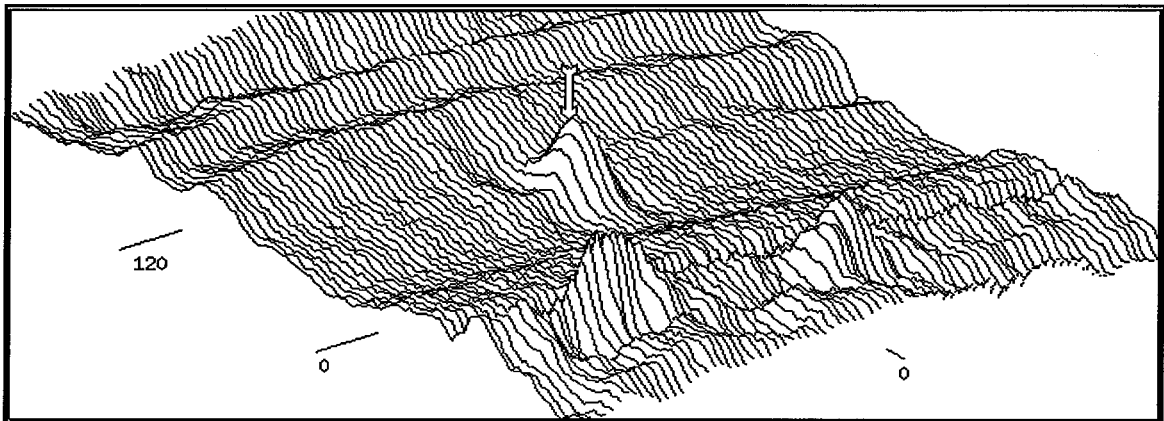
Figure 14 - 2000 scan
