Docket No. 50-278  
SUBJECT: Licensee Event Report, Peach Bottom Atomic Power Station Unit 3

Reference: Docket No. 50 278  
Report Number: 3-00-001  
Revision Number: 00  
Event Date: 08/07/00  
Report Date: 09/06/00

**LICENSEE EVENT REPORT (LER)**

**TITLE (4)**  
This LER reports the following Engineered Safety Feature (ESF) actuations: Reactor Protection System (RPS) actuation and Primary Containment Isolation System (PCIS) actuation. Additionally, this LER reports a condition prohibited by Technical Specifications and a Loss of Safety Function which occurred during the event.

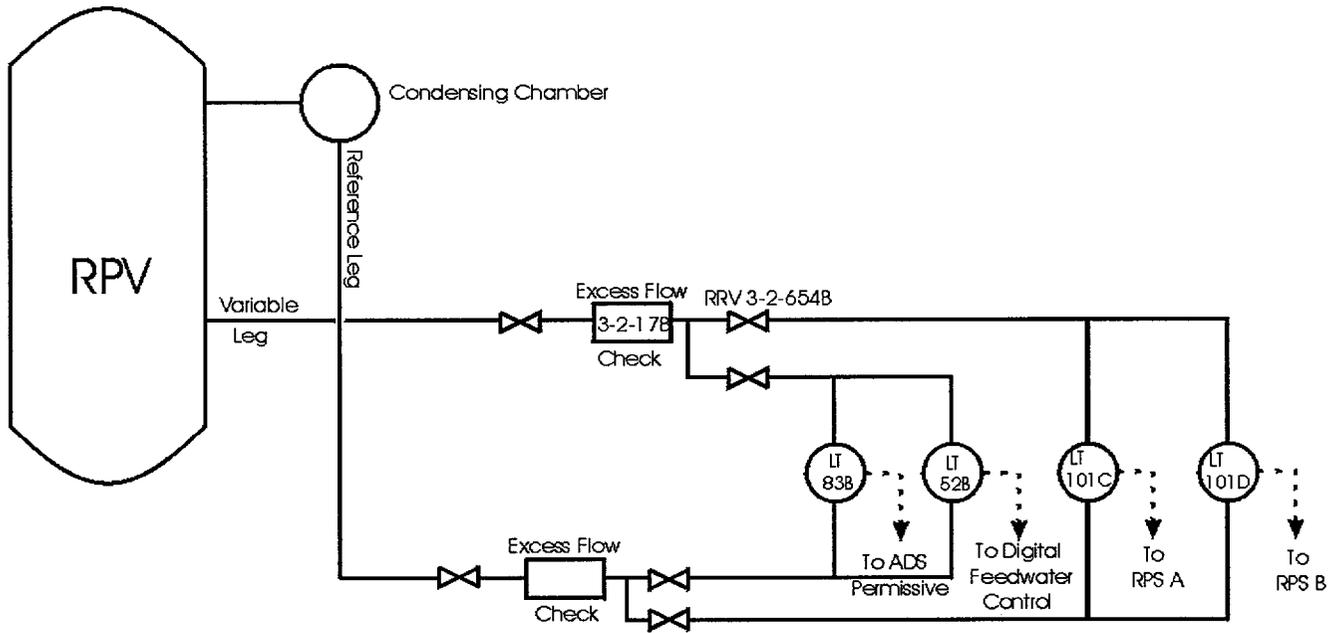
ATTACHMENT 1

The cause of the invalid low reactor water level signal was the failure of the packing gland follower on the variable leg root valve RRV 3-2-654B (see attachment 1). As a result, reactor pressure acting on the bottom of the packing created enough force to expel the failed packing gland and some of the packing from the packing chamber. This resulted in a leak through the packing gland. Excess flow check valve 3-2-17B, located upstream of RRV 3-2-654B, automatically closed as a result of sensing flow through the line. Closure of the excess flow check valve isolated the steam leak through the packing gland on RRV 3-2-654B.

As a result of the leak and the excess flow check valve closure, the variable leg to level transmitters LT-101C, LT-101D, LT-52B, and LT-83B depressurized. With the variable leg depressurized, the level transmitters experienced an increase in differential pressure, which translated into an indication of a decrease in reactor water level. Actual reactor water level had not changed.

The cause of the event was the failure of the packing gland follower on RRV 3-2-654B which resulted in depressurization of the variable leg to various instruments. This resulted in a reactor scram due to an invalid low RPV water level signal.

The cause of the packing gland follower failure has been determined to be Intergranular Stress Corrosion Cracking (IGSCC).

- Instrument line root valve RRV 3-2-654B packing gland follower has been replaced.
- An initial walkdown of accessible root valves and rack root valves in the Reactor Building was completed on both units. No obvious cracks were identified.
- A detailed plan is being developed to evaluate generic implications associated with this condition.
