# WESTERN NUCLEAR, INC.

**RE: Radon-222 Flux Measurements on the Sherwood Tailing Impoundment Surface After Final Cover Placement.**

# **EROSIONAL STABILITY OF TAILING IMPOUNDMENT SWALE FOR AS-BUILT CONDITIONS**

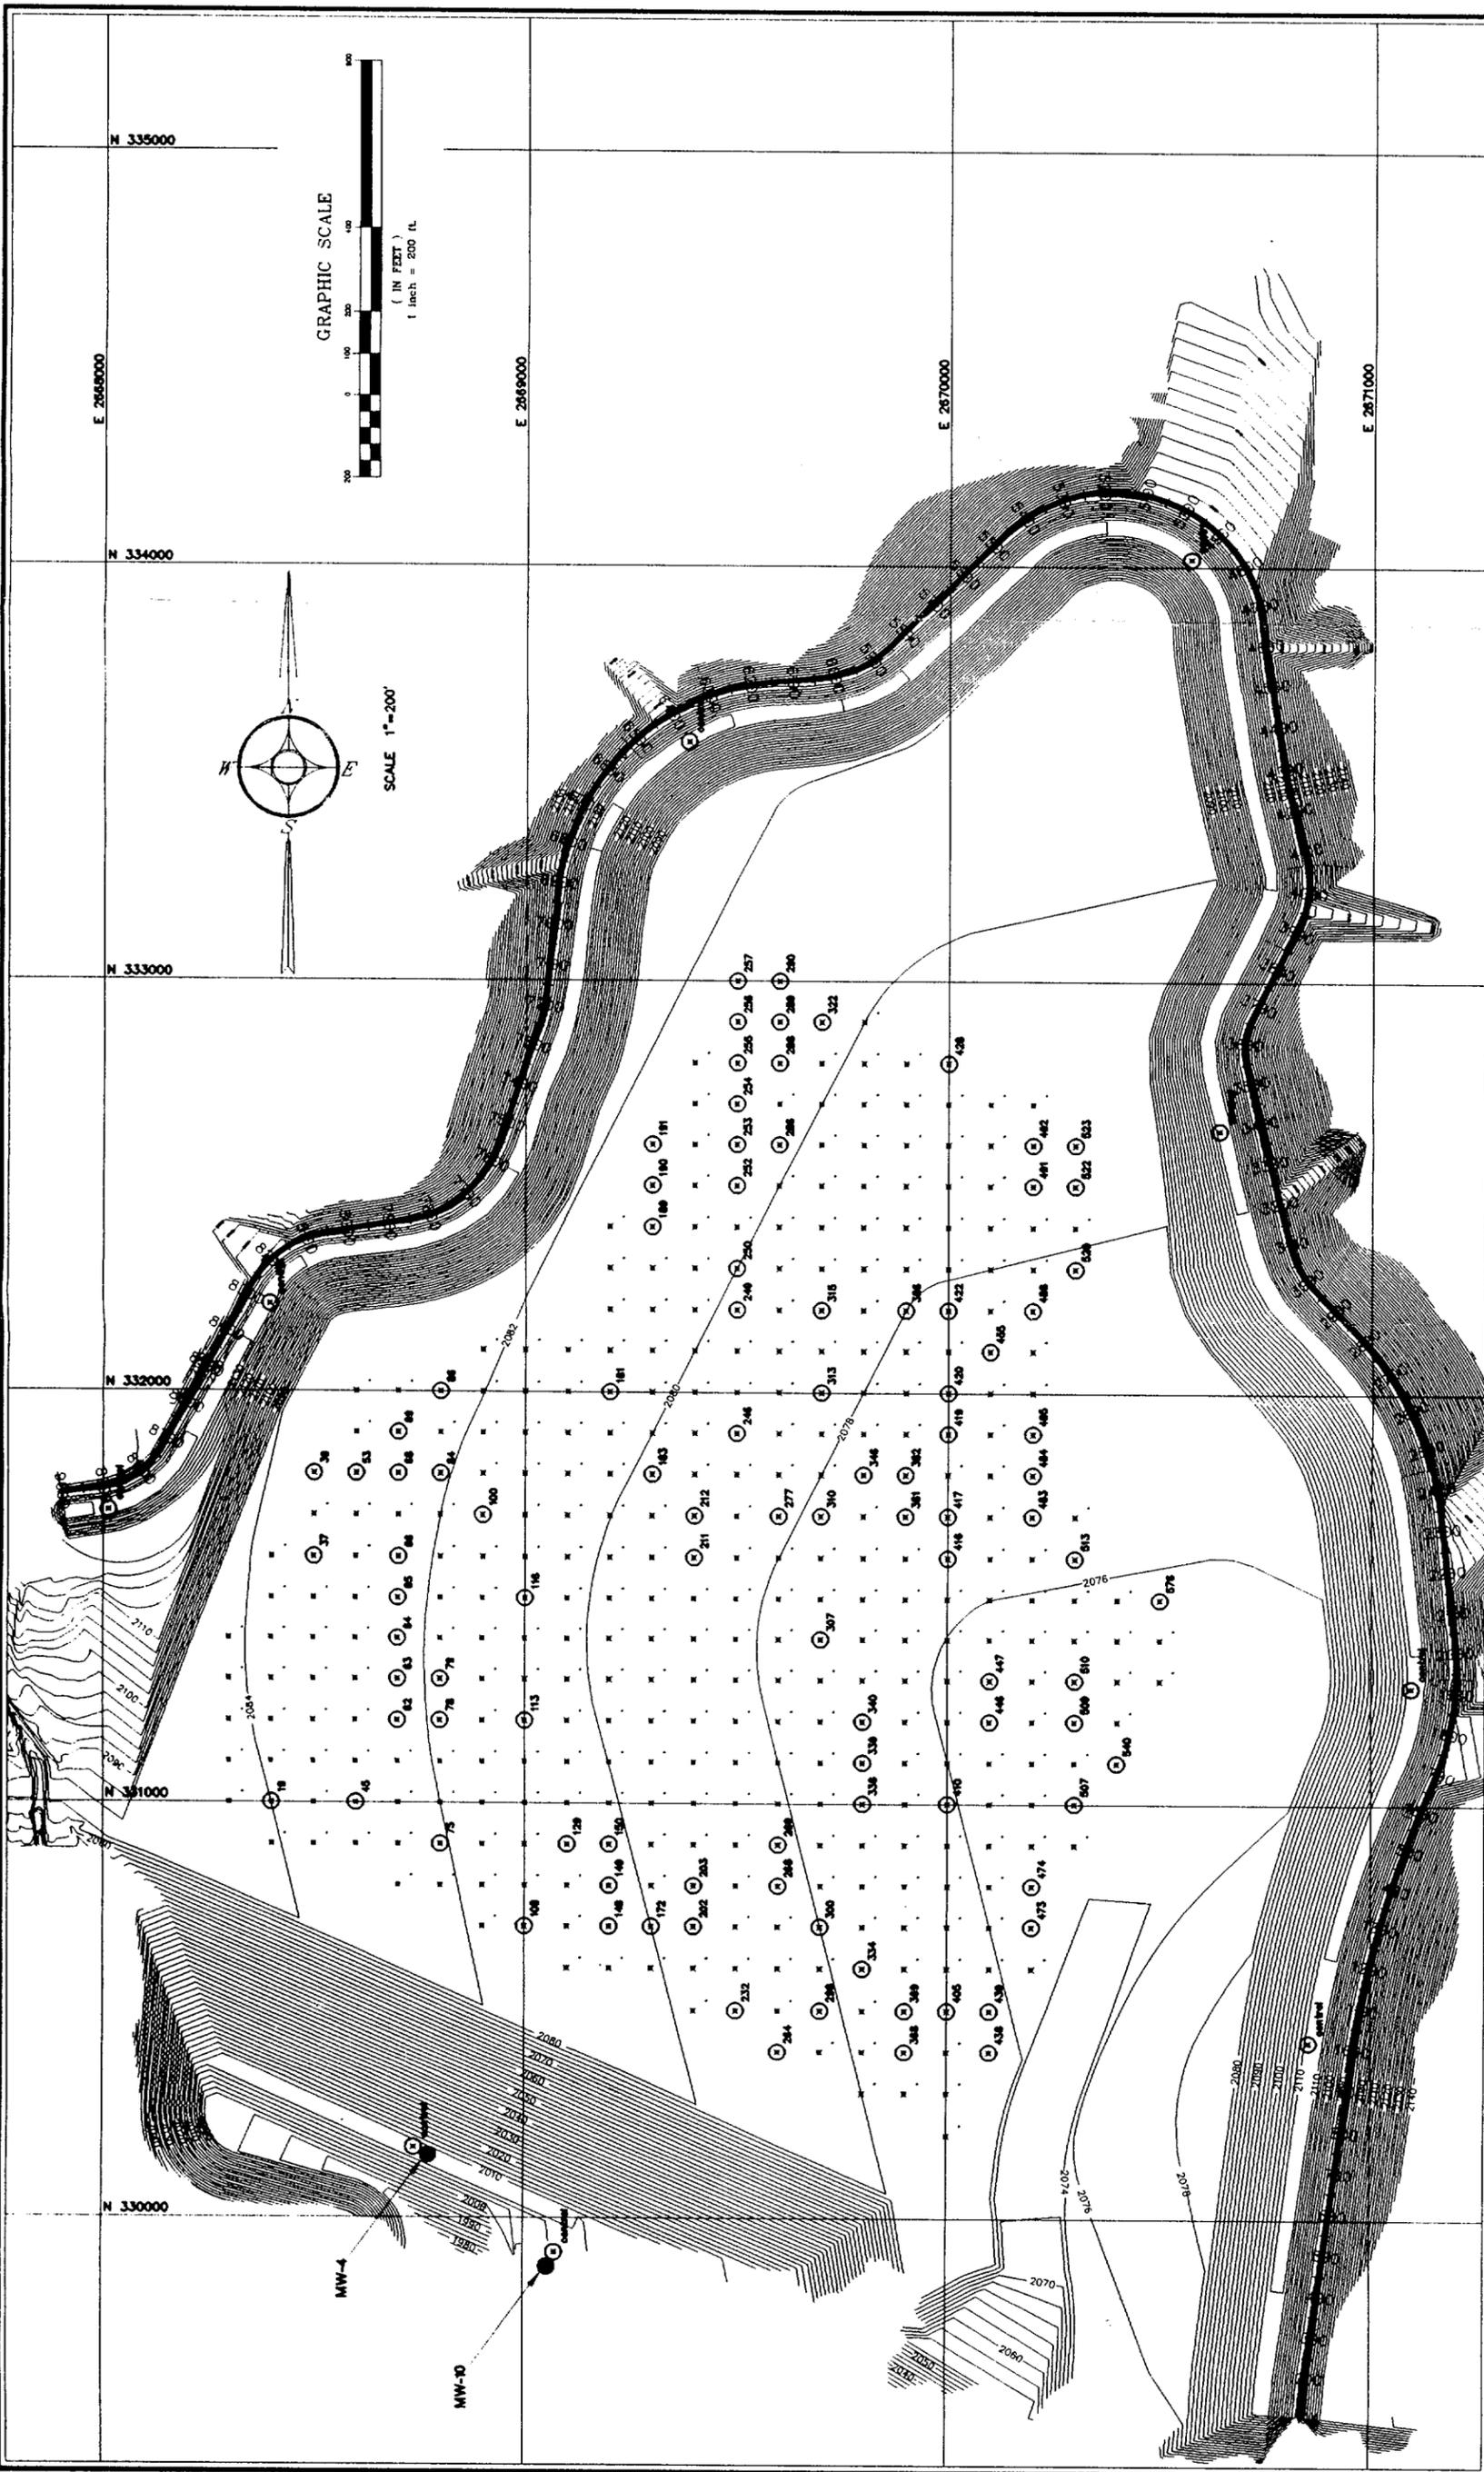
**SAMPLE LOCATIONS FOR  
RADON-222 FLUX MEASUREMENTS**

Sampling was performed with the Large Area Activated Charcoal Canister (LAACC) method as described in Method 115, § 1.0. A single set of samples was collected over the reclaimed surface of the Sherwood Tailing Impoundment (Method 115, § 2.1.1). The surface at completion of cover placement and at the time of sampling was dry, i.e.; there were no saturated areas (Method 115, § 2.1.2). A total of 105 measurements were made on the impoundment surface (Method 115, § 2.1.3). Sample sites were selected from a 100 x 100 foot grid layout over the impoundment. All sample locations, except for off-surface control sites, were located over the lined portion of the tailing impoundment (Attachment 1).

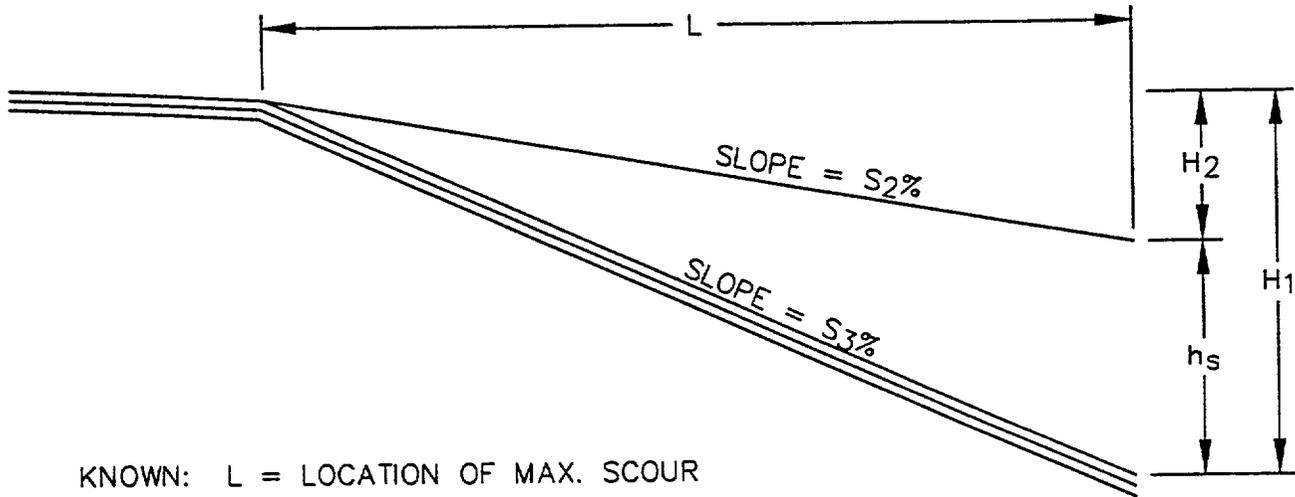
(a) The design slope in Drawing 7 of the WDOH approved November, 1996 Technical Specifications is shown as 15%. This slope was calculated by dividing the scour depth  $h_s$  (4.5 ft) by the length (L)(30 ft). This value is incorrect because as shown in Figure O-1, the slope is equal to the depth  $H_1$  divided by L. As discussed below the correct slope is 21%.

As illustrated in Figure O-1, the slope of the tailing swale apron ( $S_3$ ) is equal to the depth  $H_1$  divided by the length L. However, since the value of  $H_1$  is not known, it is necessary to derive an equation for  $S_3$  in terms of the ground slope  $S_2$  and the scour depth  $h_s$  which are known values. The equation as derived on Figure O-1 is as follows:

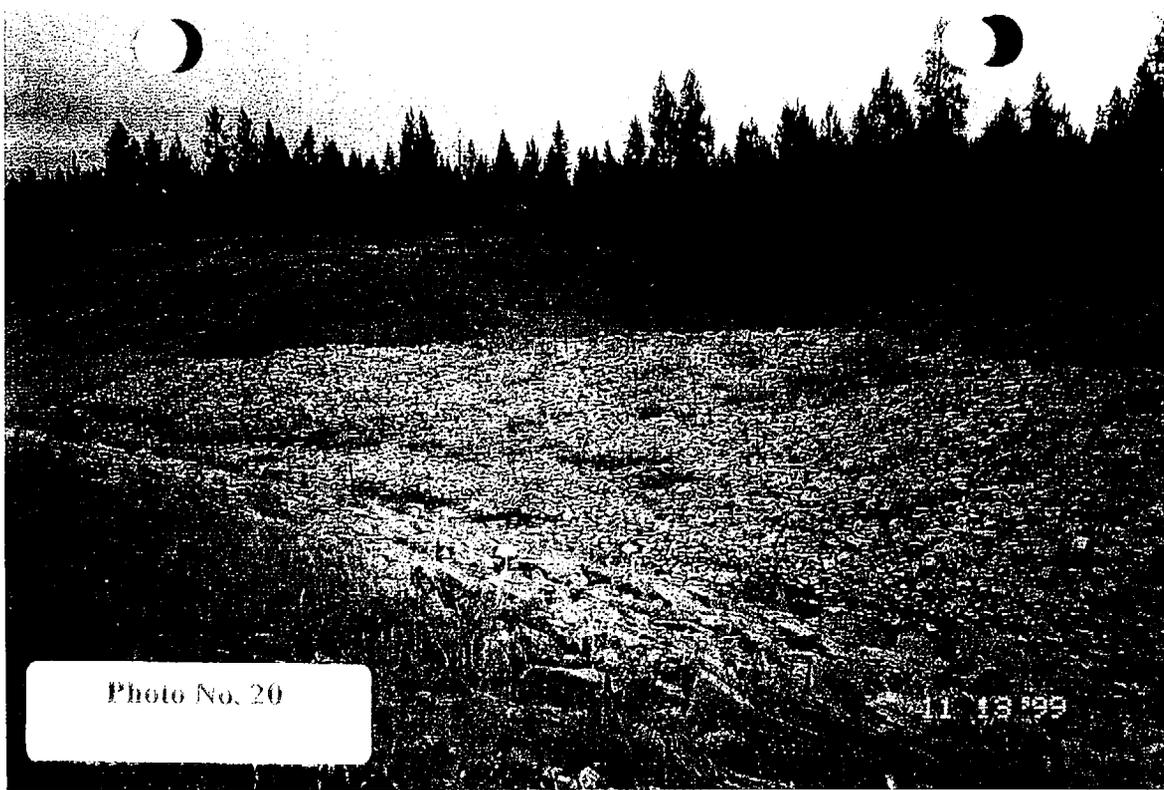
Photo No. 20

The rock armoring throughout the site has exhibited no visually observable degradation (due to weathering) that would adversely impact the function of the various reclamation components, including the conveyance and erosional protection capabilities of the drainage diversion channel. Additionally, any observed irregularities in the armor related to thickness, rock size, void spaces, and infiltration of sediment are considered to be insignificant and require **no corrective action** to maintain conveyance function of the drainage diversion channel and reclamation design element stability (refer to photo documentation numbers 16 through 22 in Attachment A).

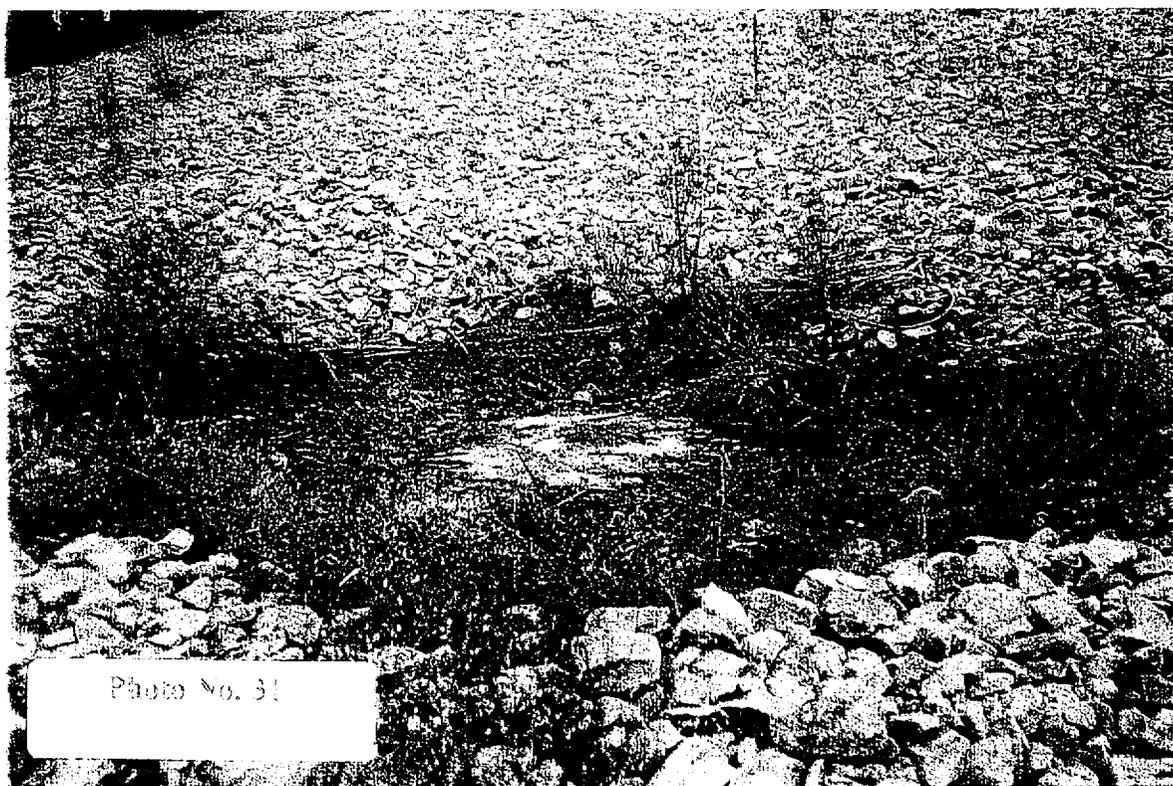
Photo No. 31

As discussed in previous inspection reports, some rills and gullies are still observed on tailing impoundment margins and in many of the disturbed area slopes above the drainage diversion channel and confluences. Soils transported during the rilling process are invading the rock armoring on the slope toes. This is considered to be beneficial by allowing vegetation to reclaim the slope from both the crown and toe. The magnitude and frequency of occurrences are becoming less apparent as vegetative cover continues to increase in density. Slopes with exposed bedrock and/or poor soil development are still relatively barren of vegetation. However, they exhibit no evidence of structural instability (refer to photo documentation numbers 25 through 30 in Attachment A). A monitoring well abandonment area is shown in photo documentation number 31.
