SUBJECT: RESULTS OF DAM SAFETY AUDIT RELATED TO THE CATEGORY I  
AUXILIARY RESERVOIR DAM AT THE SHEARON HARRIS NUCLEAR  
POWER PLANT

OPERATION INSPECTION REPORT  
for  
THE NUCLEAR REGULATORY COMMISSION

Dam (name) Auxiliary Reservoir Dam

NRC Licensed Project Shearon Harris Nuclear Station

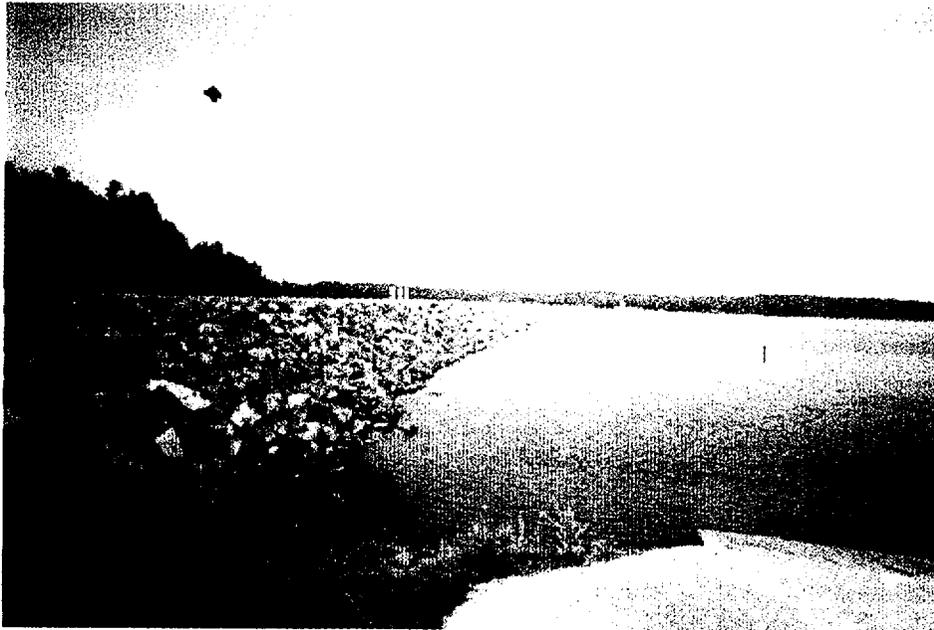
**Photograph 1**

Upstream slope of the auxiliary dam as seen from near the boat ramp on the left abutment.

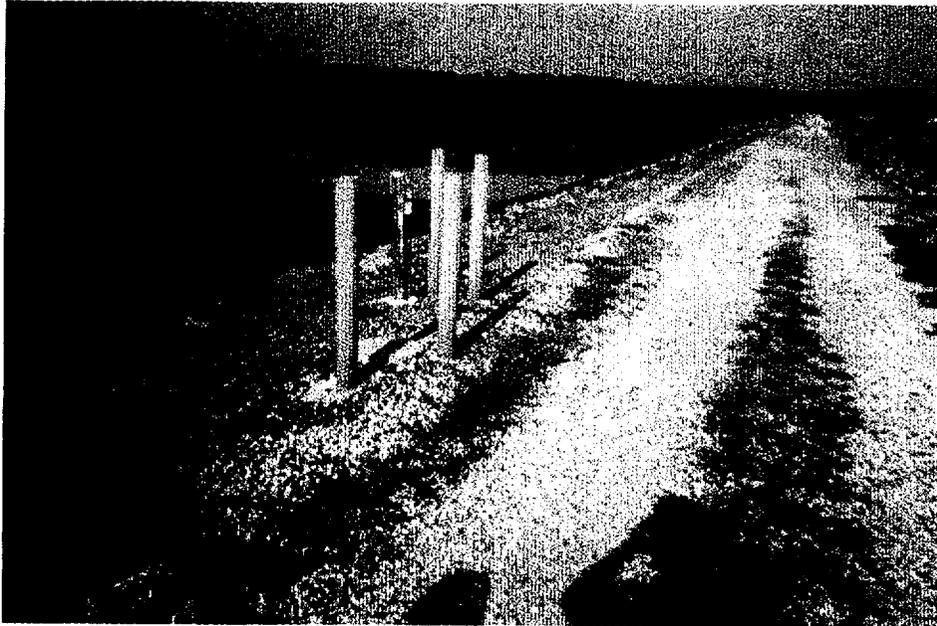
**Photograph 3**

**a. Auxiliary Reservoir Dam.** Both upstream and downstream slopes of the dam are protected by riprap (Photographs 2 and 4). No sign of movement such as sliding, sloughing, or subsidence was detected on either of the slopes. The crest and gravel roadway along the top of the dam also appeared to be in good condition (Photograph 3). There was no sign of cracking, sliding, or settlement along the crest.

2. **Instrumentation.** Project instrumentation includes surface monuments and piezometers. Surface monuments located along the crest of the dam are used to monitor horizontal and vertical movement. Piezometers are located along the crest of the dam and downstream of the toe. Photograph 3 shows a typical location of a survey reference point and/or piezometer with protective barriers.

Barricades on top of the dam. The barricades protect monuments and piezometers.

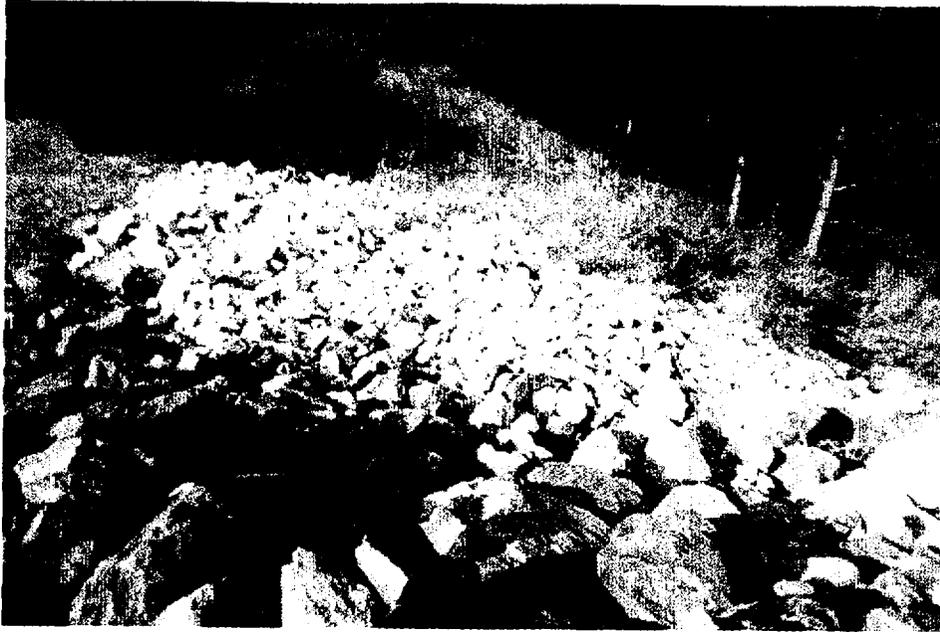
**Photograph 9**

During the previous FERC inspection, one eroded area was found on the dam's downstream slope near the left side of the spillway. The licensee has repaired this area and protected it with riprap (Photograph 9).

Previously eroded area near the left side of the spillway. The area has been repaired and protected with riprap.

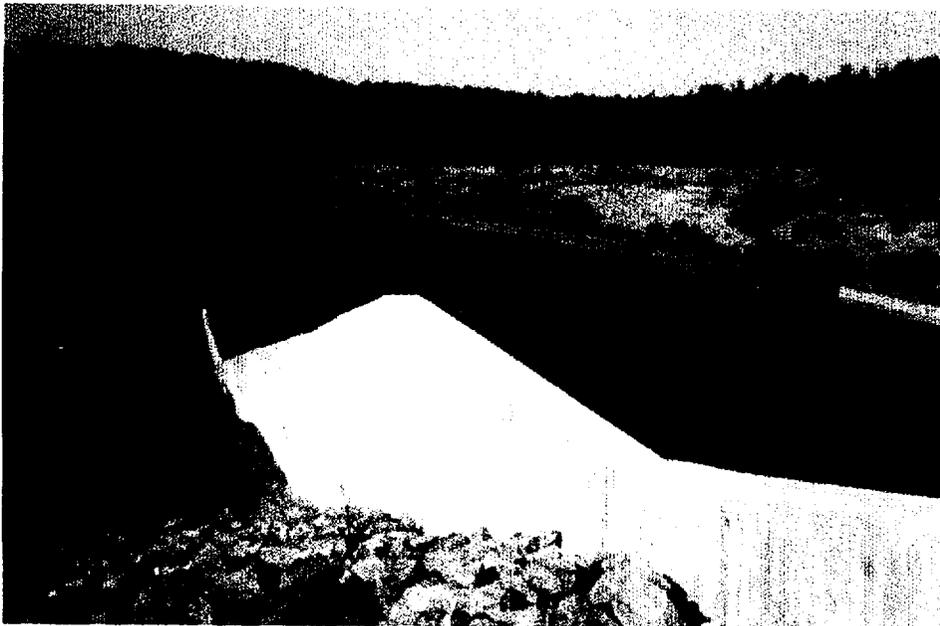
**Photograph 10**

Embankment, left spillway training wall, and spillway channel.

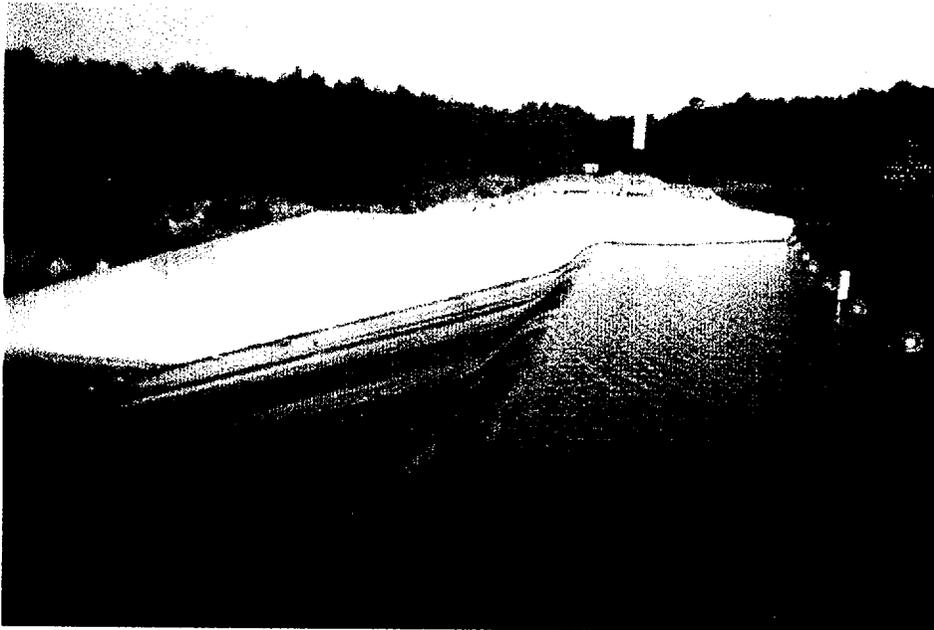
**Photograph 11**

Spillway as seen from the left training wall.  
Note the boat barrier and warning sign.

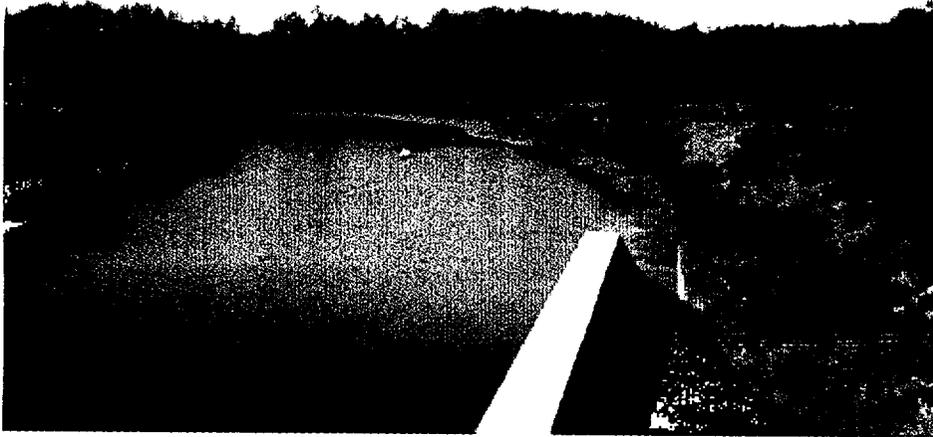
**Photograph 13**

(Photograph 11). The spillway, abutment walls, and outlet channel (Photograph 13) appeared to be stable and in good condition.

Spillway outlet channel as seen from the top of the dam.
