Kewaunee Nuclear Power Plant  
 N490, State Highway 42  
 Kewaunee, WI 54216-9511  
 920-388-2560

Docket 50-305  
 Operating License DPR-43  
 Kewaunee Nuclear Power Plant  
Reportable Occurrence 2000-014-00

**LICENSEE EVENT REPORT (LER)**

TITLE (4)  
All Three Auxiliary Feedwater Pumps Declared Inoperable Due to the Potential to Plug Their Suction Strainers.

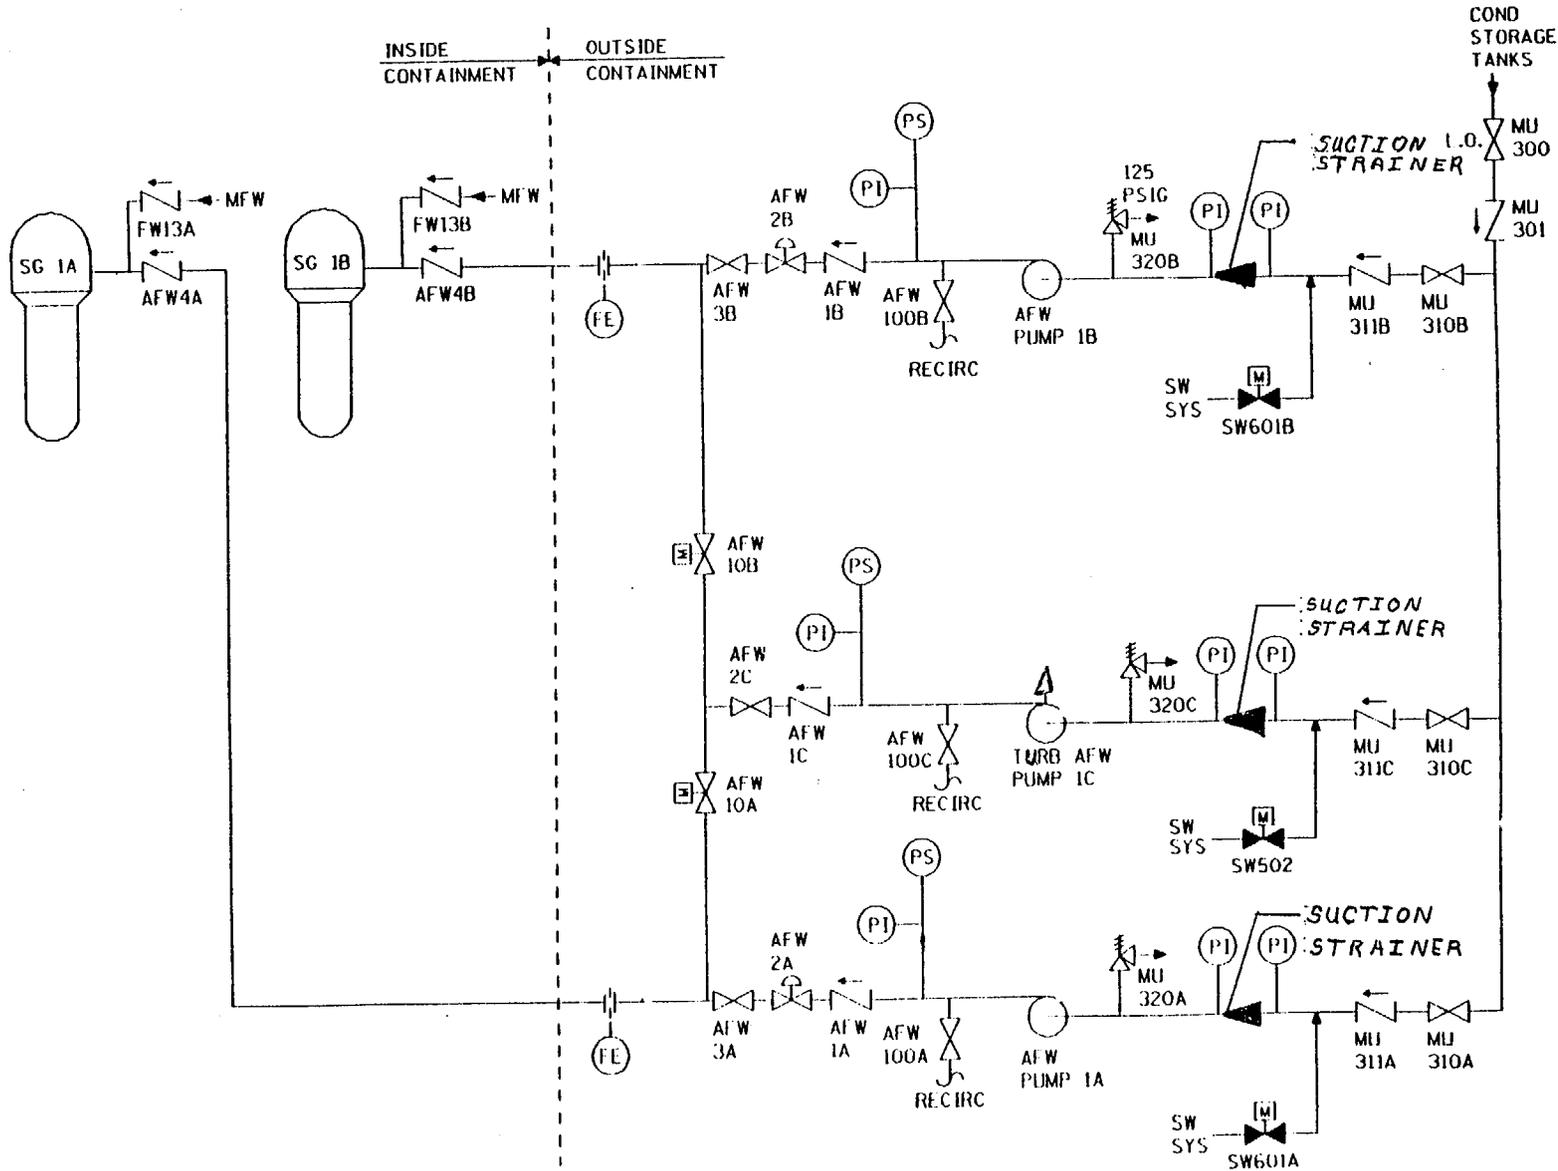
ATTACHMENT 1

There are three AFW pumps at the Kewaunee plant, two motor [MO] driven pumps and one turbine [TRB] driven pump, refer to Attachment 1 for a simplified diagram of the AFW system. Any one of the three pumps supplies adequate flow to remove the decay heat following a design basis event. As can be seen from Attachment 1, there are two sources of water to the AFW pumps, condensate [KA] and service water[BI]. No matter which system is used to supply the AFW pumps the flow must pass through the pump's strainer. Each of these sources is described in the following paragraphs.
