SUBJECT: INDIAN POINT NUCLEAR GENERATING UNIT NO. 2, TECHNICAL  
EVALUATION REPORT OF STEAM GENERATOR TUBE FAILURE,  
CATEGORY C-3 STEAM GENERATOR INSPECTION RESULTS, AND  
STEAM GENERATOR OPERATIONAL ASSESSMENT

TECHNICAL EVALUATION REPORT BY THE  
OFFICE OF NUCLEAR REACTOR REGULATION  
STEAM GENERATOR TUBE FAILURE, CATEGORY C-3 STEAM GENERATOR  
INSPECTION RESULTS, AND STEAM GENERATOR OPERATIONAL ASSESSMENT  
CONSOLIDATED EDISON COMPANY OF NEW YORK, INC  
INDIAN POINT NUCLEAR GENERATING UNIT NO. 2  
DOCKET NO. 50-247

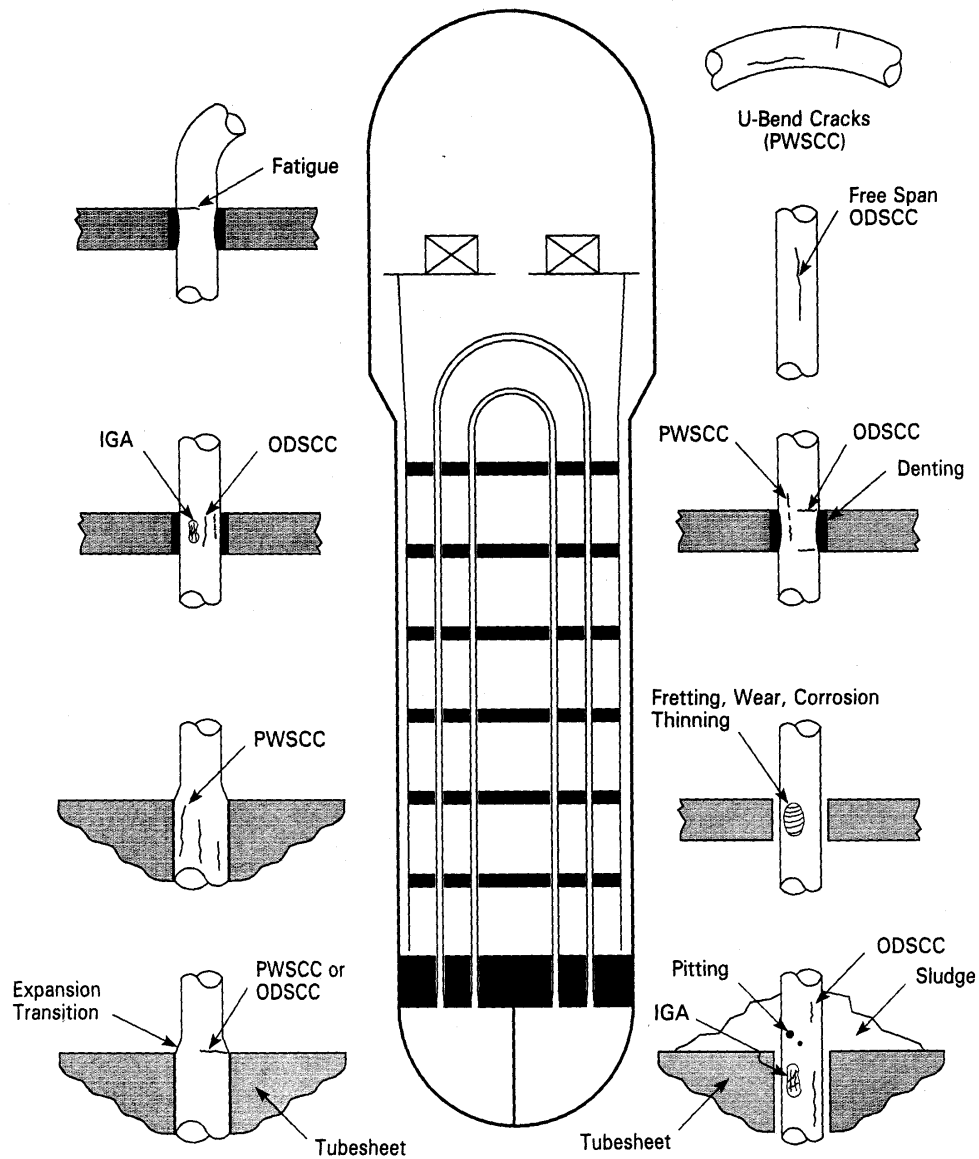
Figure 1

# EXAMPLES OF SG TUBE DEGRADATION MECHANISMS
