Millstone Nuclear Power Station, Unit No. 3
Licensee Event Report 2000-003-00
Cable Routing for 3CHS*P3B Does Not Meet Fire Safe Shutdown Analysis

LER 2000-003-00

TITLE (4)
Cable Routing for 3CHS*P3B Does Not Meet Fire Safe Shutdown Analysis

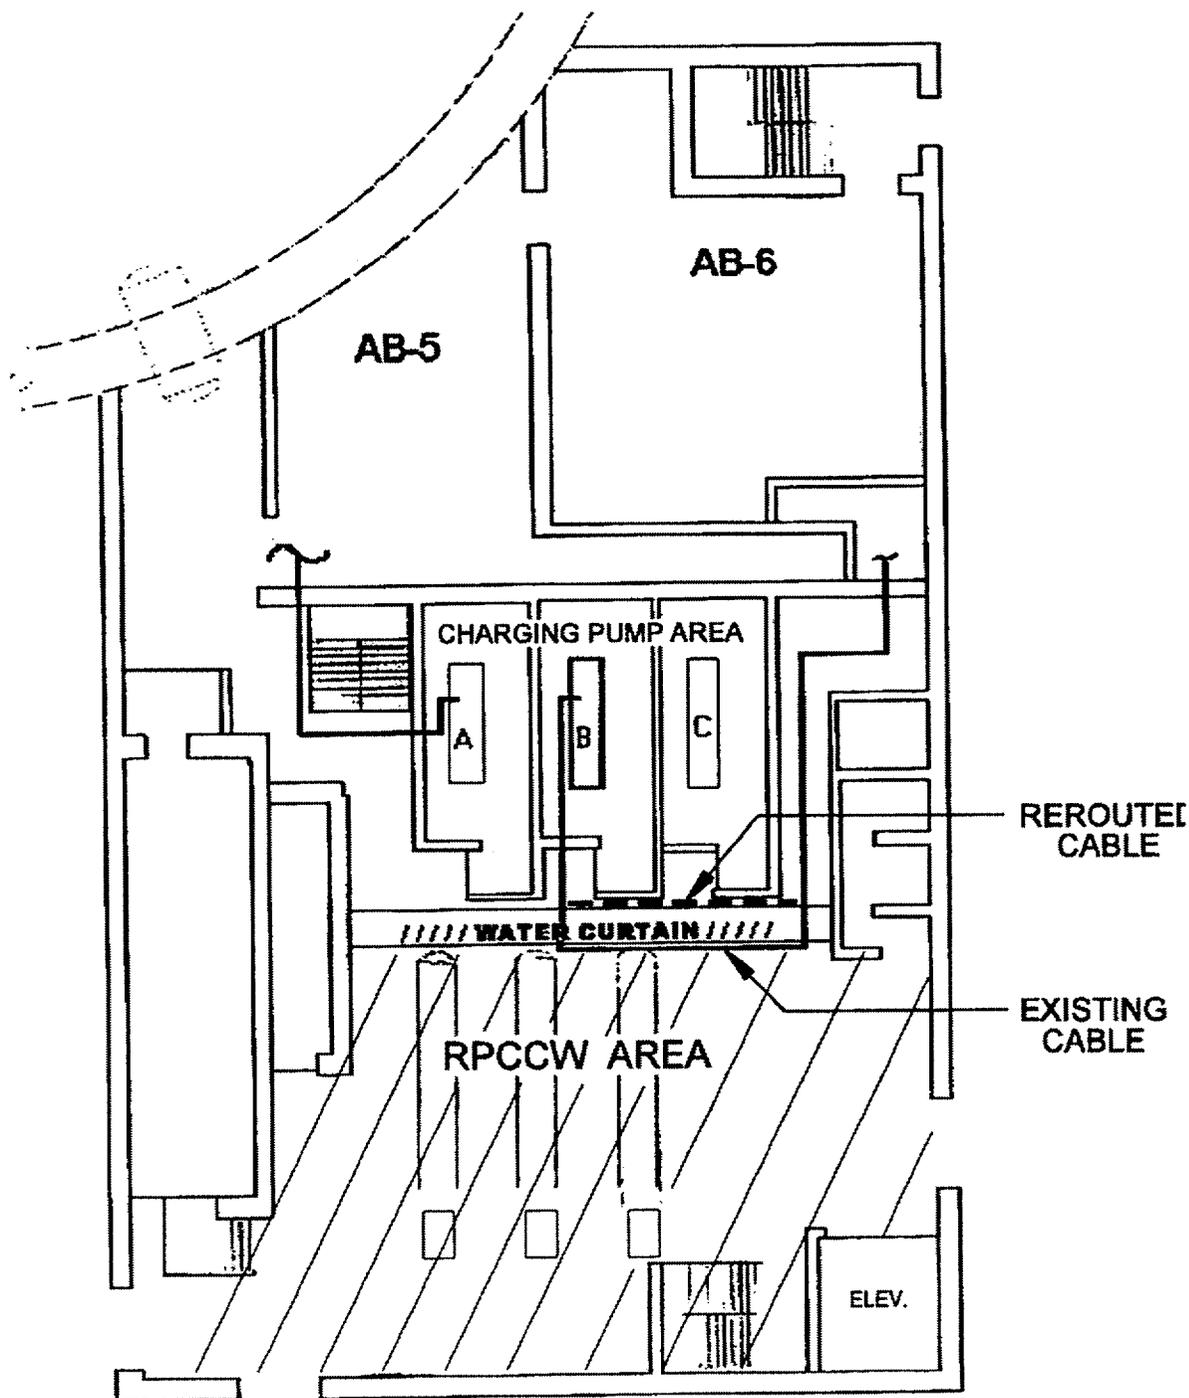
AUXILIARY BUILDING * ELEV 24'-6"

On September 28, 2000, while performing a self-assessment, with the plant in mode 1 at 100% power, it was discovered that the 4160V power cable for charging pump, 3CHS*P3B [P] was not installed in the Auxiliary Building [NF] as identified by the MP3 BTP 9.5-1 Compliance Report. Contrary to the compliance report cable routing analysis, the cable is routed to the north of the water curtain located on the 24'6" elevation for a short distance such that cable integrity could not be ensured if a fire were to occur in this area. It was determined that this condition could have significantly challenged the ability to achieve and maintain cold shutdown per the requirements of CMEB BTP 9.5-1 if a design basis fire occurred in the area and the pump cable was damaged as a result of this fire. The MP3 BTP 9.5-1 Compliance Report credits this pump to provide Reactor Coolant Pump (RCP) [P] seal cooling, Reactor Coolant System (RCS) [AB] inventory make-up, and RCS boration functions in the event of a postulated fire in an area of the Auxiliary Building [NF] where a fire could potentially damage all Reactor Plant Closed Cooling Water (RPCCW) pumps [P]. The RPCCW pumps [P] provide an alternate means of cooling the seals and are assumed to be lost in such a fire.

The attached diagram depicts the area of concern in the Auxiliary Building, and the cable in question is identified in the diagram.

The cause of this condition is that the reviews performed historically failed to correctly identify the location of the power cable for the charging pump 3CHS*P3B relative to the water curtain which has been credited as a barrier between two methods of safe shutdown. The cable is part of the original construction of the facility.

1. The power cable for the 3CHS*P3B Pump has been relocated to place the plant in agreement with the MP3 BTP 9.5-1 Compliance Report. The attached diagram indicates the position of the relocated cable.
2. A limited evaluation was completed to document that this is most probably an isolated condition.
