Subject: Oyster Creek Nuclear Generating Station
Facility License No. DPR-16
Docket No. 50-219
Core Spray Sparger – 18R Inspections

Oyster Creek Core Spray System
Inspection Program - 18R

Topical Report No. TR-137

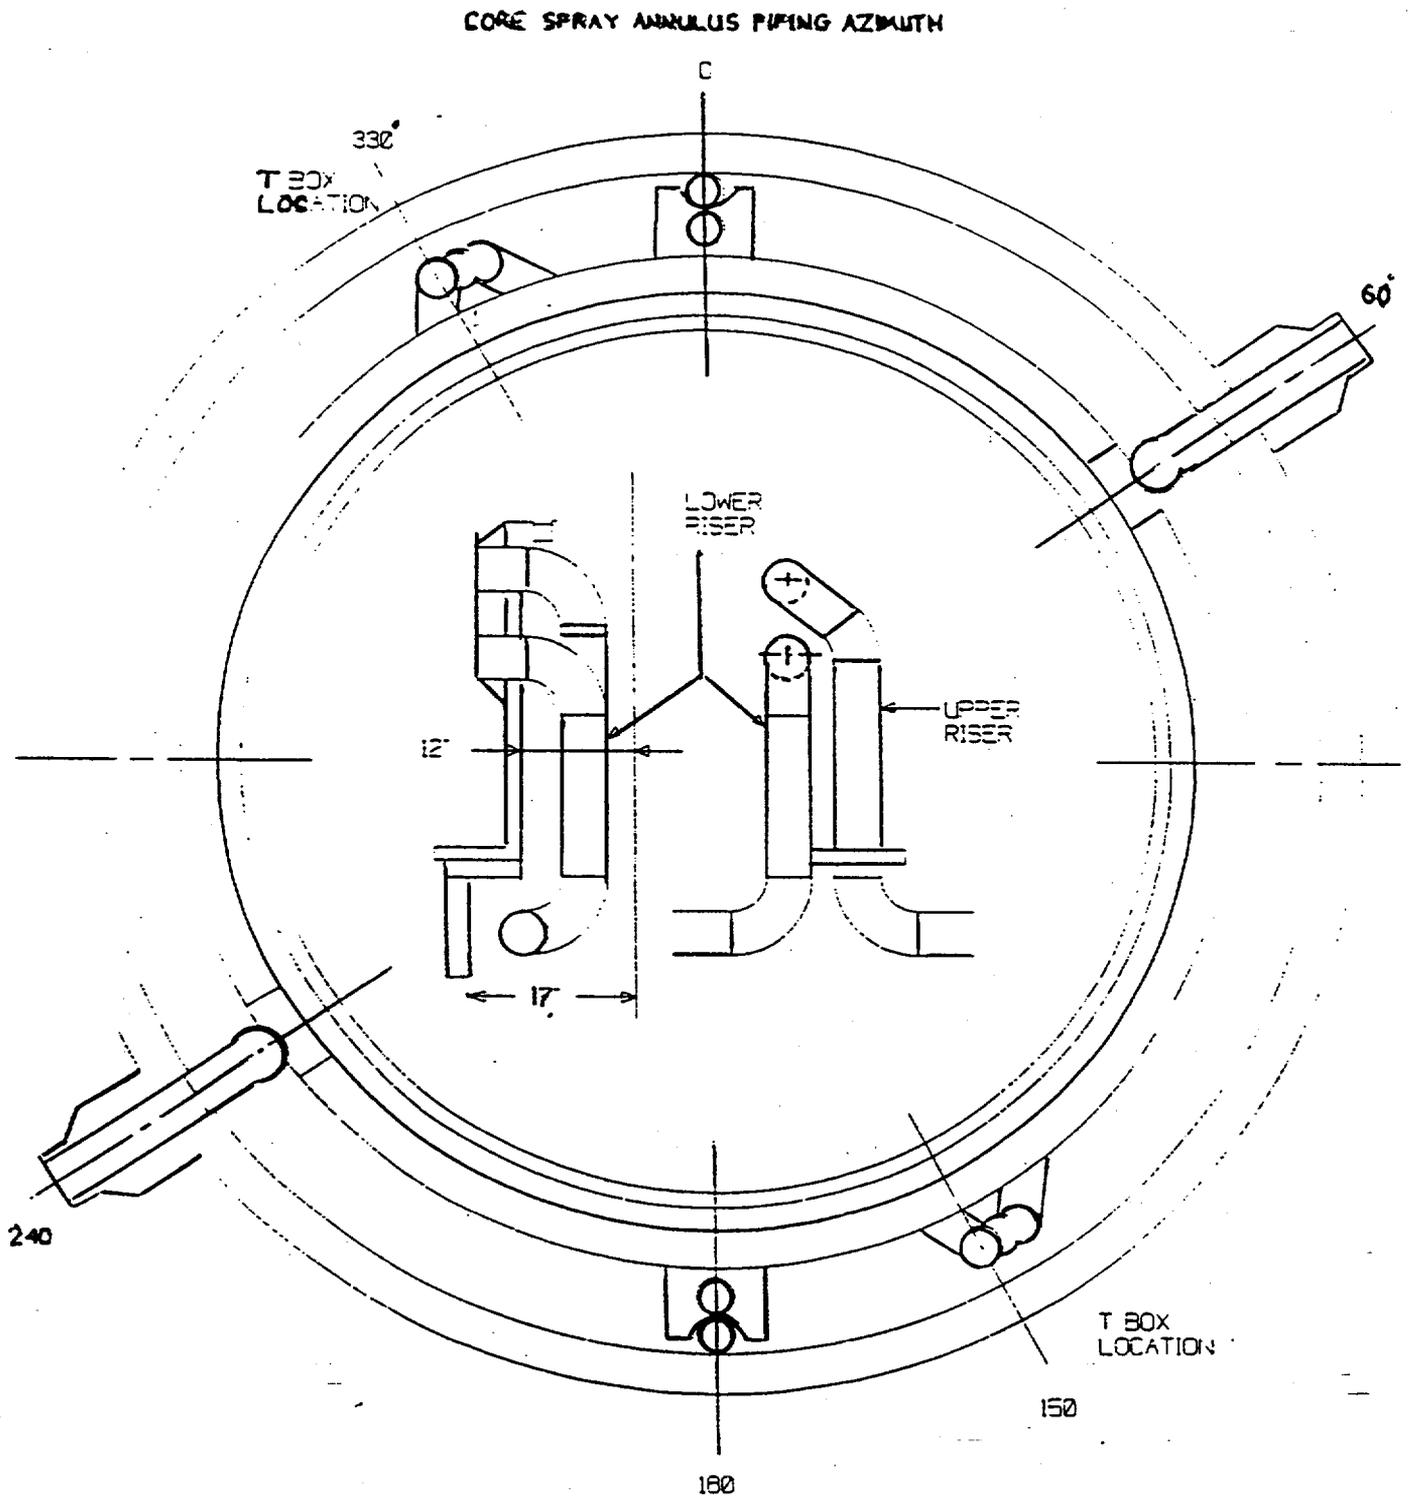
FIGURE 1

The visual inspection of the Core Spray spargers was performed as follows (Reference Figure 1 and 2):

1. Upper view - looking down on the sparger from above.
2. Front view - looking straight at the sparger.
3. Nozzle view - looking below the sparger directly at the nozzles and tack welds.
4. End cap welds - cleaned and EVT-1.

1. Upper view - looking down on the sparger from above.
2. Front view - looking straight at the sparger.
3. Nozzle view - looking below the sparger directly at the nozzles and tack welds
4. End cap welds - cleaned and EVT-1.

No relevant indications were noted during the inspections or subsequent review of the videotapes.

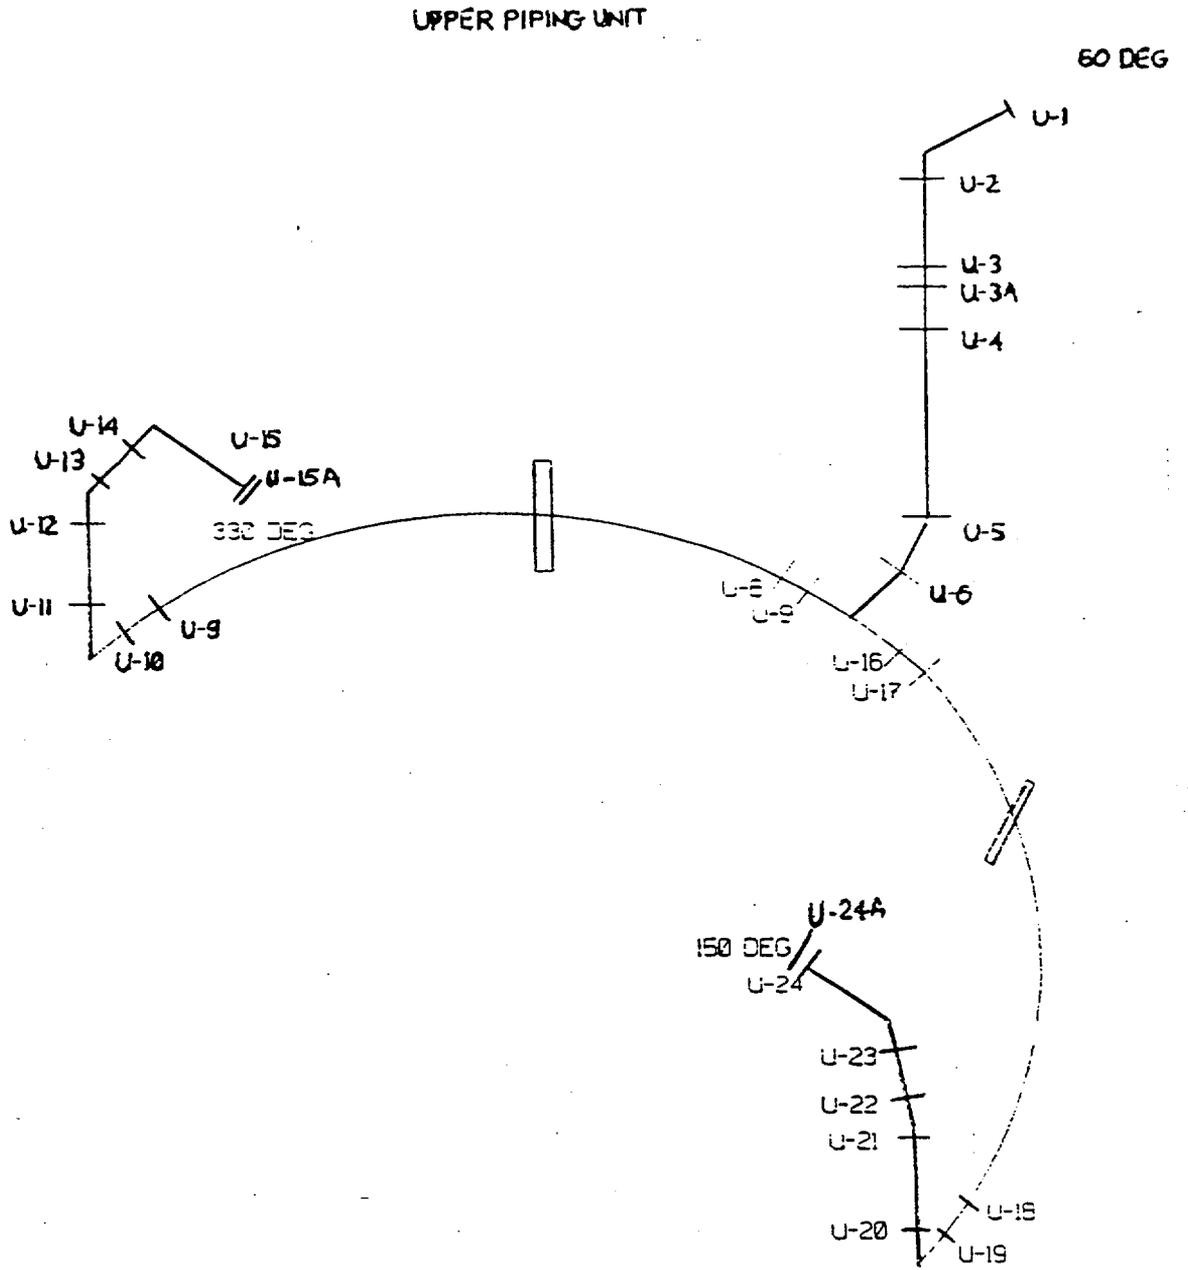
FIGURE 3

U3, U3A, U4, U7, U8, U15A and U16 on System II (see Figure 3); and

Inspections were performed using the ETV-1250 camera system and the VIT CA-Zoom color camera. No new relevant indications were noted during the inspection or subsequent review of the videotapes.

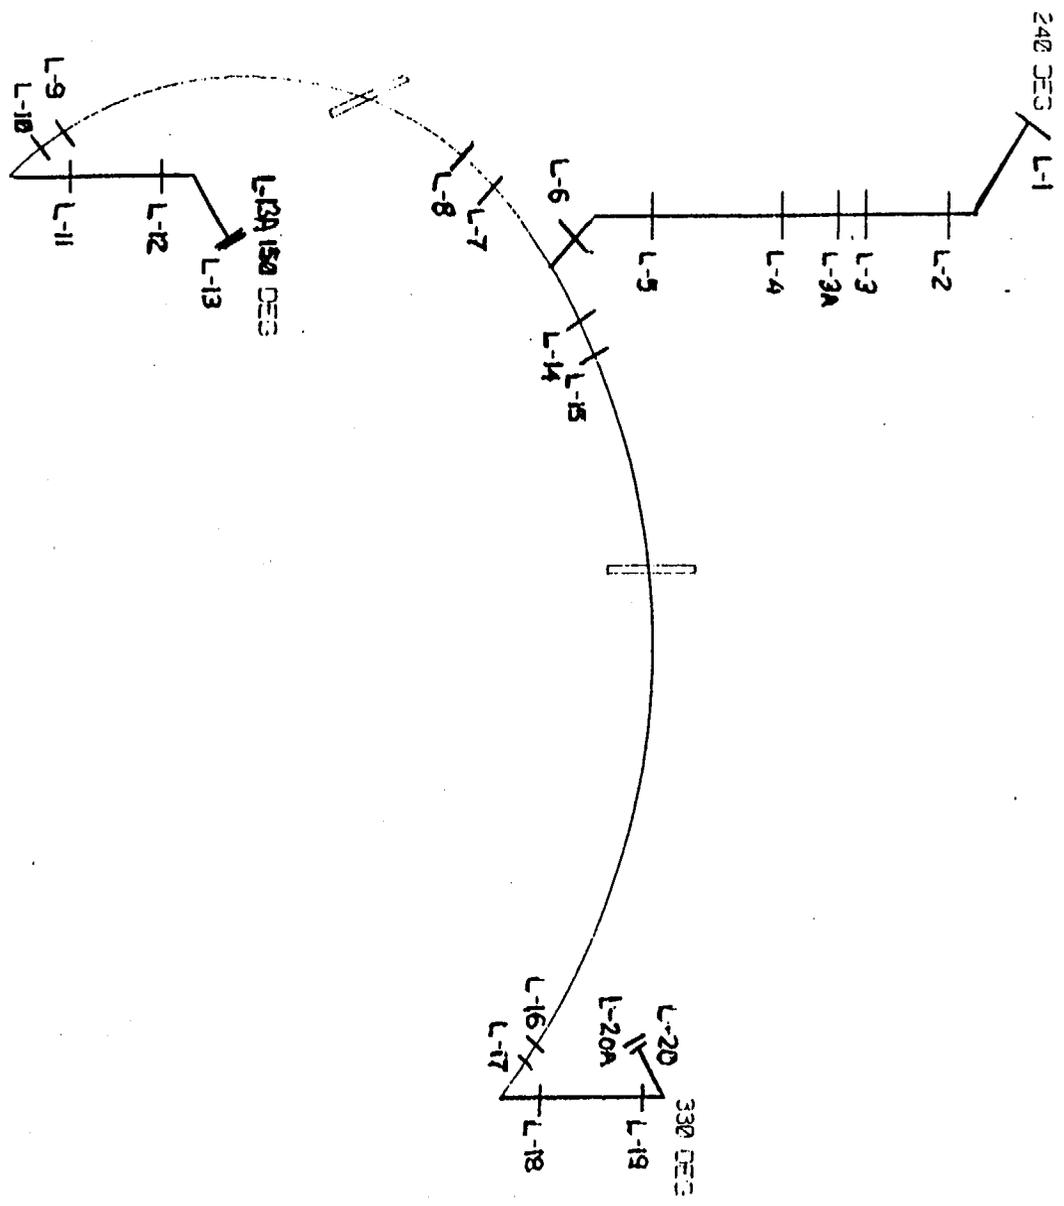
FIGURE 4

L3, L3A, L4, L6, L13A, L14, L15 and L20A on System I, (see Figure 4).

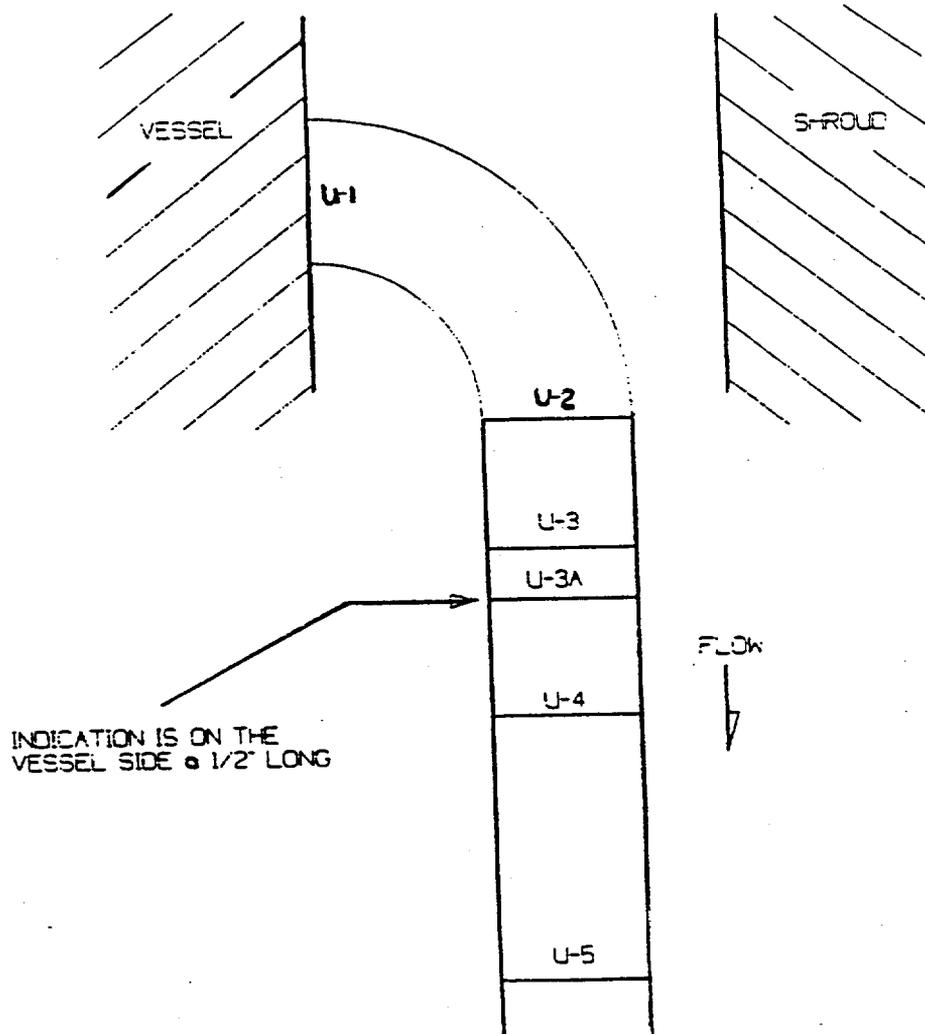
FIGURE 6

- Two linear indications originally observed during outage 14R in the annulus piping in System II at weld U-3A appear to be a weld pass between 2 beads, as determined after cleaning. No changes and no air bubbles were observed emanating from this location during the air test.

CORE SPRAY PIPING WELD I.D.S
INDICATION AT WELD U-3A

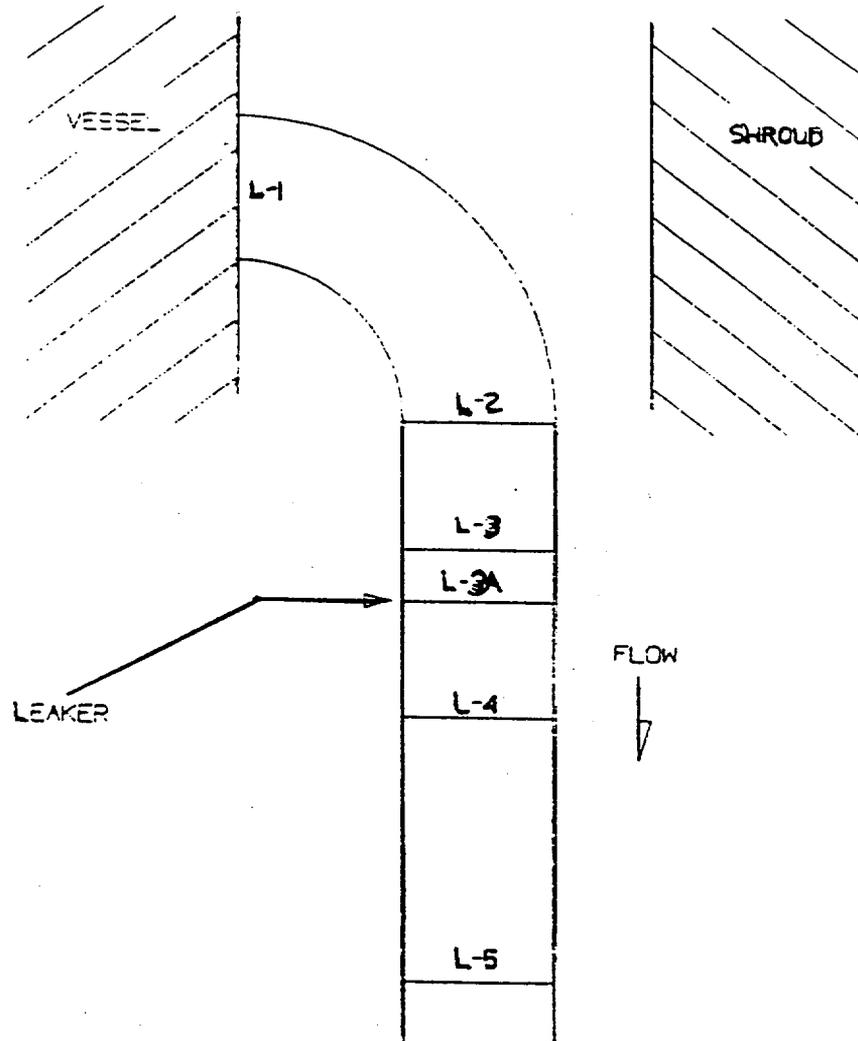
FIGURE 7

Inspection of the sparger during the air test noted air bubbles coming from the nozzles. With no means of isolating the nozzles, air escaping is normal during this examination. Inspection of the balance of the lower spargers on System I revealed no additional air leaks. Air bubbles were observed from the downcomer at 240°, weld L-3A as previously observed.

- One rounded, through wall, indication was observed in the toe of weld designated as L-3A. This weld is in System I of the annulus piping. Visual examination during outage 18R and previous air test revealed no change in this indication since it was discovered during outage 14R. This indication was determined to be a fabrication flaw.

CORE SPRAY PIPING WELD ID'S
LEAKER AT WELD L-3A
