**Operation Inspection Report
for
Nuclear Regulatory Commission
Inspected by
F E R C
Atlanta Regional Office**

Date of Inspection September 5, 1999

Dam (name) Safe Shutdown Impoundment Dam

NRC Licensed Project Comanche Peak Steam Electric Station

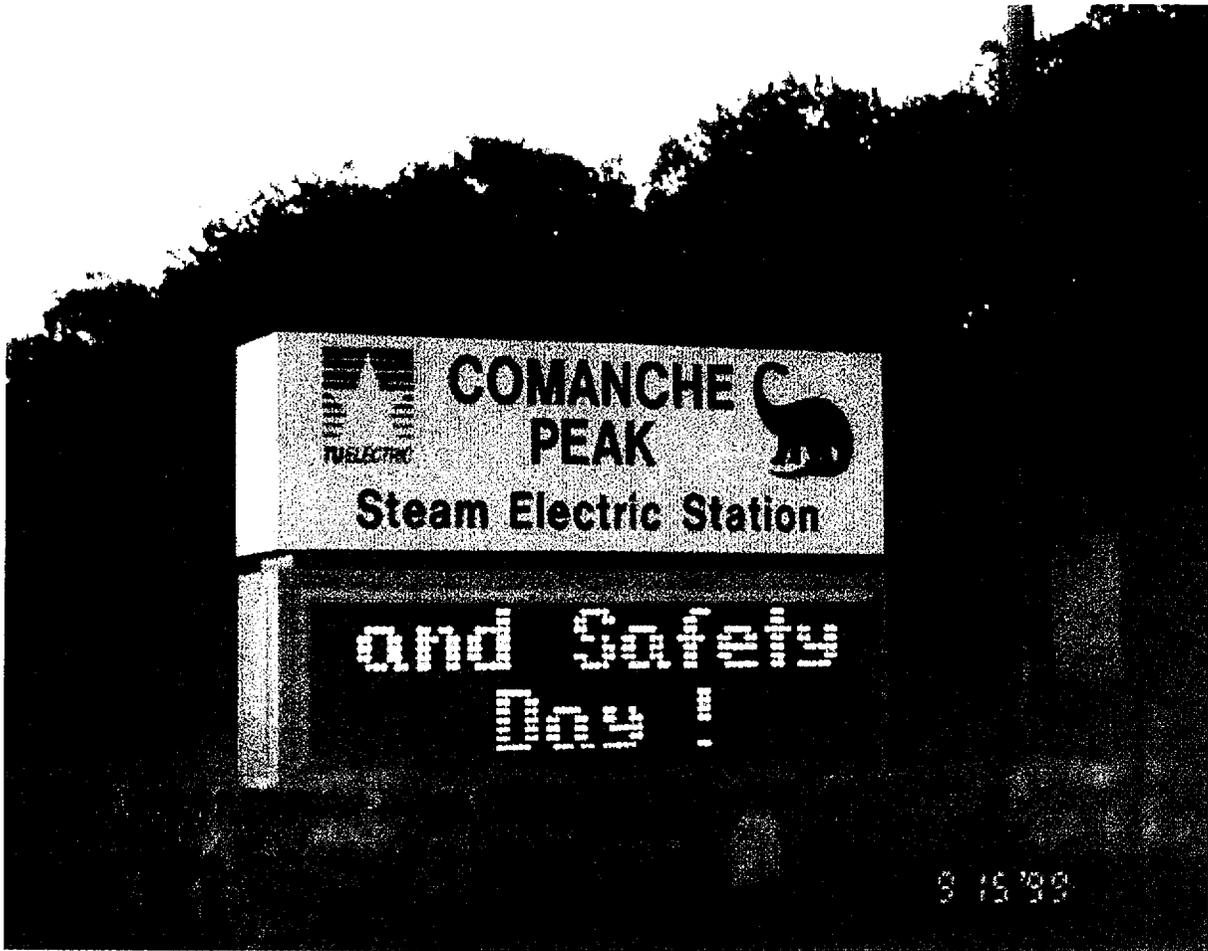
Photograph 1 Project sign located on the main entrance road.

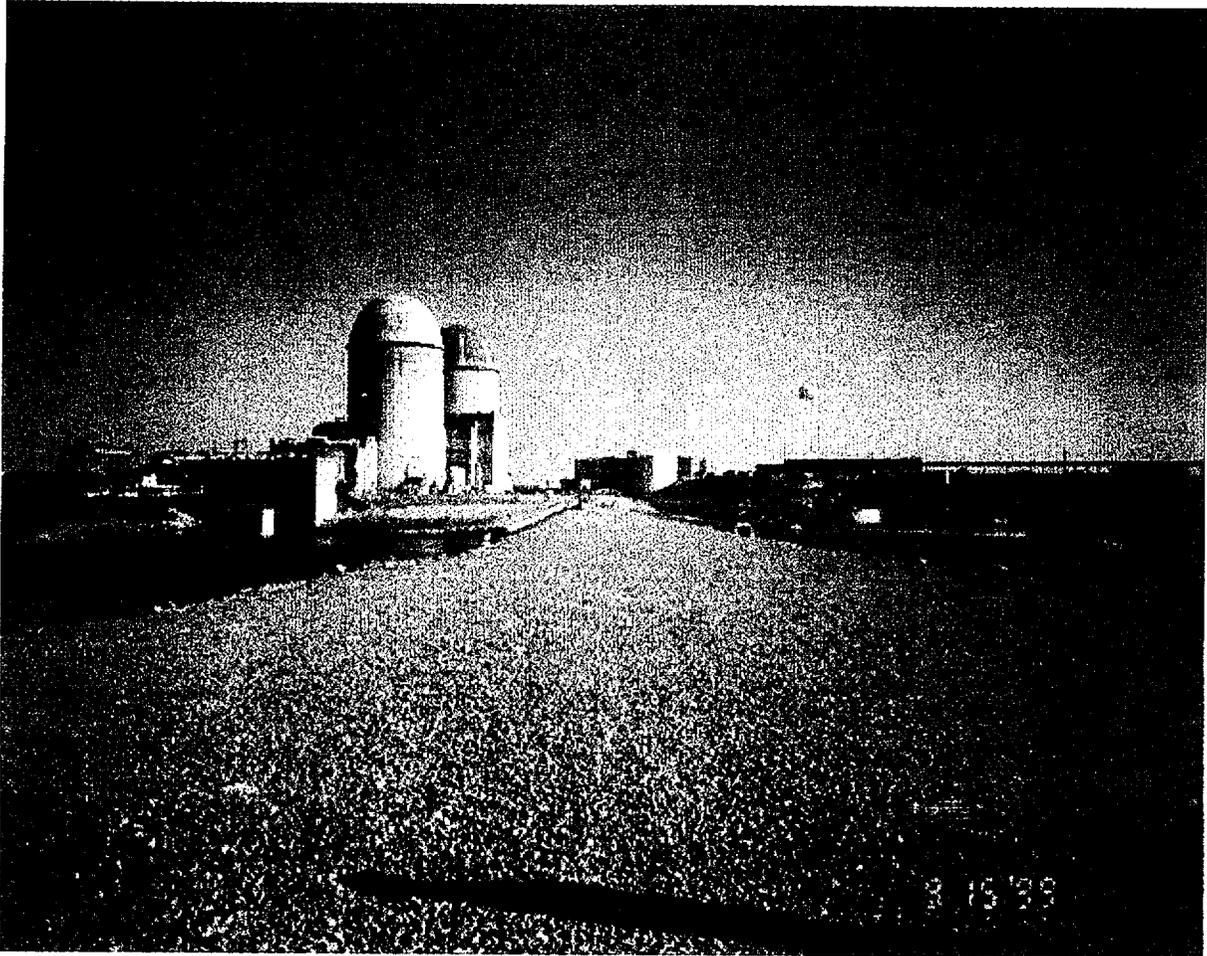
1. Safe Shutdown Impoundment Dam. The dam crest did not display any settlement, instability, or significant erosion. The crest gravel road did not exhibit any significant ruts or problem areas from vehicular traffic (Photograph 2). The left (north) end of the crest had an area that indicated the ponding of rainfall runoff from the abutment (Photograph 3). At the time of this inspection, the ponding did not appear to pose an immediate danger to the integrity of the dam. However, the licensee representatives were informed that some regrading or modifying of the left abutment might be necessary to redirect rainfall runoff from accessing and ponding on the dam. The alignment of the SSID appeared normal with no deformations observed.

Photograph 2 Gravel road on the SSID crest. The upstream slope (west\impoundment) side is on the left. The downstream slope (east\Squaw Creek Reservoir) is on the right. The Comanche Peak nuclear station is in the background.

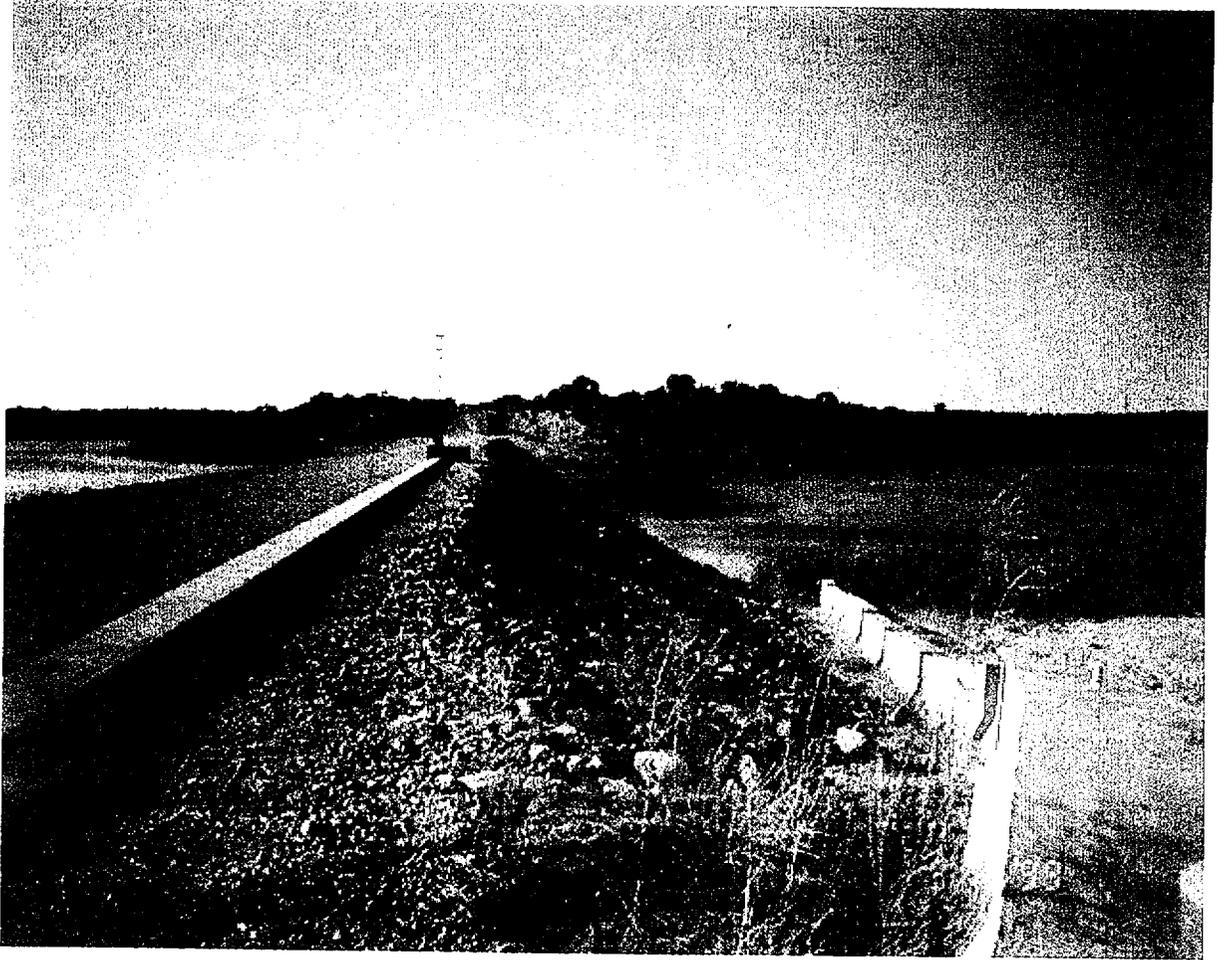
The slopes on the upstream (west\impoundment) side and downstream (east\Squaw Creek Reservoir) side appeared to be stable with no indications of movement, settlement, or instability observed (Photographs 4 and 5). Slope conditions underwater were not observed or surveyed; therefore, no determination of conditions below the reservoir or impoundment elevations were made during this inspection.

As noted during the FERC 1997 inspection, this inspection found the surface rock in the outside shells of the embankment to be subject to degradation. While no beaching or localized settlement appears to have occurred due to this condition, continued degradation of the rock could result in maintenance and possible stability problems. As in 1997, it was again recommended that when additional rockfill is required for slope repairs, the material should not be from the same source, and the licensee should conduct an evaluation of the rock for durability. Also discussed was the need for the licensee to inspect the rock slopes regularly for beaching, rock degradation, and slope instability. During the reporting period, the licensee conducted a survey of the rock shell slopes to ensure no detrimental conditions existed underwater.

Photograph 4 Riprapped upstream slope of the SSID.

1. As the surface rock on the outer shells of the SSID deteriorates, new rock will be required to repair deficient areas. Any new rock should be evaluated for durability and sized for fetch and wave run-up determined from the latest design criteria.
2. Piezometers should be tested and evaluated as to their operational status and the cause of the erratic readings above reservoir levels.
3. Survey base monuments should be checked to ensure the accuracy of the data.
4. The licensee should conduct periodic inspections and/or survey the slopes underwater to ensure the quality of the outer shells of the SSID.

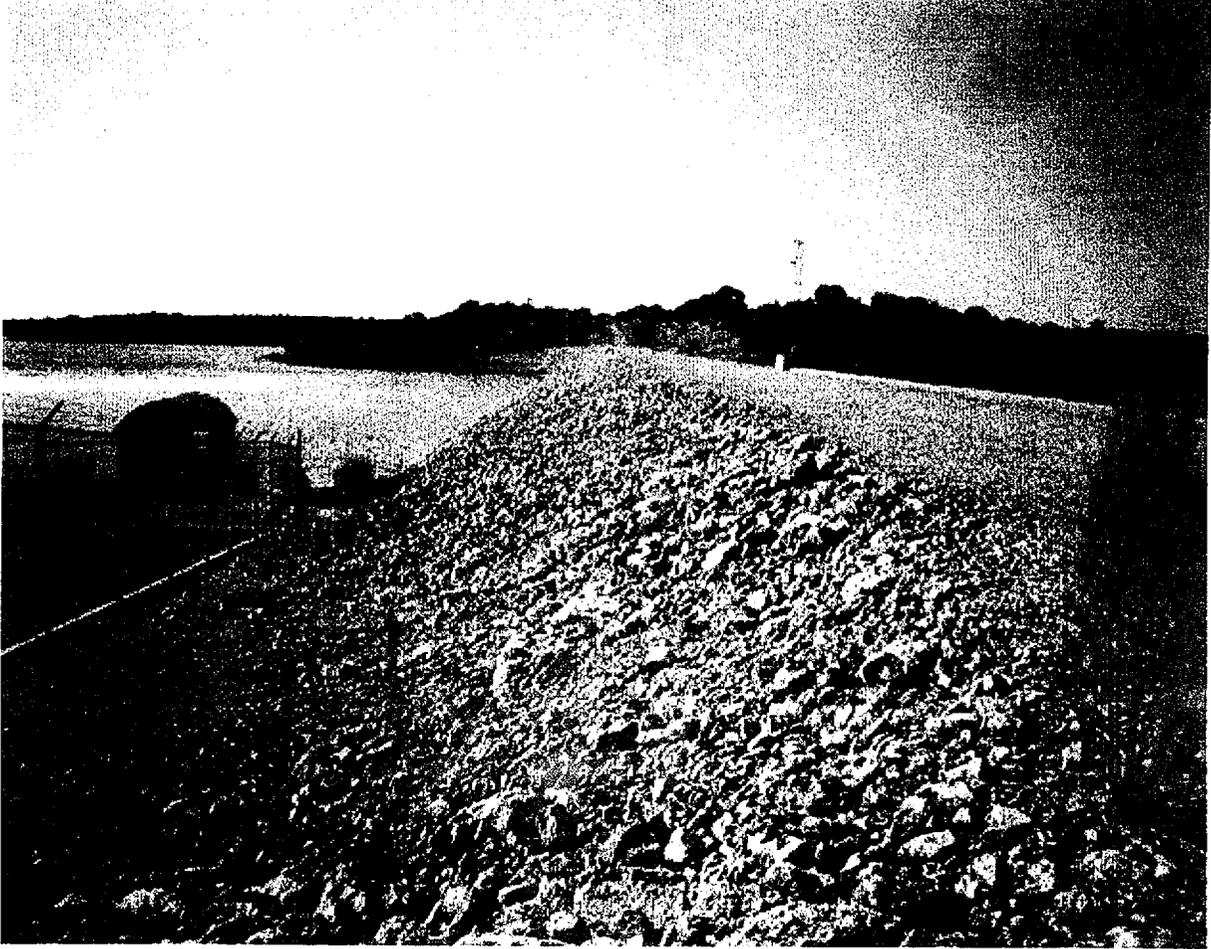
Photograph 5 Riprapped downstream slope of the SSID.

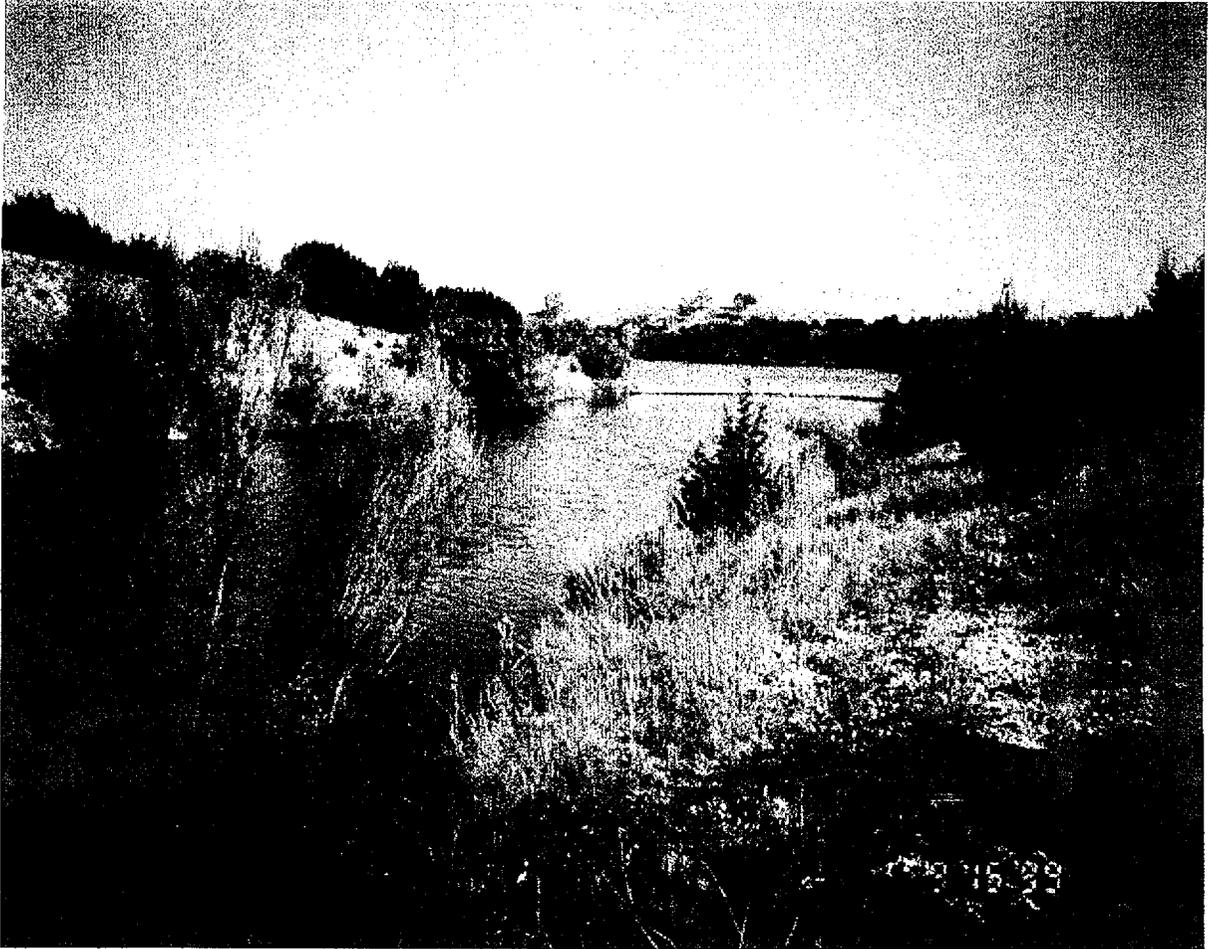
b. Equalization Canal. The equalization canal separates the impoundment from the main Squaw Creek reservoir (Photograph 6). A concrete weir with a top elevation of 769.5 feet NGVD, retains the required volume of cooling water should the main reservoir be lost. A floating boom at the impoundment end of the canal keeps algae out of the impoundment. The impoundment intake also has a strainer on it to remove algae. Along the equalization canal, no deficiencies in slope stability or erosion were noted. Underwater conditions of the canal could not be determined; however, licensee representatives stated that sedimentation in the canal and reservoir was deemed acceptable in a 1997 inspection. The licensee has scheduled a sediment survey of the canal to be conducted every 10 years. The 10-year timeframe appears to be acceptable since the SSI and canal are isolated and have a small rainfall runoff area. Based upon the survey results, the licensee will take the necessary actions to remove excess sediment and any undesirable underwater debris.

Photograph 6 The equalization canal looking towards the impoundment. The floating boom at the end of the canal keeps algae out of the impoundment.

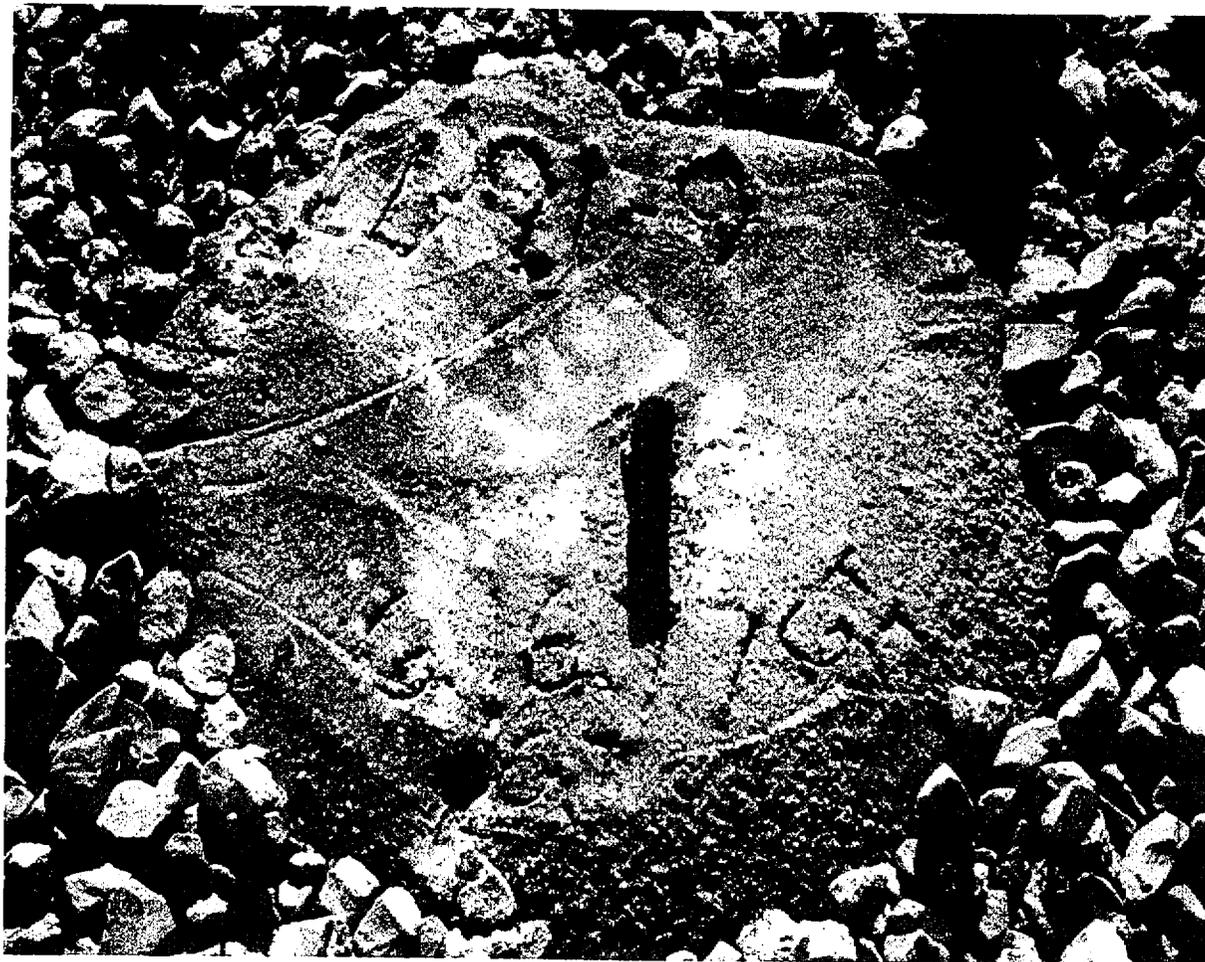
2. Instrumentation. Initially, instrumentation at the SSID included four piezometers and eight settlement monuments (Photographs 7 and 8). Currently, the settlement monuments and three piezometers are monitored.

A survey of the SSID settlement monuments was last conducted on June 26, 1998. The survey was compared to the 1996 and 1997 surveys and the 1983 baseline survey. The 1998 data had no change in the vertical or horizontal readings greater than +0.02 foot or -0.01 foot. Settlement since 1990 has been negligible with a total settlement since construction of about 0.12 foot. Horizontal deflection of the survey monument has been negligible since 1986 with a total deflection of about 0.12 to 0.14 foot. The changes are acceptable and within the expected range for a 70-foot-high rock filled dam. The licensee should also check the base monuments during the next survey to ensure the accuracy and reliability of the monitoring program.

Photograph 8 Typical survey monument located on the SSID crest to monitor movement.
