Byron Station, Unit 1  
Facility Operating License No. NPF-37  
NRC Docket No. STN 50-454

Subject: Licensee Event Report (LER) Unit 1-2000-003-00

**TITLE (4)** Unintentional Violation of Low Temperature Over Pressure Protection System Technical Specification Due to Operator Error

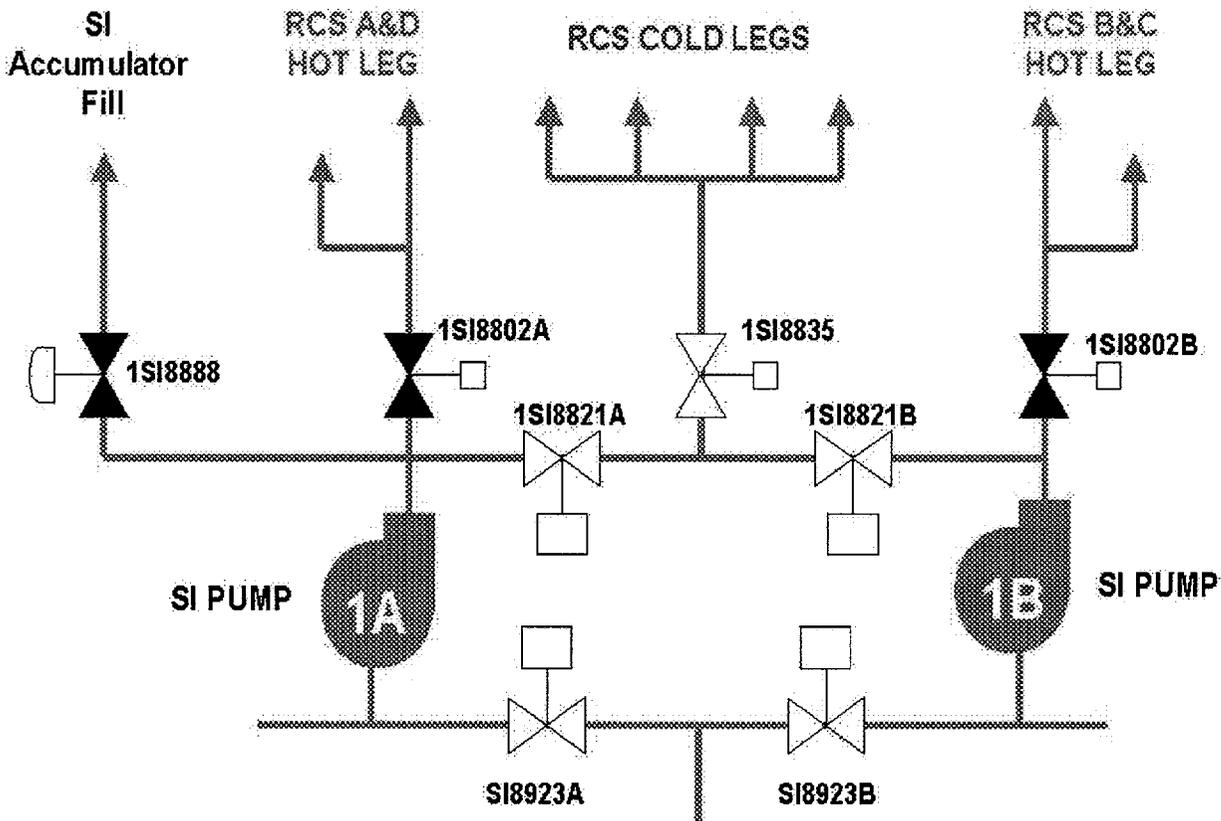
FIGURE 1 - Simplified Diagram of SI Flowpaths to the RCS

BOP-SI-5 ensured LTOP compliance for the 1A SI pump by closing and de-energizing valves 1SI8835, 1SI88802A, and 1SI8802B (refer to Figure 1). However, LTOP compliance for the 1A SI pump could be also be ensured by only closing and de-energizing 1SI8802A and 1SI8821A. In addition, a similar procedure change to improve LTOP flexibility was successfully used to the same procedure a few days before while attempting to fill the SI Accumulators. The U1 SRO and Shift Manager concurred and authorized a procedure change to allow, but not require, the option to substitute 1SI8821A for 1SI8835 and 1SI8802B. The change did not address the restoration. The U1 SRO later stated that he intentionally did not address 1SI8821A in the restoration step to ensure it would remain closed and de-energized. This possibility of changing the procedure was not discussed at the pre-job brief.

At approximately 2125 hours when 1SI8821A was opened, a direct flow path existed from the 1A SI pump to the RCS cold legs. With the 1A SI pump's motor breaker racked in and the control switch in PTL, two independent means to prevent a mass addition into the RCS did not exist. This condition is in non-compliance with Technical Specifications 3.4.12. On October 9, 2000, at 0129 hours while performing a routine Unit 1 Main Control Board walkdown, another licensed operator not involved in the Accumulator fill evolution discovered the non-compliant situation. 1SI8821A was immediately closed, which restored compliance to Technical Specification 3.4.12. This condition existed for approximately 4 hours and is a condition prohibited by Technical Specification and accordingly, reportable to the NRC in accordance with 10 CFR 50.73(a)(2)(i)(B).

BOP-SI-5 will be reviewed and revised, as appropriate, to correct wording weaknesses and to provide enhanced controls for LTOP compliance.
