RESPONSE TO FREEDOM OF INFORMATION ACT (FOIA) / PRIVACY ACT (PA) REQUEST

June 12, 2000

SUBJECT: RESOLUTION OF DEGRADED CEQ FAN ROOM WALL

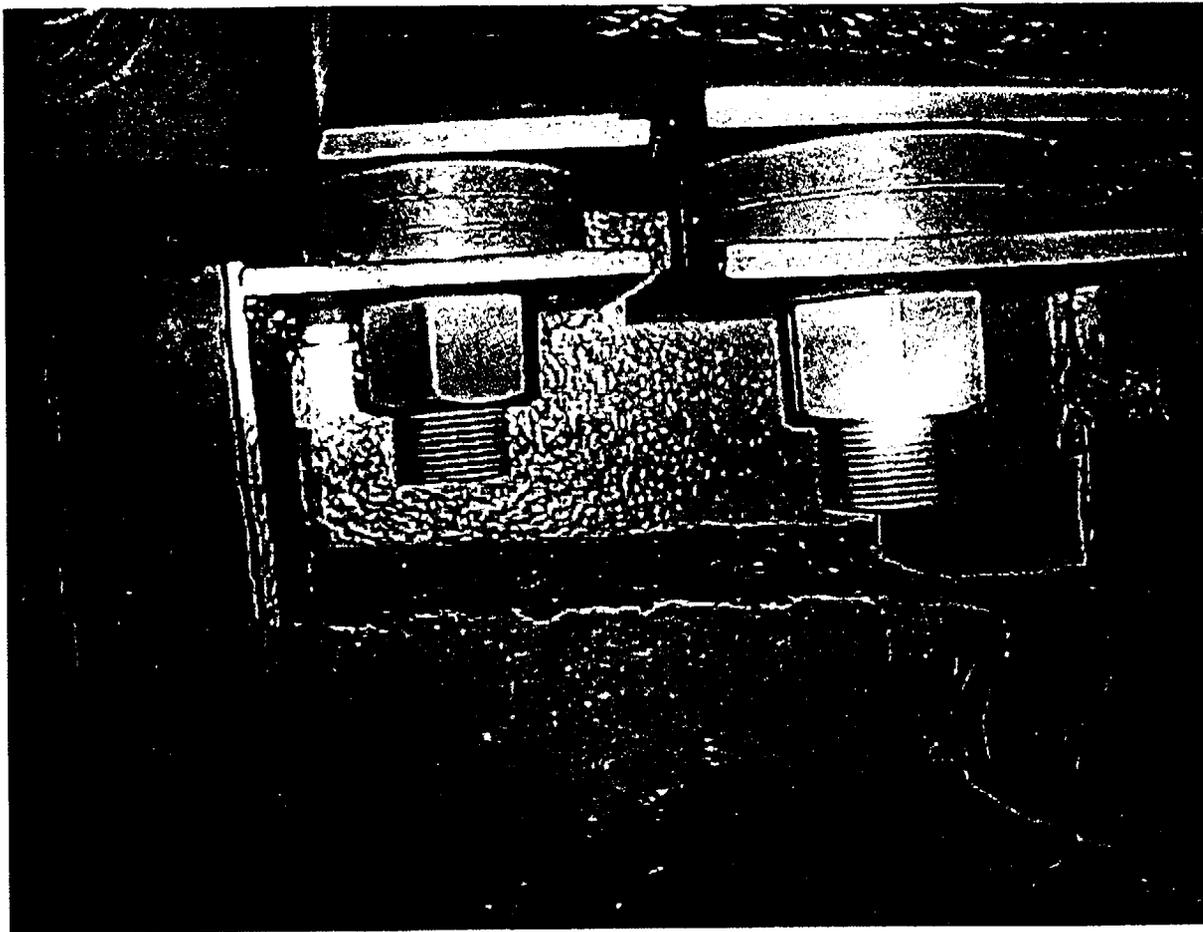
■ Detail Showing Pocket for Anchorage Through Bolts

Description of the Issues: Open Pockets - Configuration of Unit 2 Ice Condenser Column Anchorage

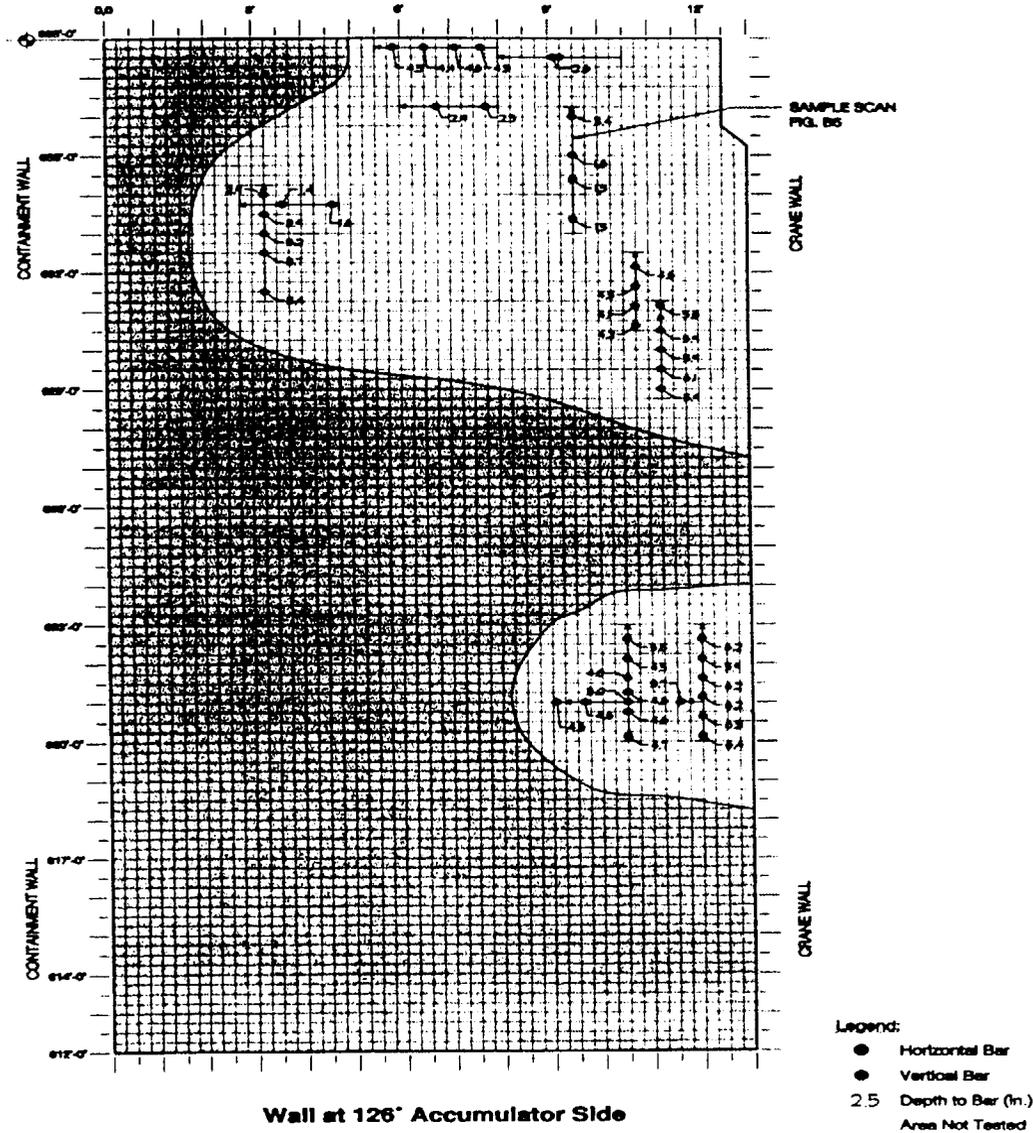
Description of the Issues: Wall Radar Mapping

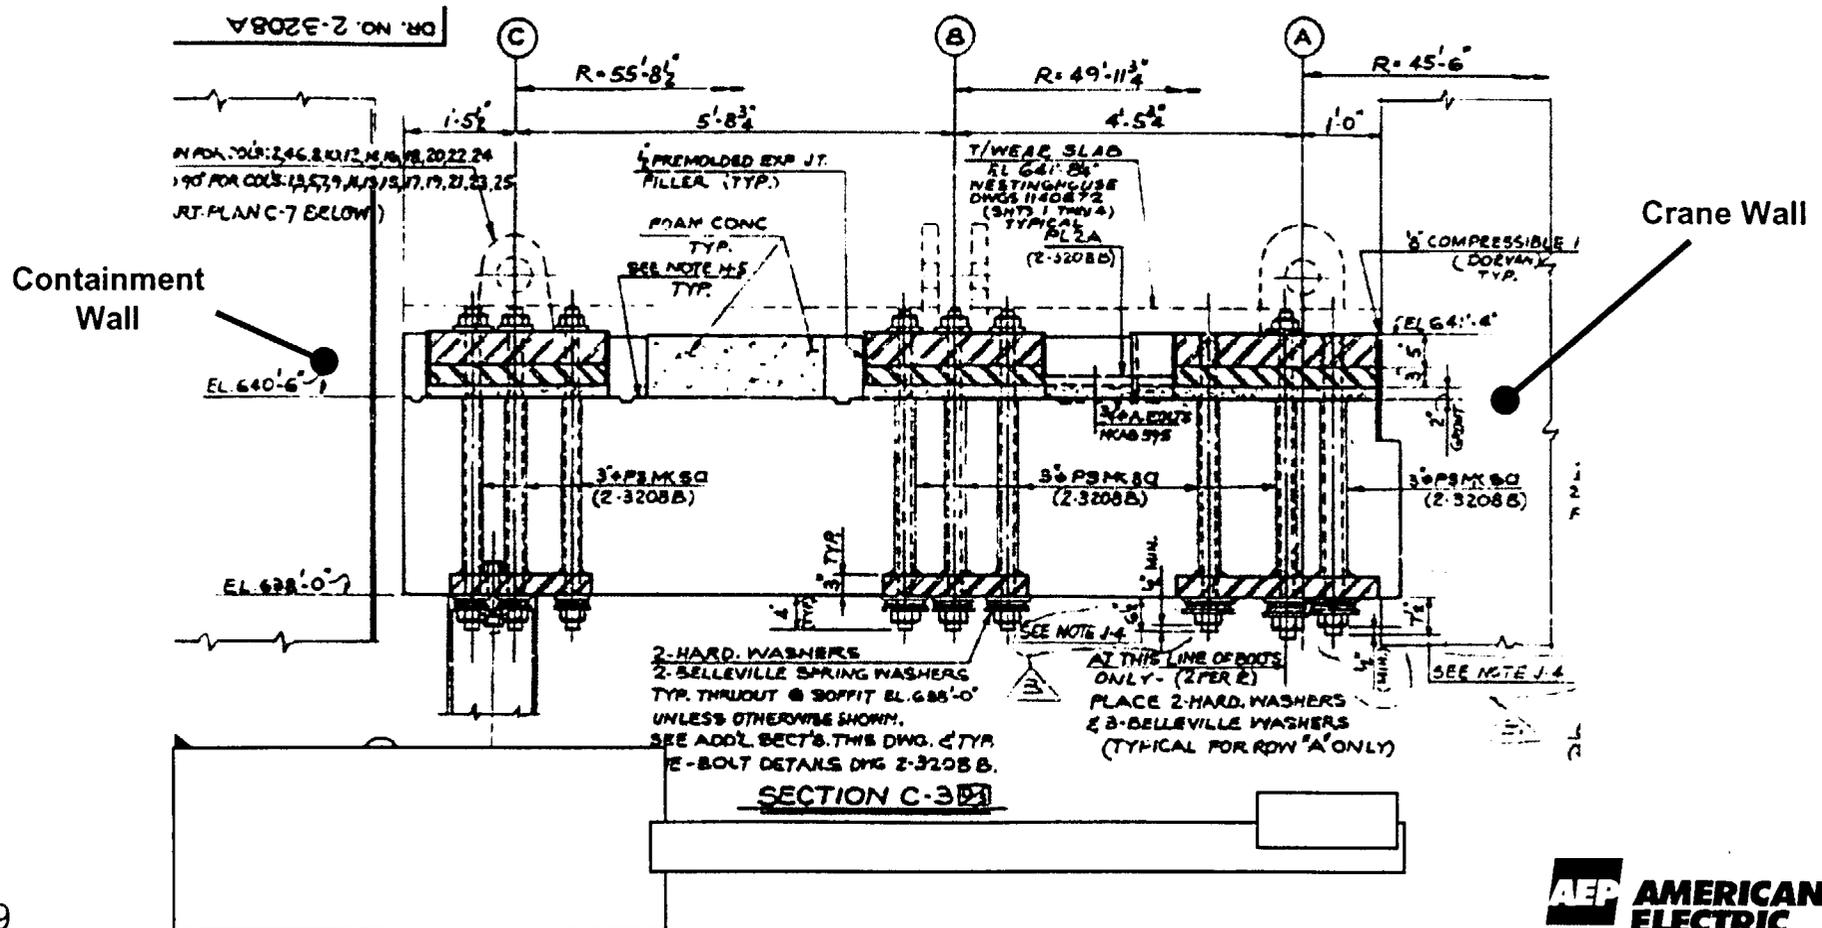
■ Typical Slab/Column Connection (Unit 2 Only)

Description of the Issues: Open Pockets - Configuration of Unit 2 Ice Condenser Column Anchorage

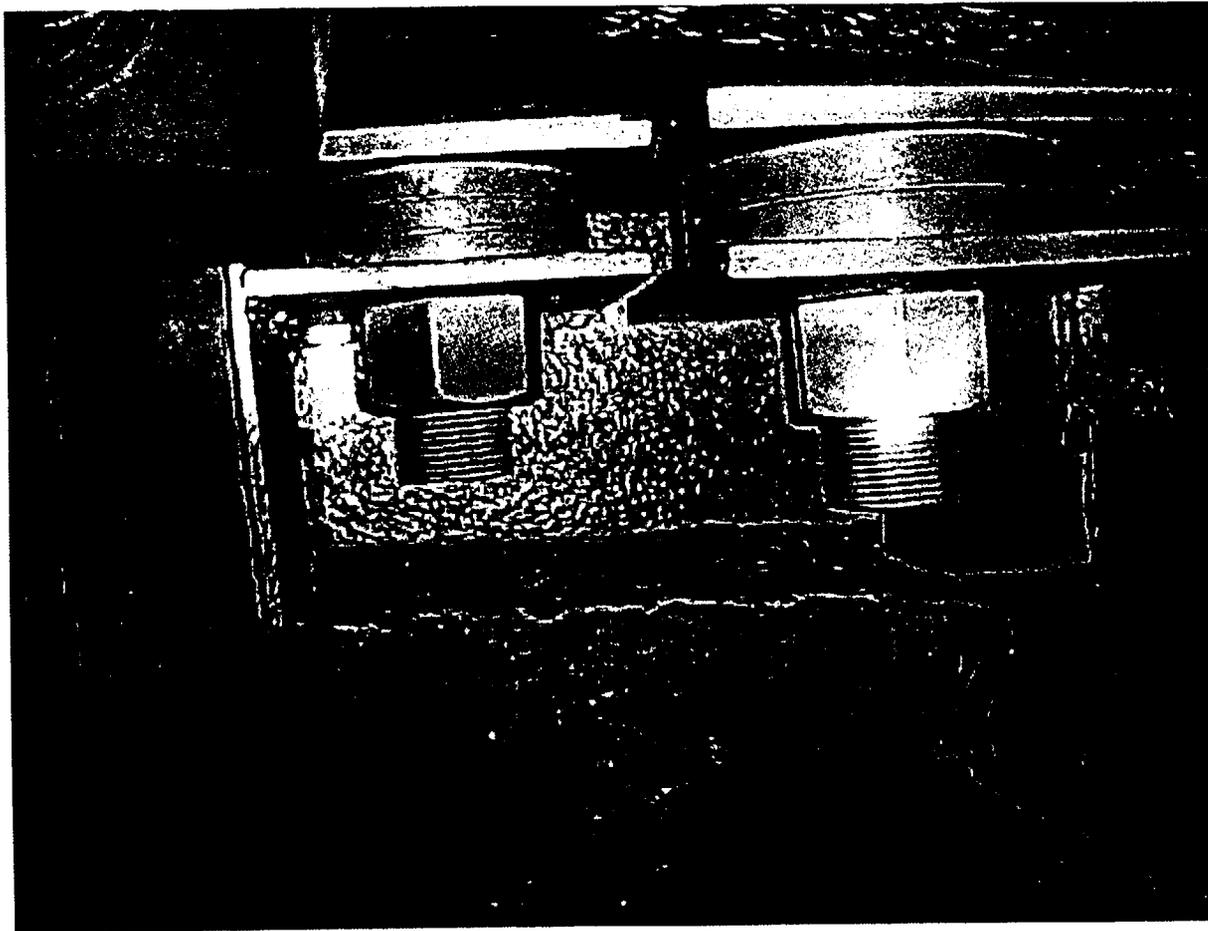
■ Detail Showing Pocket for Anchorage Through Bolts

Description of the Issues: Open Pockets - Configuration of Unit 2 Ice Condenser Column Anchorage

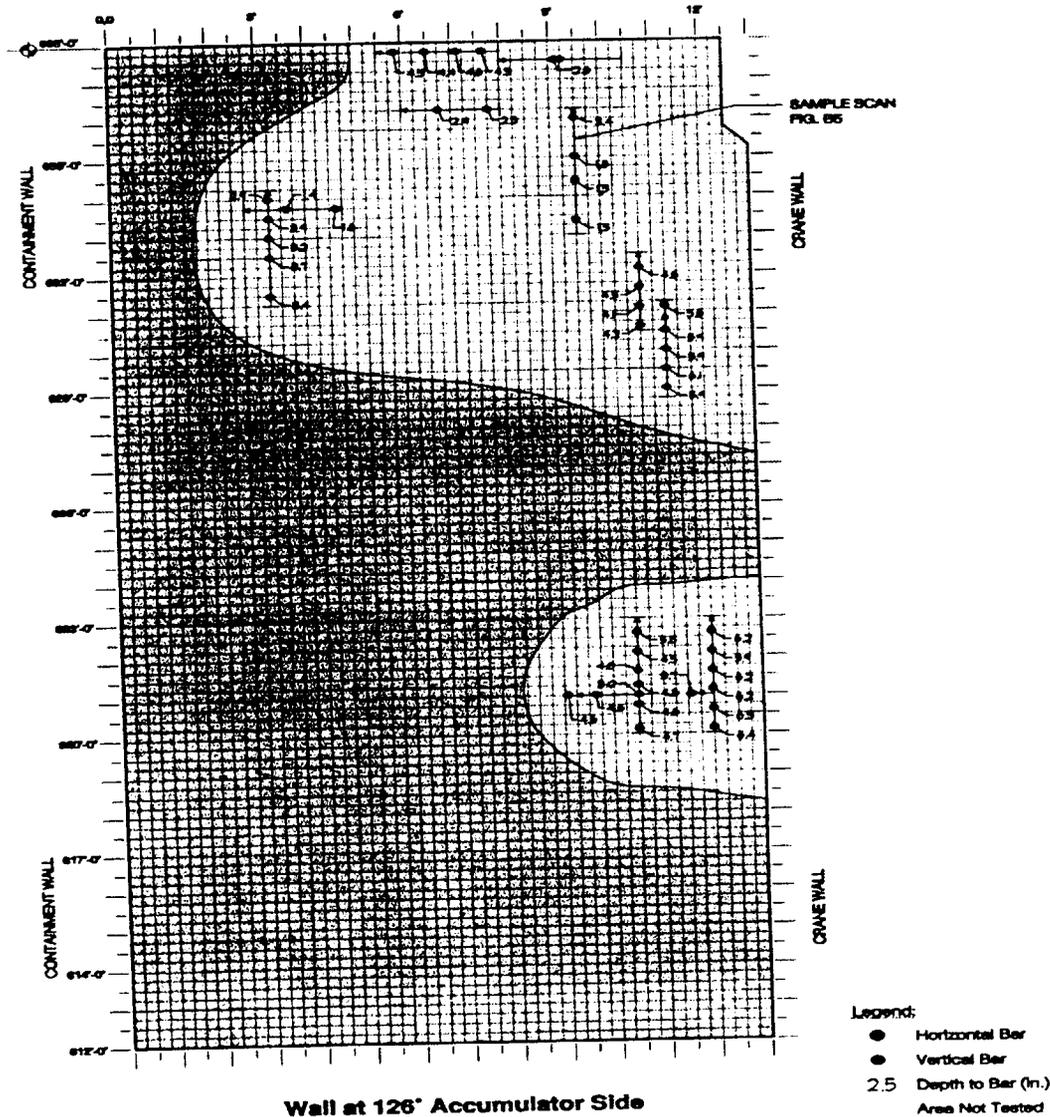
- **Radar Mapping - All Four Walls**
 - Critical accessible areas
 - Both sides of each wall

Description of the Issues: Wall Radar Mapping
