PG&E Letter DCL-00-148

Docket No. 50-323, OL-DPR-82  
Diablo Canyon Unit 2  
Licensee Event Report 2-2000-004-00  
Engineered Safety Features Actuation, Diesel Generators Started When Startup  
Power Was Lost Due to Personnel Error

# LICENSEE EVENT REPORT (LER)

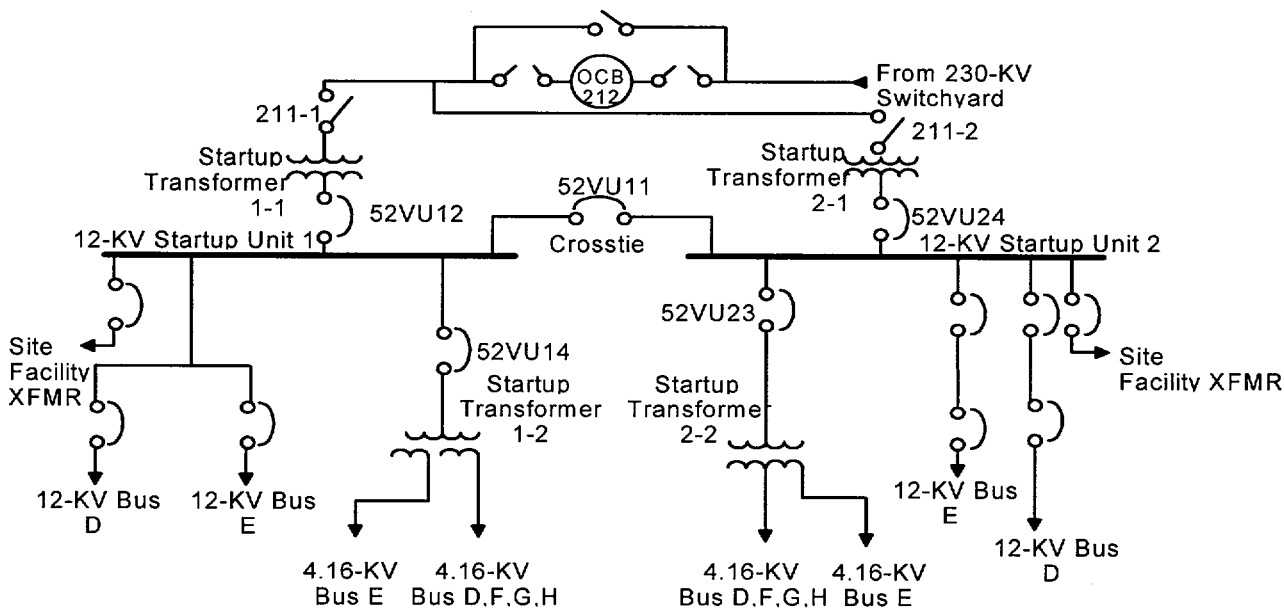
**Figure 1: Startup Power Diagram**

During normal operation, the vital buses are powered from the auxiliary power system. The 230kV system provides an alternate source of offsite power to the 4160V System. The 230kV system provides power to Startup Transformers (SUT)[EA][XFMR] 1-1 and 2-1 (230kV to 12kV), which feeds SUT 1-2 and 2-2 (12kV to 4160V), respectively. Startup Transformers 1-2 and 2-2 then supply power to each vital bus. Figure 1 provides additional detail of the startup power system.

On October 23, 2000, at 1637 PDT, while performing switching associated with T0-0006, Step 6.2, licensed plant operators incorrectly opened Disconnect Switch 211-2, causing a loss of startup power to Unit 2, starting all three Unit 2 EDGs. Step 6.2 actually instructed plant operators to open 211-1 to deenergize SUT 1-1.

Disconnect switch 211-2 was inadvertently opened, which caused the EDGs to start.

The root cause of the event is personnel error due to lack of attention. Both the performer and the verifier failed to verify that the disconnect switch number matched the number in the procedure.

Labeling of the 211-1 and 211-2 air switch control cabinets was insufficient. The labels did not identify the unit by color.

1. Color-coded signs have been installed to designate the switch corresponding to each unit.
2. The operators that made the error were coached and counseled on correct self-verification techniques.
