DOCKET NOS. 50-266 AND 50-301  
LICENSEE EVENT REPORT 266/2000-010-00  
MANUAL REACTOR TRIP DUE TO CONCERNS FOR DIVER SAFETY  
POINT BEACH NUCLEAR PLANT UNIT 1

<b>FACILITY NAME (1)</b> Point Beach Nuclear Plant, Unit 1	<b>DOCKET NUMBER (2)</b> 05000266	<b>PAGE (3)</b> 1 of 5
---	--------------------------------------	---------------------------

**TITLE (4)**  
Manual Reactor Trip Due to Concerns for Diver Safety

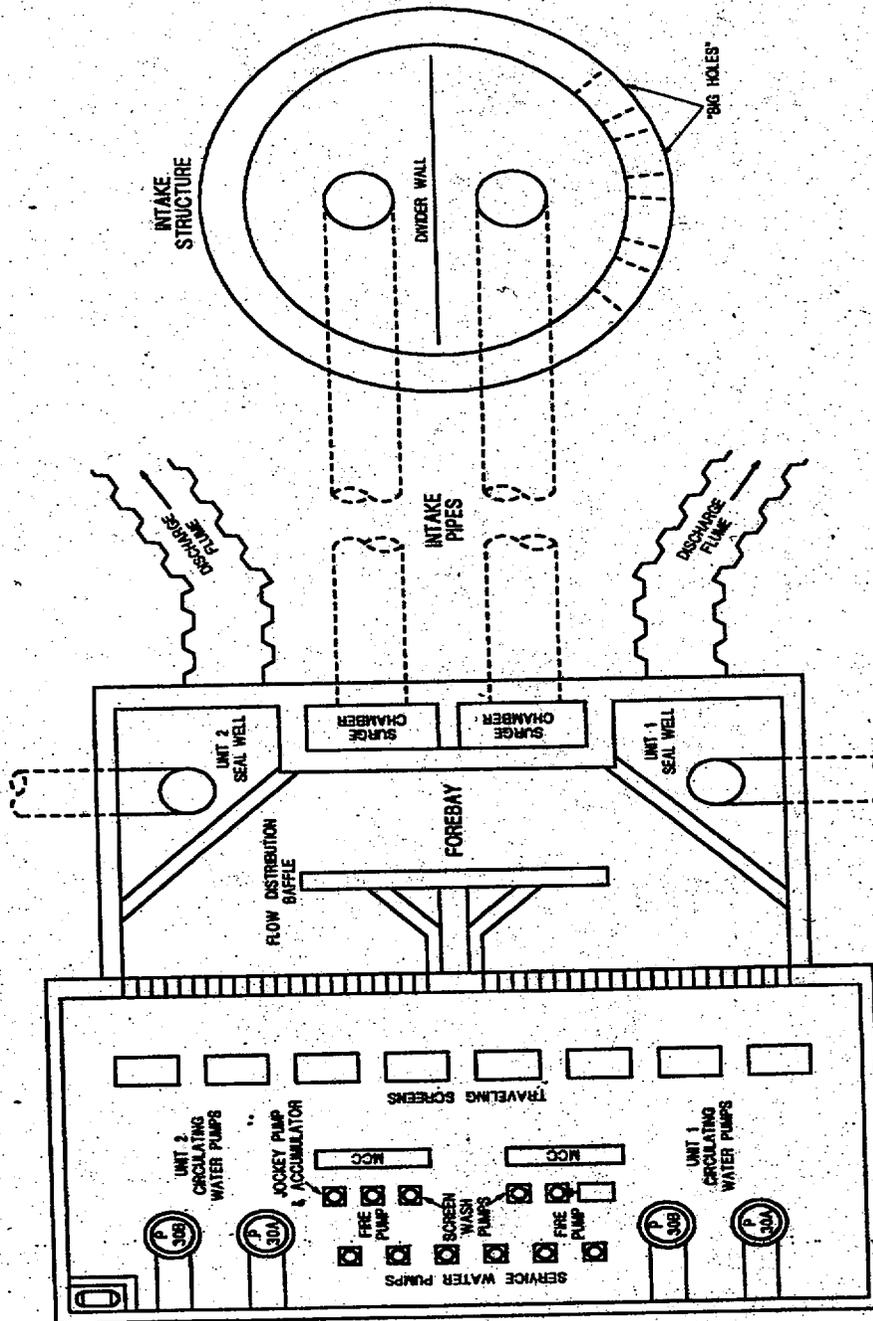
**FIGURE 11.7.1 INTAKE AND PUMP HOUSE**

The circulating water system consists of the intake system pump house facility, circulating water pumps, traveling screen and screen wash system, main condensers, vacuum priming system, discharge flumes and interconnecting piping and valves (See Figure 11.7.1 attached). The circulating water intake system is common; but once in the pump house the system splits to Unit 1 and Unit 2 components. The intake system consists of an open-ended, cylindrically-shaped structure constructed of steel piling and limestone rock located 1750 feet off-shore. Two 14 foot diameter pipes connect the intake structure to the forebay of the pump house facility. The pump house facility consists of two intake surge chambers, a common forebay, pump bay and two discharge seal wells. The pump bay is divided into two sections with two circulating water pumps, three service water pumps, one screen wash pump and one fire pump taking suction from each section. Fourteen foot diameter motor-operated butterfly valves isolate the intake surge chambers from the forebay and discharge seal wells. Fourteen foot diameter motor-operated butterfly valve are also provided to isolate the seal wells from the respective discharge flumes. The arrangement of isolation valves permits reversing flow through either inlet pipe during winter operations to recirculate warm circulating water out to the intake structure to prevent freezing. The entrance to each pump bay section is partitioned into four separate passageways each containing traveling water screens to remove small debris. After passing through the screens, the water enters the pump bay section.

The circulating water systems in both units are identical. Each system consists of two single-stage, vertical pumps rated at 178,000 gpm, a common supply header, individual condenser waterbox inlet and outlet lines, and a common discharge header. The discharge header runs from the outlet of the condenser water boxes into two 96" diameter discharge lines. The two discharge lines run through the turbine building foundation and then transition into a 12 foot diameter line which runs underground and terminates under water in the forebay seal well compartment. It was this discharge piping that was being inspected by the divers during this event. In the days prior to this event, the contract diving service personnel had been on-site to inspect other areas of the Unit 2 circulating system including the forebay, pump bay and surge chamber.

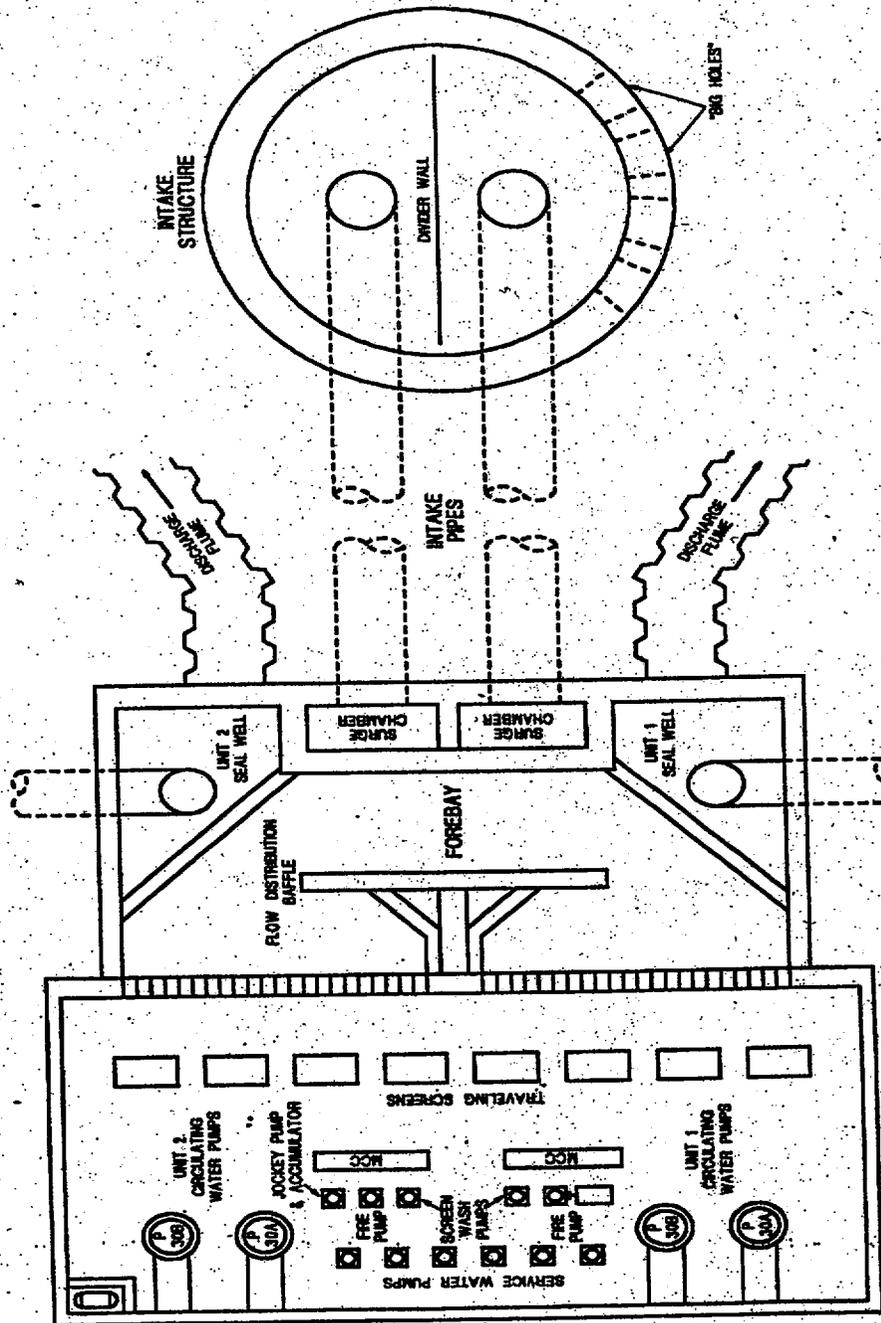
**FIGURE 11.7.1 INTAKE AND PUMP HOUSE**

The circulating water system consists of the intake system pump house facility, circulating water pumps, traveling screen and screen wash system, main condensers, vacuum priming system, discharge flumes and interconnecting piping and valves (See Figure 11.7.1 attached). The circulating water intake system is common; but once in the pump house the system splits to Unit 1 and Unit 2 components. The intake system consists of an open-ended, cylindrically-shaped structure constructed of steel piling and limestone rock located 1750 feet off-shore. Two 14 foot diameter pipes connect the intake structure to the forebay of the pump house facility. The pump house facility consists of two intake surge chambers, a common forebay, pump bay and two discharge seal wells. The pump bay is divided into two sections with two circulating water pumps, three service water pumps, one screen wash pump and one fire pump taking suction from each section. Fourteen foot diameter motor-operated butterfly valves isolate the intake surge chambers from the forebay and discharge seal wells. Fourteen foot diameter motor-operated butterfly valve are also provided to isolate the seal wells from the respective discharge flumes. The arrangement of isolation valves permits reversing flow through either inlet pipe during winter operations to recirculate warm circulating water out to the intake structure to prevent freezing. The entrance to each pump bay section is partitioned into four separate passageways each containing traveling water screens to remove small debris. After passing through the screens, the water enters the pump bay section.

The circulating water systems in both units are identical. Each system consists of two single-stage, vertical pumps rated at 178,000 gpm, a common supply header, individual condenser waterbox inlet and outlet lines, and a common discharge header. The discharge header runs from the outlet of the condenser water boxes into two 96" diameter discharge lines. The two discharge lines run through the turbine building foundation and then transition into a 12 foot diameter line which runs underground and terminates under water in the forebay seal well compartment. It was this discharge piping that was being inspected by the divers during this event. In the days prior to this event, the contract diving service personnel had been on-site to inspect other areas of the Unit 2 circulating system including the forebay, pump bay and surge chamber.
